SUBJECT: *Historic Structures Survey Report – Improve Four Sections on SR 1152 (Holly Springs Road) at SR 3977 (Cary Parkway), SR 1385 (Lilly Atkins Road), SR 1379 (Penny Road), and SR 1010 (Ten Ten Road), Wake County, North Carolina.*  
*TIP No. U-6217, WBS No. 48677.1.1, PA Tracking No. 24-05-0002.*  
*ER 25-0951.*

**SUBJECT:** Historic Structures Survey Report – Improve Four Sections on SR 1152  
(Holly Springs Road) at SR 3977 (Cary Parkway), SR 1385 (Lilly Atkins Road),  
SR 1379 (Penny Road), and SR 1010 (Ten Ten Road), Tip No. U-6217,  
WBS No. 48677.1.1, PA Tracking No. 24-05-0002, Wake County, ER 25-0951

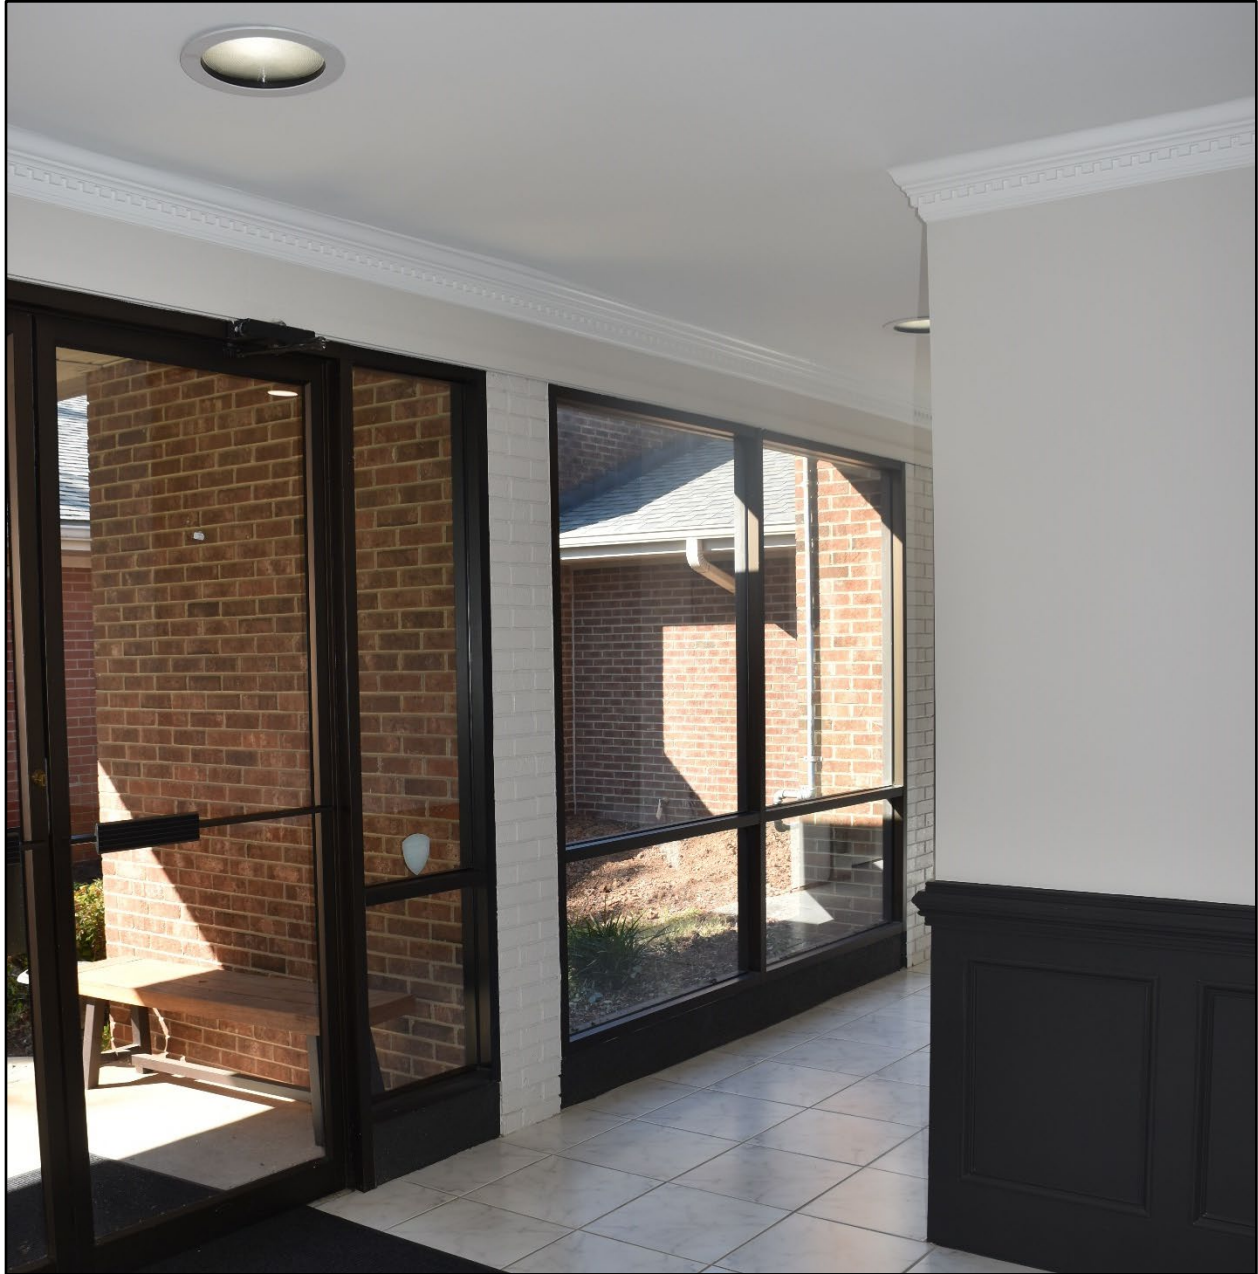
*Figure 8- View of non-historic tile, trim, and paint in the church foyer, which is located between the sanctuary and educational wing.*

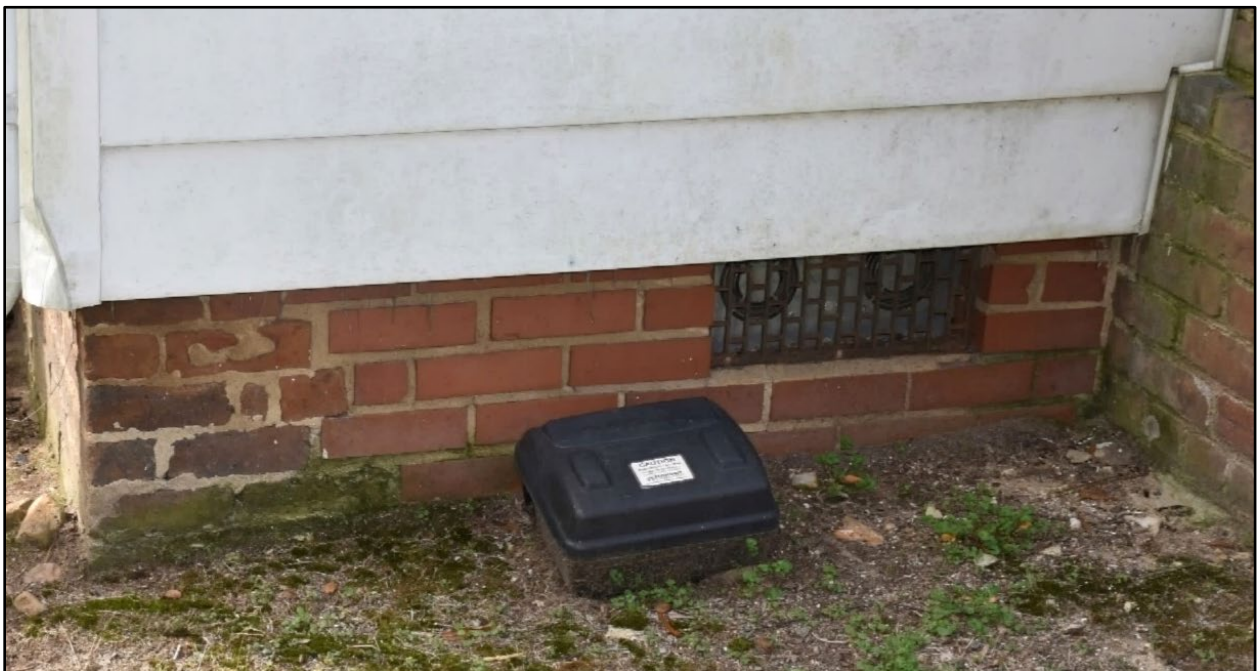
*Figure 102- Original brick foundation piers (left) and brick chimney (right) on the southeast corner of the house, with a post-1961 brick foundation course between (compare with Figure 124).*

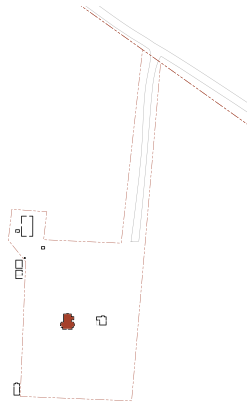
FARM HOUSE

OVERALL STRUCTURAL CONDITION: GOOD

OVERALL ARCHITECTURAL CONDITION: GOOD

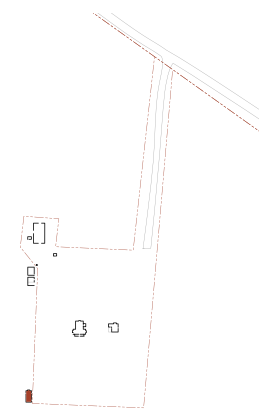
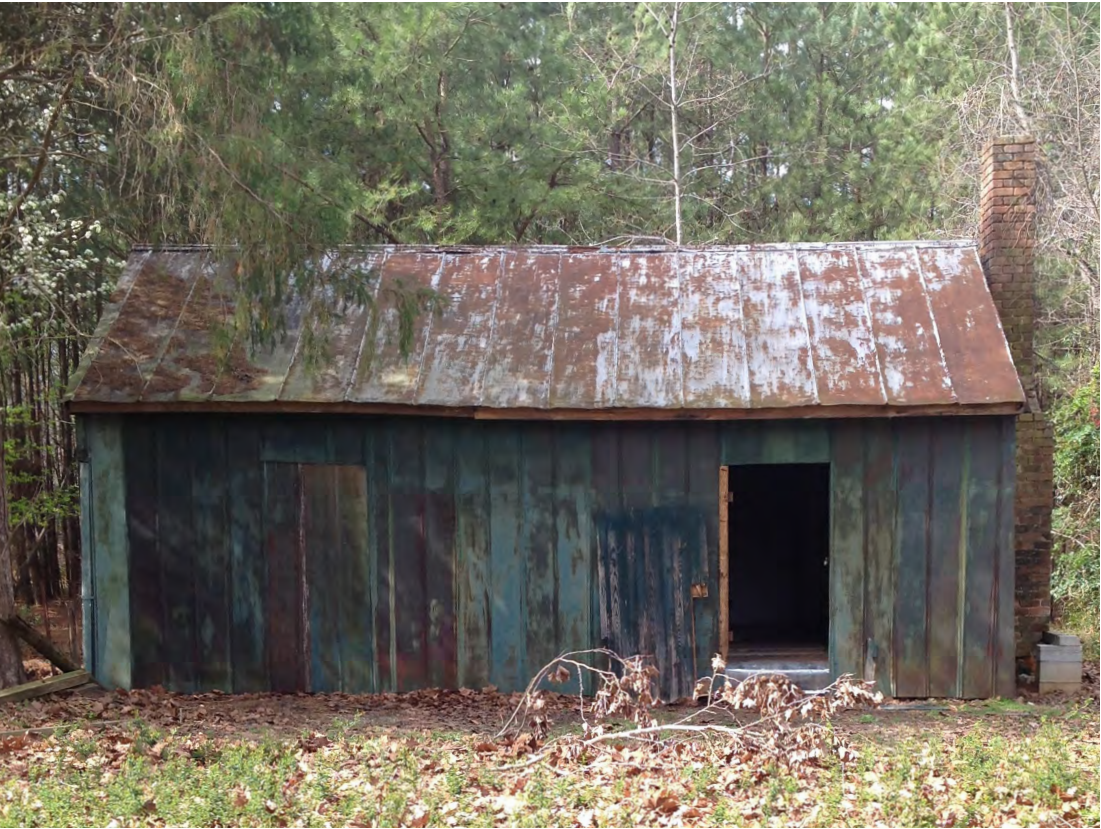
BUILDING:  
DWELLING

OVERALL STRUCTURAL CONDITION: FAIR TO POOR

OVERALL ARCHITECTURAL CONDITION: FAIR TO POOR

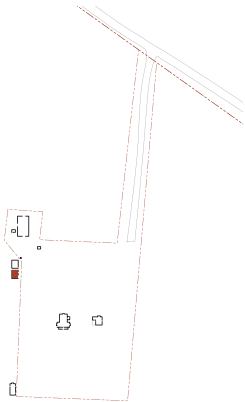
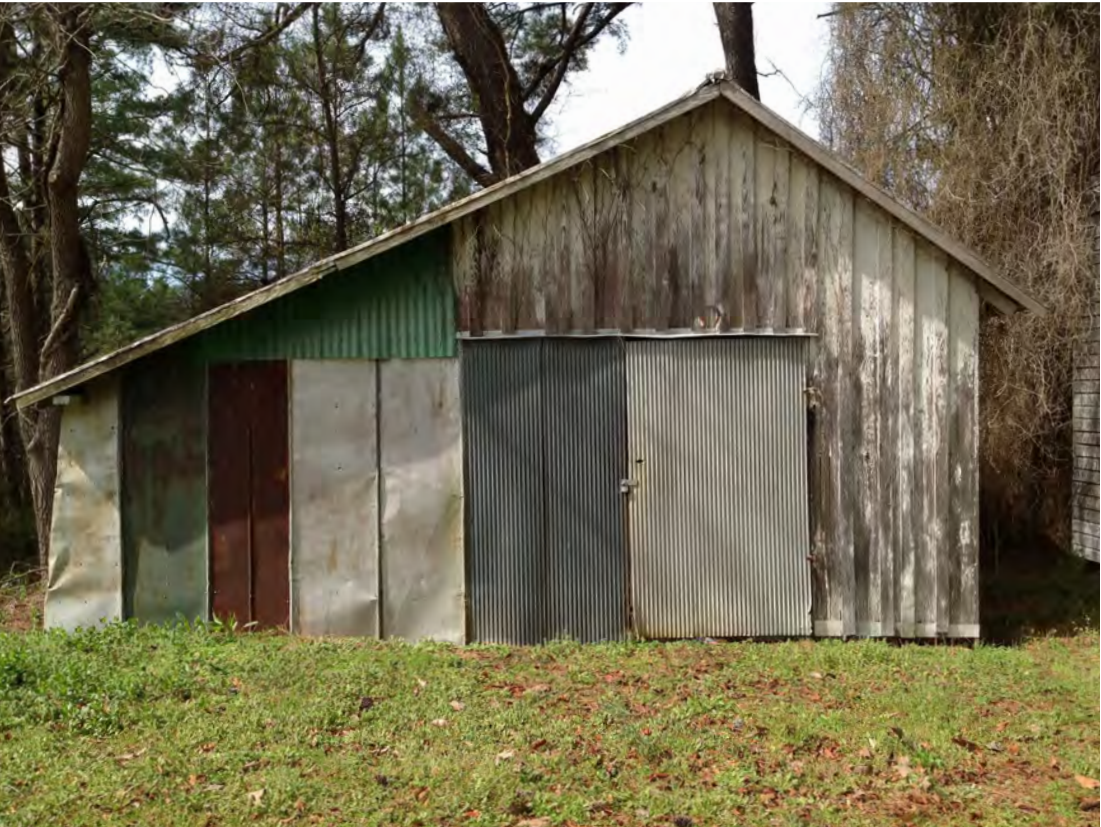
CIDER BARN

OVERALL STRUCTURAL CONDITION: POOR

OVERALL ARCHITECTURAL CONDITION: POOR

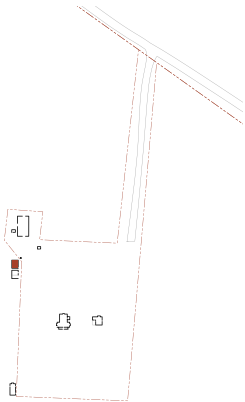
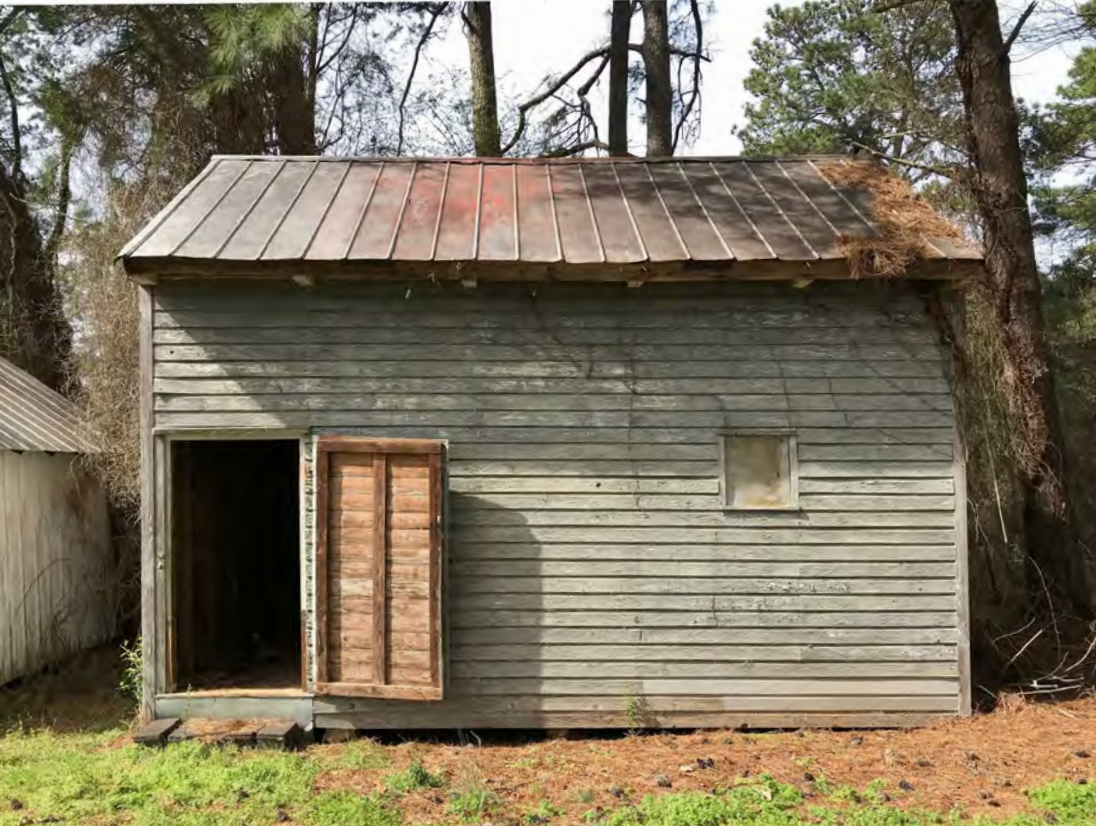
GRAIN BARN

OVERALL STRUCTURAL CONDITION: FAIR TO POOR

OVERALL ARCHITECTURAL CONDITION: FAIR

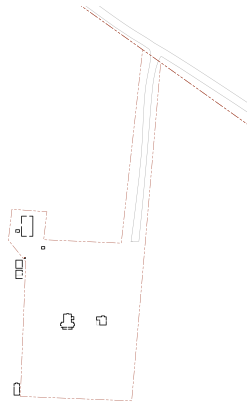
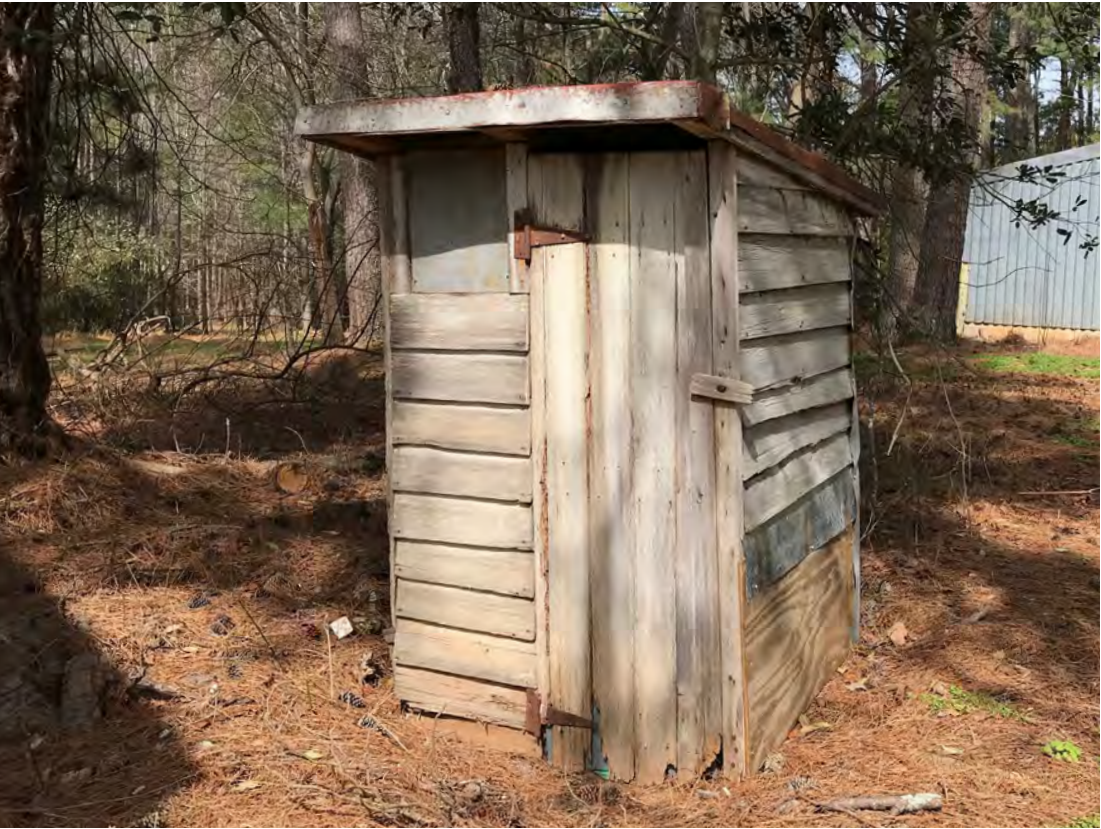
BUILDING:  
OUTHOUSE

OVERALL STRUCTURAL CONDITION: FAIR

OVERALL ARCHITECTURAL CONDITION: POOR

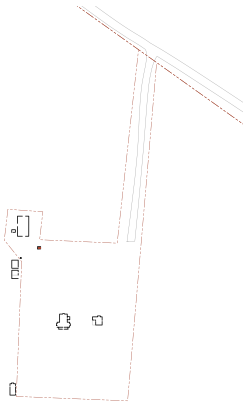
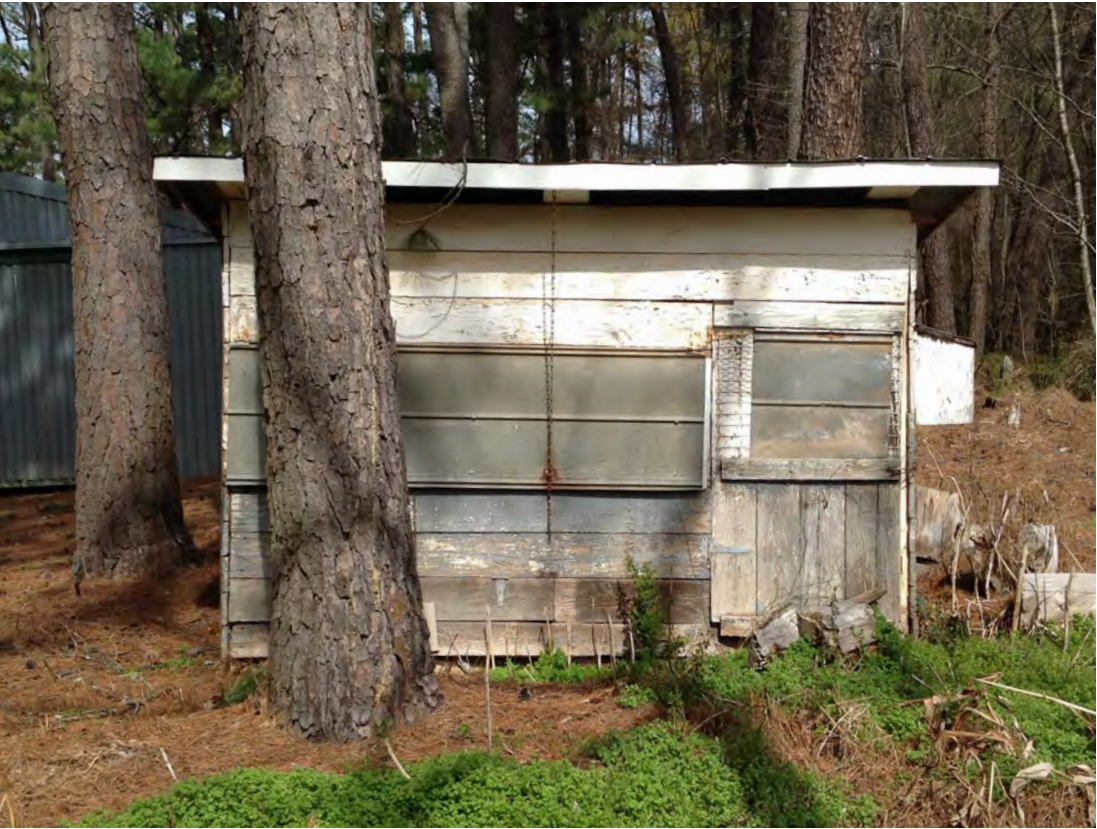
CHICKEN COOP

OVERALL STRUCTURAL CONDITION: FAIR

OVERALL ARCHITECTURAL CONDITION: FAIR TO POOR

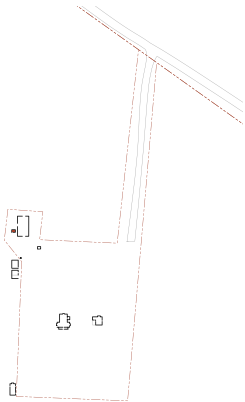
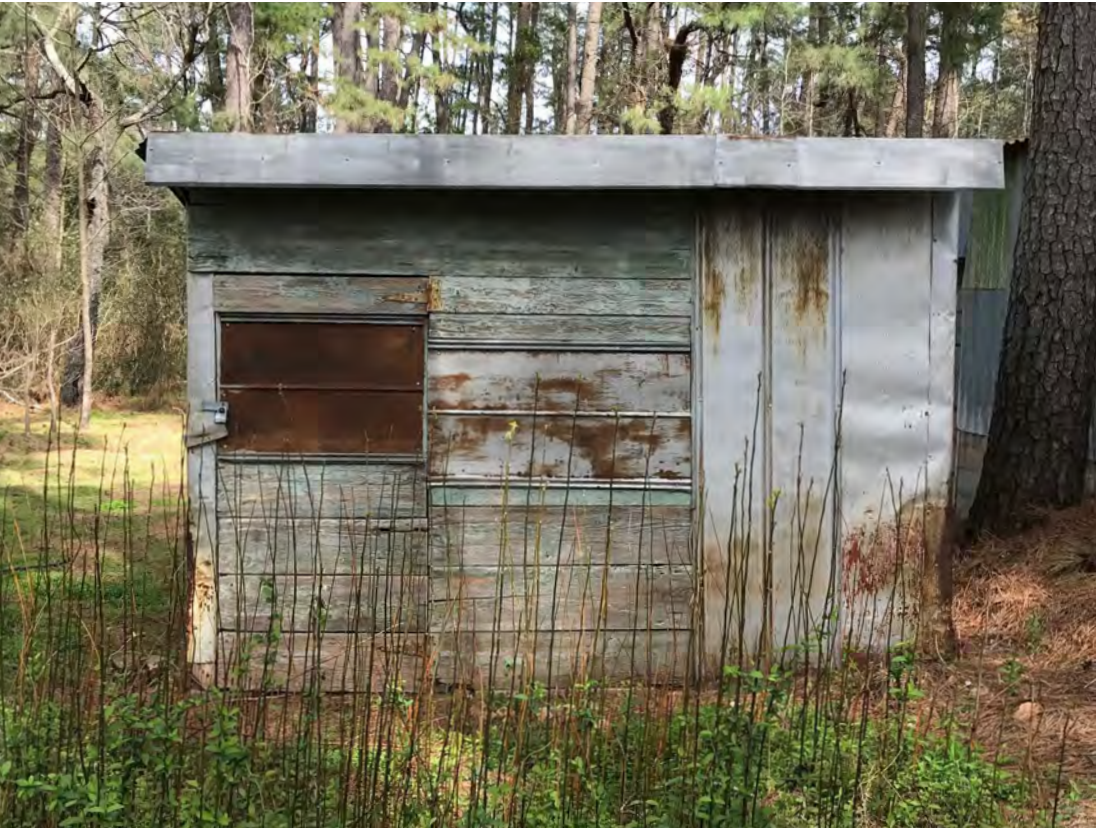
FEED SHED

OVERALL STRUCTURAL CONDITION: FAIR

OVERALL ARCHITECTURAL CONDITION: FAIR TO POOR

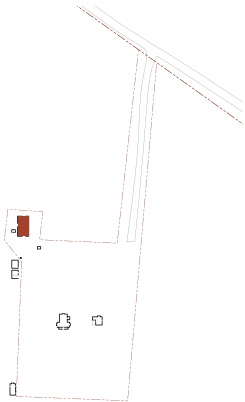
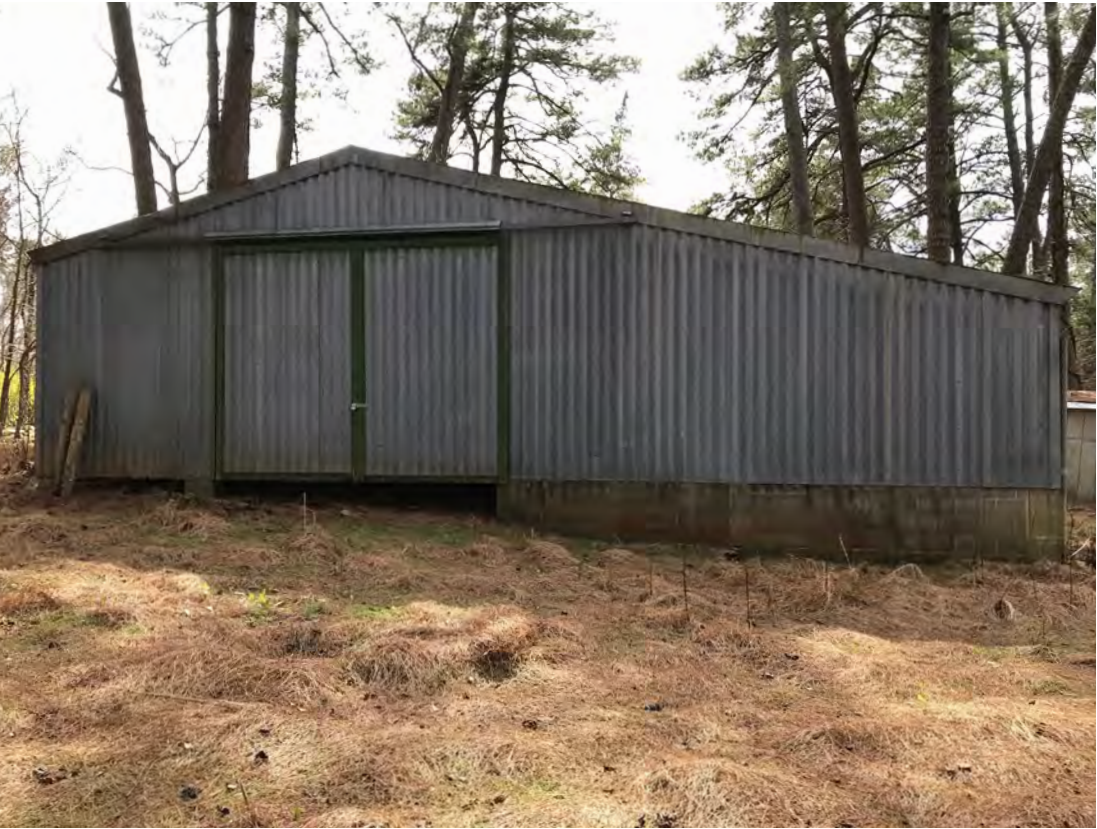
LIVESTOCK BARN

OVERALL STRUCTURAL CONDITION: GOOD TO FAIR

OVERALL ARCHITECTURAL CONDITION: GOOD TO FAIR
