**North Carolina Department of Natural and Cultural Resources  
State Historic Preservation Office**

Re: Feasibility Study for Downtown Multi Modal Transit Center, Cary, Wake County, ER 19-0950

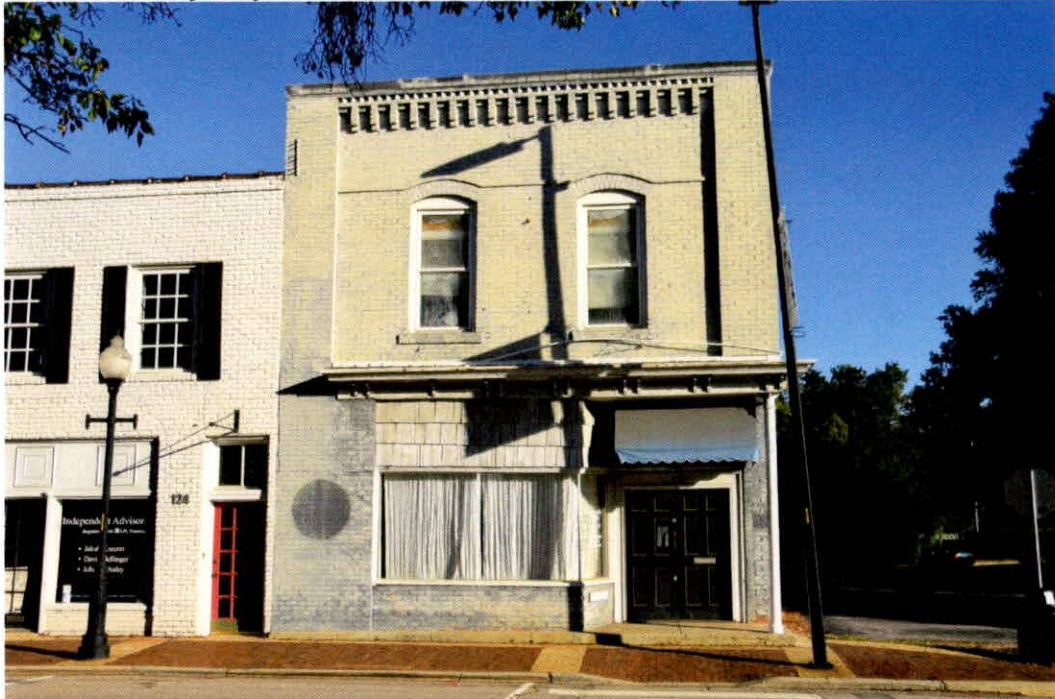
Early twentieth-century, two-story brick Italianate commercial building with parapet roof, corbelled cornice, bracketed cornice at first-floor storefront, segmental-arched hooded windows. Storefront is wood and metal, dating to first half of twentieth century. Recessed corner entrance has replacement doors and shingled transom; replacement 1/1 sash at second story.

The building's form, materials, and architectural style are evident, meaning some integrity of design, materials, and workmanship is intact, but also somewhat compromised due to replacement windows, shingles added in transoms, and changes to the entry. The original location translates to an intact integrity of location. While the setting of commercial district associated with transportation modalities has been compromised with nearby demolition and later development, this building stands in a small fragment of the original extent of the commercial district. The building is not individually eligible for the NRHP and is not in an area that appears to be eligible as a NRHP historic district.

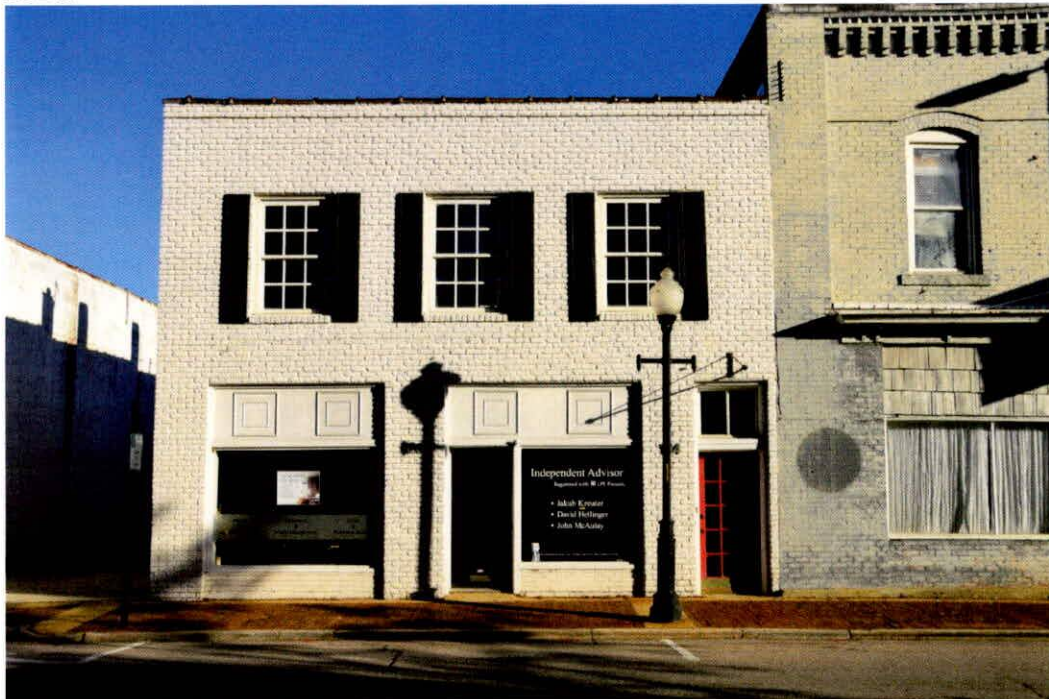
Early twentieth-century, two-story brick standard commercial building with parapet roof, tile coping, and plain cornice. The two storefronts have covered transoms and replacement windows over brick skirting. Original entry with transom at the right side to stairwell. Doors are replacement French doors. Windows at second story are replacement double-hung sash with added faux shutters.

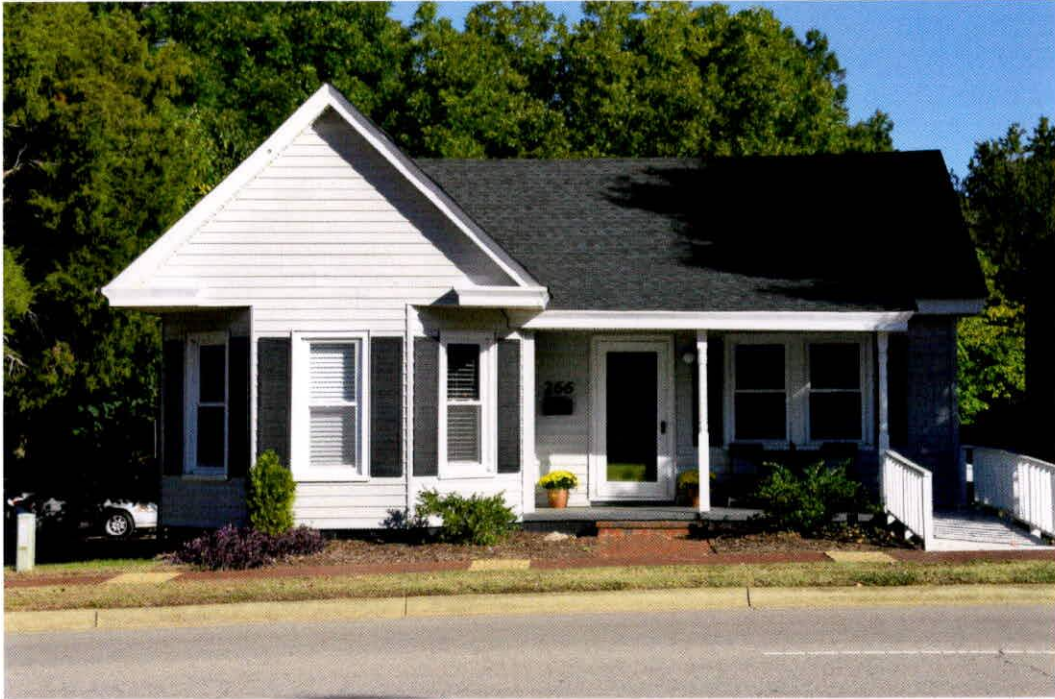
One-story, gable-front-and-wing Queen Anne dwelling with cutaway bay at façade gable and shed-roofed porch at façade ell. Vinyl covers the original wall sheathing, eave soffits, and other trim. Turned porch posts are replacements, as are 1/1 sash. The Wake County GIS system dates the building to 1935, which is very late for this architectural style. It is likely the date of major alterations or perhaps relocation of the house to this parcel, but more recent replacement and covering of original features makes further analysis difficult.

The basic form of the house is intact, allowing identification of architectural style, but the integrity of materials, workmanship, and design are compromised by the application of modern vinyl siding and installation of replacement windows and porch posts. As noted above, the late date for this architectural style may indicate that the building has been moved, but that is unconfirmed; the integrity of location, then, is in question. Integrity of setting seems unlikely to be intact regardless of original location: The house is surrounded by much later commercial development, so the integrity of what would have originally been a residential setting is clearly compromised. The integrity of feeling and association are lacking due to other compromised aspects of integrity. The house is not in an area that appears to be eligible as an NRHP historic district.

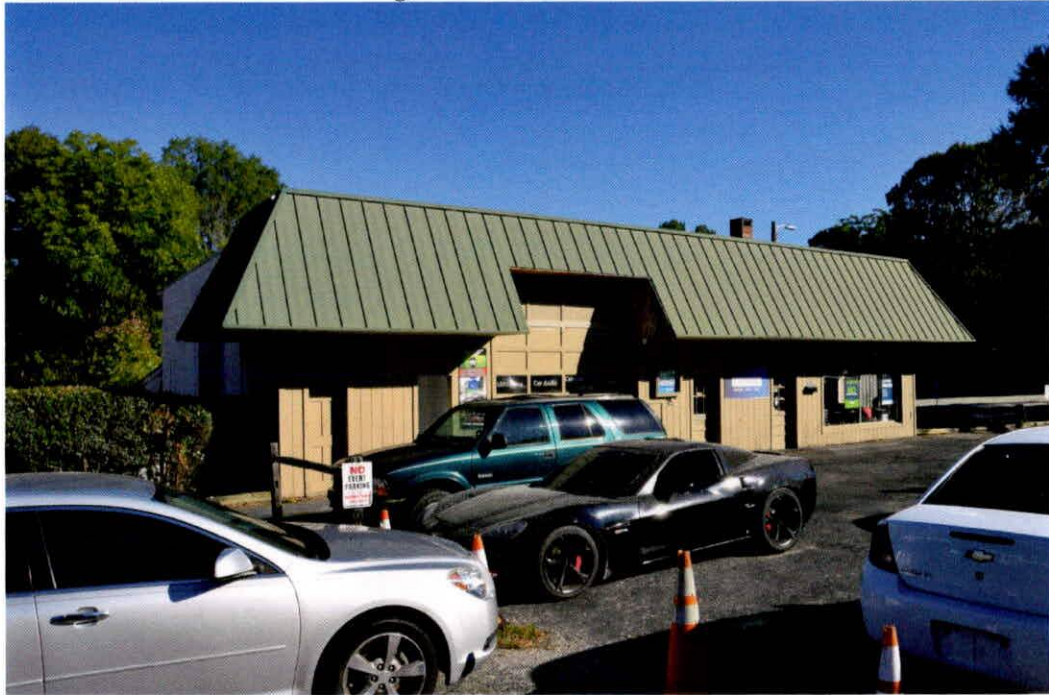
Single-story, concrete-block commercial building with steel-sash windows on side elevations. Completely altered at façade with rearranged fenestration, including plate-glass windows and overhead-lifting garage door, as well as plywood siding and large added mansard across façade wrapping to south end of side elevations. Garage attached at rear elevation.

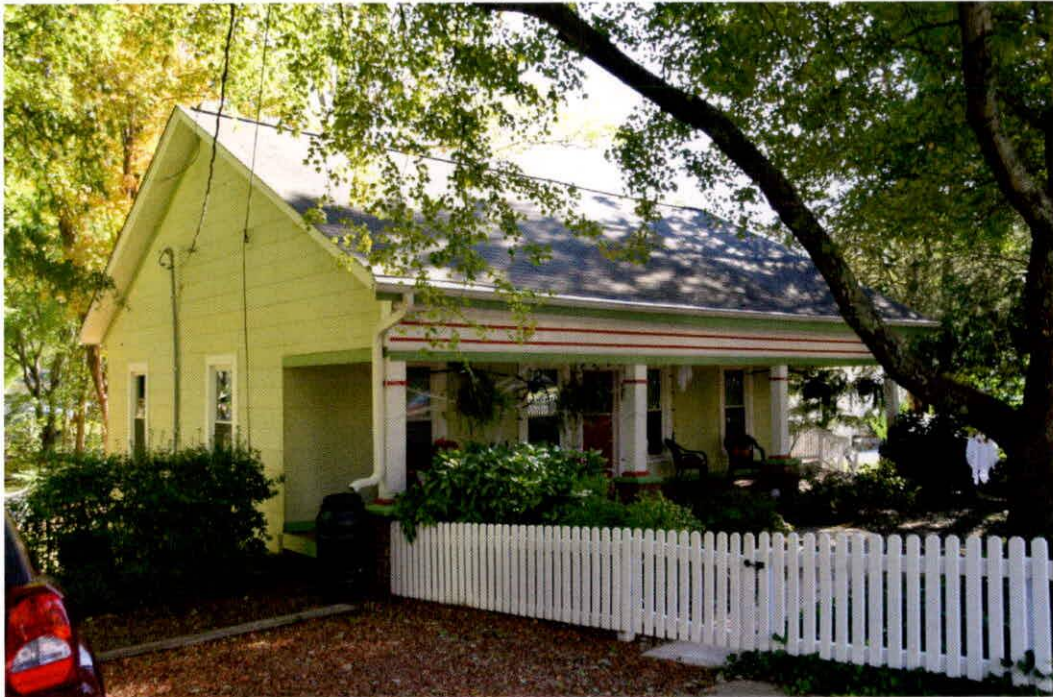
One-and-a-half-story, side-gabled bungalow with inset front porch on replacement square posts on brick piers, replacement 1/1 sash, replacement door, asbestos-shingle siding, and addition at south side elevation. The asbestos shingles were likely added at midcentury, and Wake County GIS records the side addition in 2009.

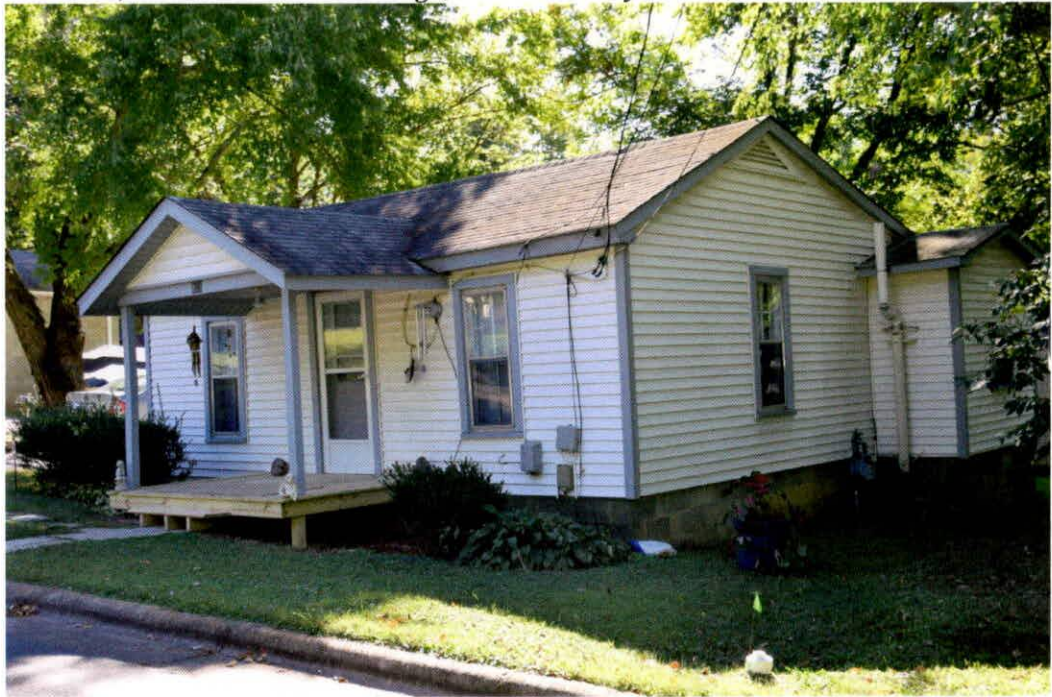
16a. House, 1910: One-story, single-pile, side-gabled vernacular house with 4/4 sash, vinyl siding, front-gabled replacement porch with wood deck and slender square porch posts, partially glazed front door, and brick stack at side elevation. Small, shed-roofed room at rear elevation is inset at east end but extends past west end of house, terminating with a side-gabled roof. Photos at the Wake County GIS website show asbestos shingle siding predated application of vinyl siding; the latter was applied after 2014.

The house retains integrity of location, but application of vinyl siding and construction of the nearby large garage has reduced its integrity of materials, workmanship, and setting. The vinyl siding and replacement porch make assessment of the original form of the porch and rear section difficult, so the integrity of design appears to be reduced as well. These changes also reduce the integrity of feeling and association. The house is not in an area that appears to be eligible as an NRHP historic district.

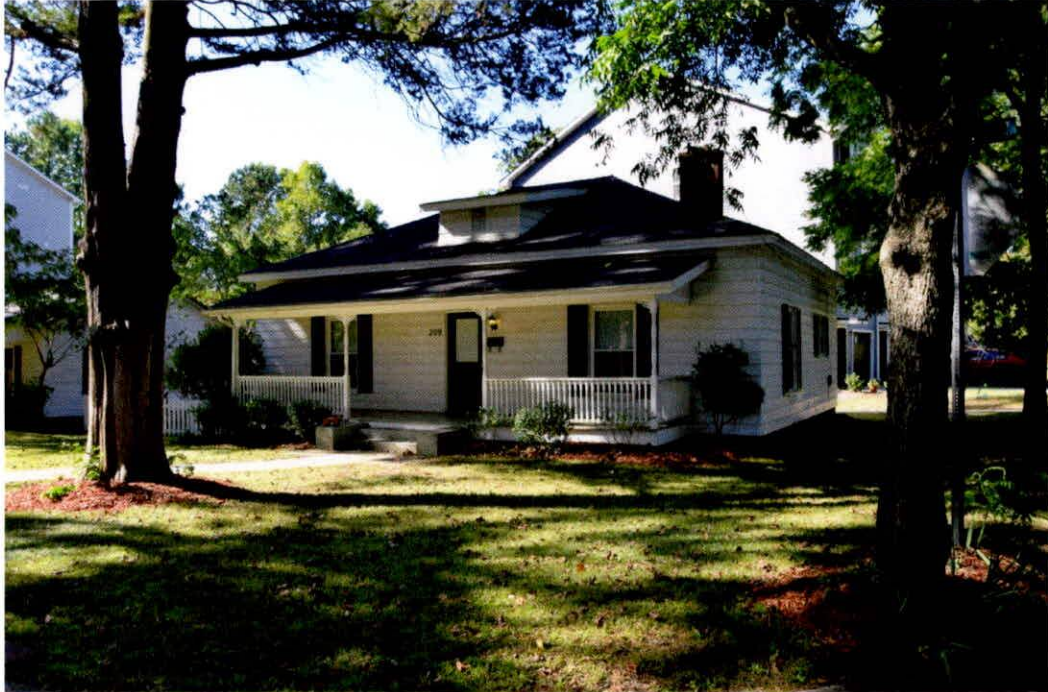
One-story, hip-roofed house with 1/1 sash, aluminum siding, shed dormer, and shed-roofed front porch with replacement turned posts and turned-baluster porch rail.

Application of vinyl siding, replacement of windows, and changes to the porch have reduced the integrity of materials, design, and workmanship. Integrity of location is presumably intact; the integrity of setting has been somewhat compromised by the large building erected on the parcel behind this house and the townhouses built since 2017. Reduction of integrity in all these areas has reduced integrity of feeling and association. The house is not in an area that appears to be eligible as an NRHP historic district.

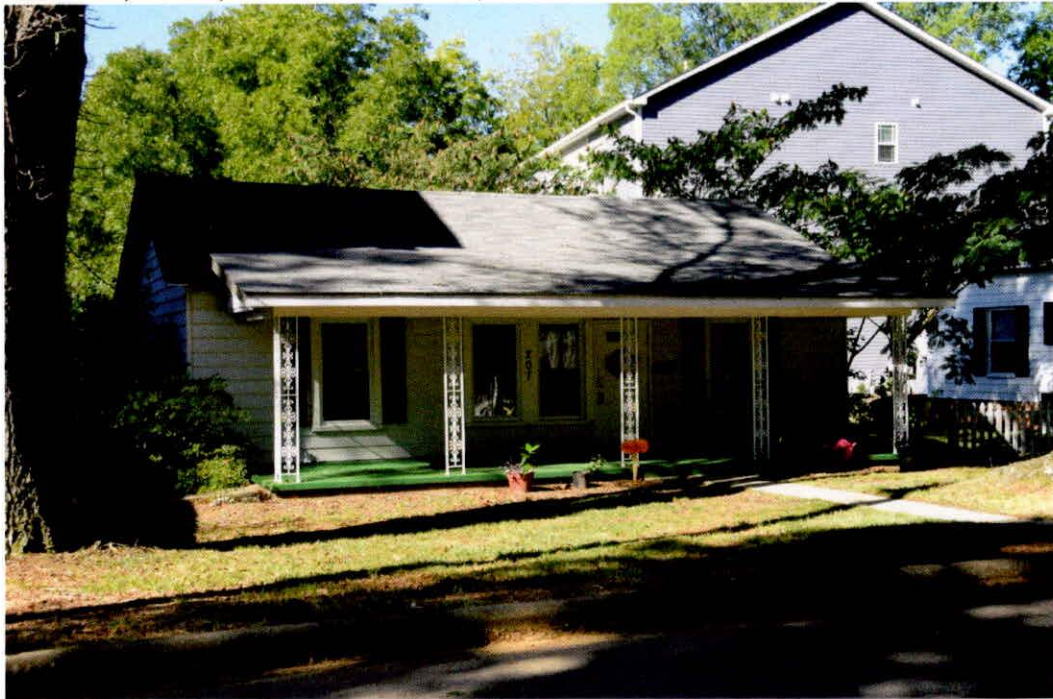
One-story, side-gabled house with aluminum siding, replacement 1/1 windows, and full-façade shed porch supported by metal porch posts. Porch floor is covered with AstroTurf which may cover poured concrete.

Application of aluminum siding, replacement of windows, and changes to the porch have reduced the integrity of materials, design, and workmanship. Integrity of location is presumably intact; the integrity of setting has been somewhat compromised by the large buildings recently erected on neighboring parcels. Reduction of integrity in all these areas has eroded integrity of feeling and association. The house is not in an area that appears to be eligible as an NRHP historic district.

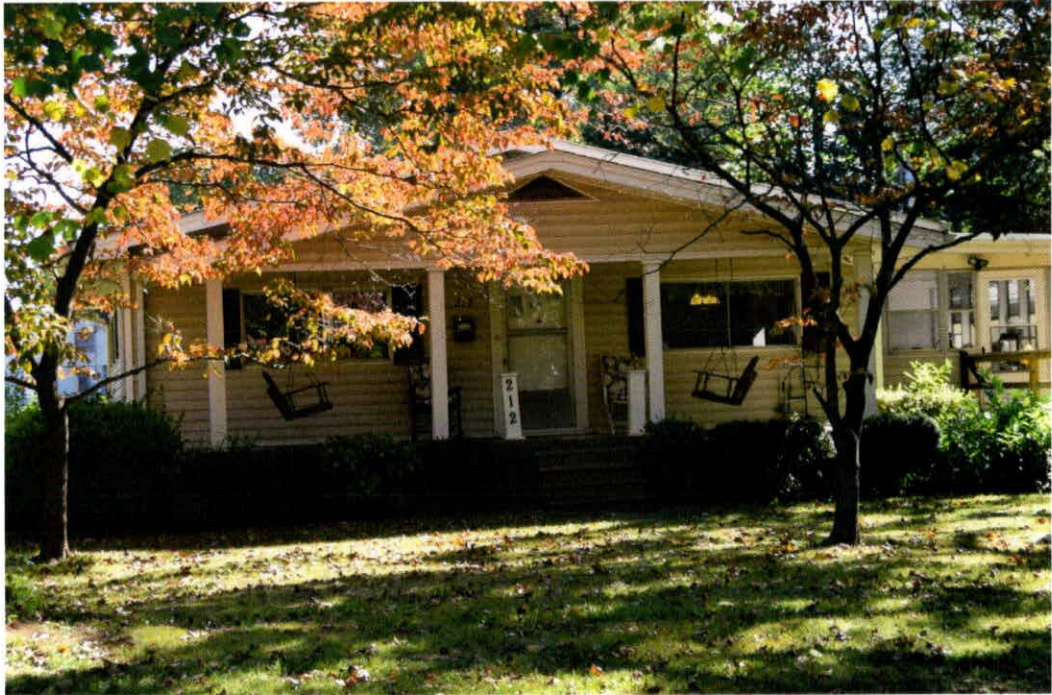
119a. House, 1950. Front-gabled house with gabled front porch on stout squared posts has vinyl siding, replacement aluminum windows, and enclosed porch at south (side) elevation that appears to date to ca. 2000, according to aerials on Wake County iMaps. Three sheds appear to have been added around that time as well.

The siding, replacement windows, and side addition have reduced the integrity of materials, design, and workmanship. Integrity of location is presumably intact; the integrity of setting has been somewhat compromised addition of large carport and prefabricated sheds in rear yard. Reduction of integrity in all these areas has reduced integrity of feeling and association. The house is not in an area that appears to be eligible as an NRHP historic district.

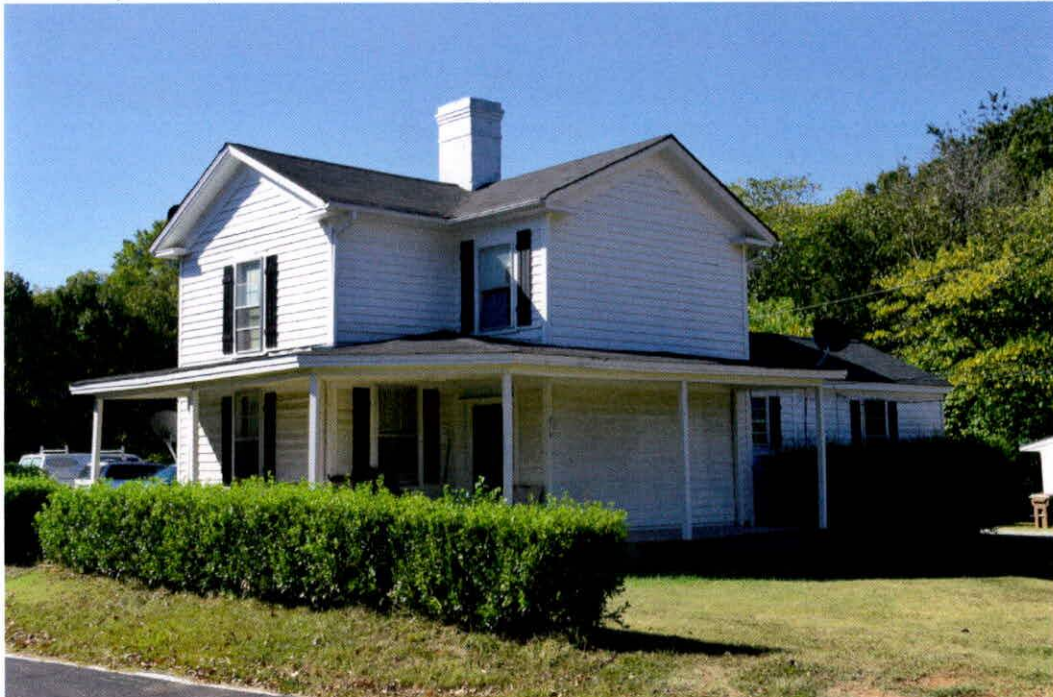
Two-story, front-gabled Queen Anne with gabled side bay and wrap-around porch on replacement posts at north side; gable-end returns; pilastered corner boards; corbelled brick chimney; and an entry with sidelights and transom. The 6/6 sash was likely installed in the mid-twentieth century, and the weatherboard appears to be replacement. Faux shutters have also been added. Single-story gabled rear addition with shed extension, inset porch, weatherboard siding and 6/6 sash. The house faces a commercial parking lot with its side elevation facing Hillsboro Street.

The dwelling's overall form is intact, as are a few architectural details, such as the pilastered corner boards and the gable-end returns. However, window replacement, likely siding replacement, and loss of original porch details reduces the building's integrity of design, materials, and workmanship. While the integrity of location may be intact, the setting has been altered from mainly residential to residential/commercial with four large commercial buildings erected on surrounding parcels since 1950. With so many aspects of integrity compromised, the integrity of feeling and association are also diminished. The house is not in an area that appears to be eligible as an NRHP historic district.

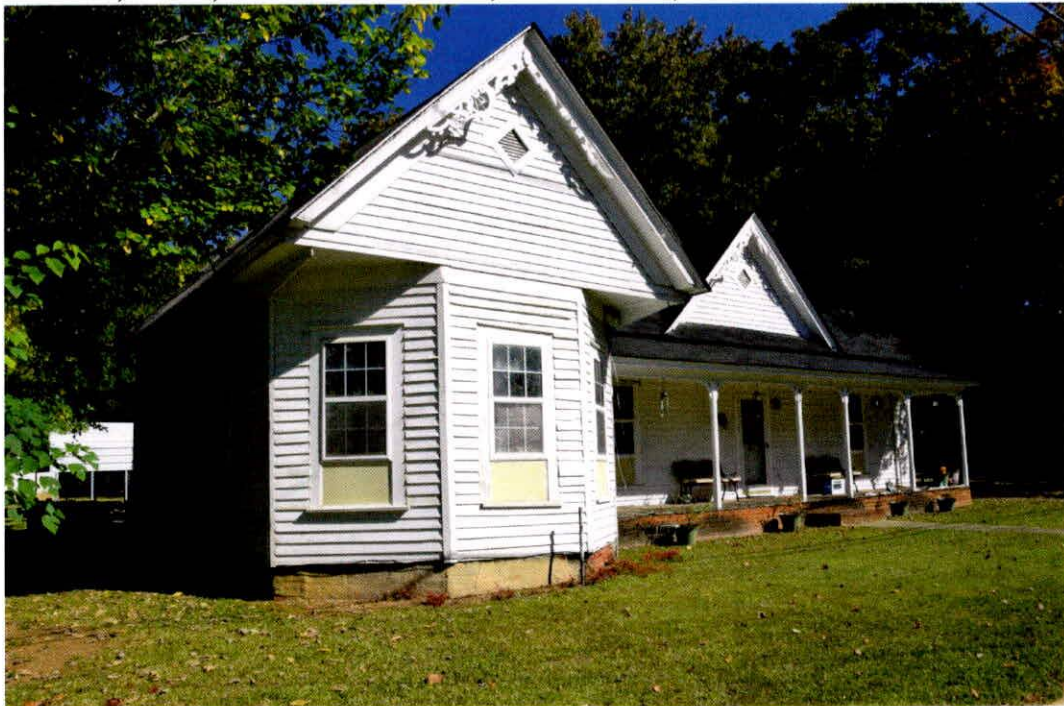
Side-gabled, triple-A Queen Anne with projecting gabled bay with cut-away corners, elaborate sawn trim, louvered diamond-shaped ventilators in the gables, and chamfered porch posts with sawn brackets. Windows replaced in early 1990s with 6/6 sash that is too small for the openings, so panels have been installed below the sash to fill the remaining area. The porch floor and foundation have been replaced and the siding appears to be replacement as well.

The house retains integrity of location and, with the retention of cutaway bay, sawn trim, louvered vents, and chamfered porch posts, retains some integrity of design and workmanship. However, the replacement of windows, porch floor and foundation, loss of porch railing, and possible replacement of siding reduces the integrity of materials and some integrity of design and workmanship. The setting appears to be intact; it is buffered a bit from the commercial development at the east end of the street. Still, the alterations and loss of materials and architectural features has reduced the integrity of feeling and association. The house does not appear to have sufficient architectural integrity for individual listing in the NRHP. The house is not in an area that appears to be eligible as an NRHP historic district. There are excellent examples of Queen Anne ornament and characteristic massing at the James Jones House (WA091) and the Captain Harrison P. Guess House (WA906) both on S. Academy Street in the NRHP-listed Cary Historic District.

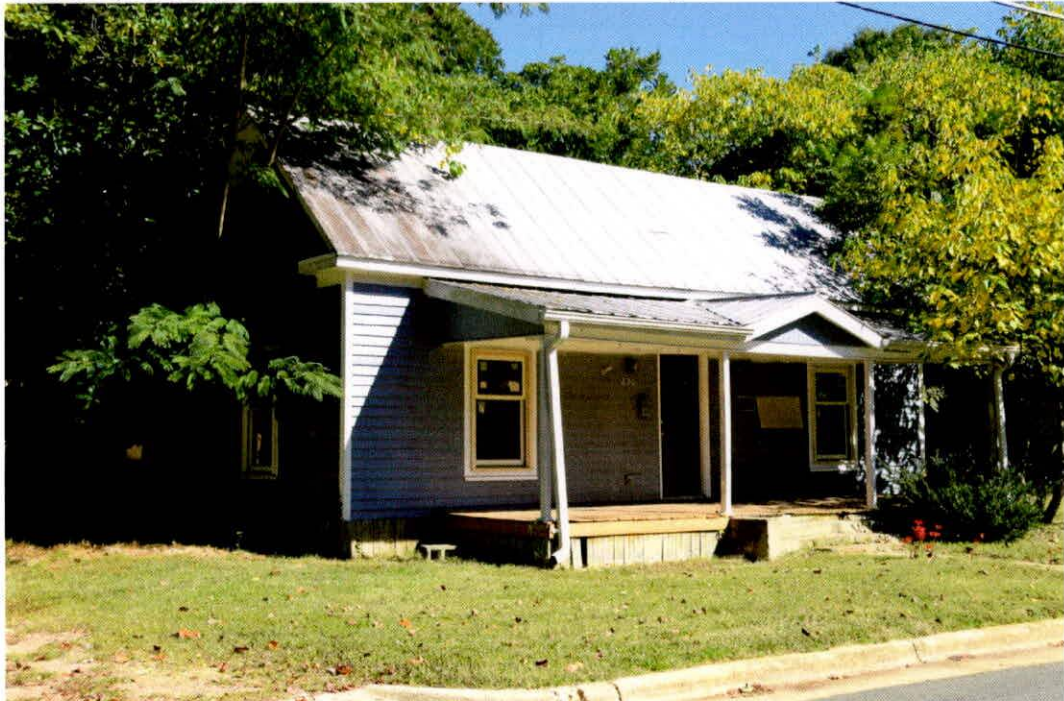
One-story, side-gabled house with end returns, shed-roofed porch with a gabled entry bay, recently replaced windows, and standing-seam metal roofing. The house is sheathed in weatherboards but there is plywood in the gable at the porch. The porch flooring is replaced with plain boards and posts are likely replacements as well.

The house has integrity of location, but replacements of windows and porch elements reduce the simple dwelling's integrity of design, materials, and workmanship. The setting may be intact, but the integrity of feeling and association is reduced by alterations as well. The house is not in an area that appears to be eligible as an NRHP historic district.

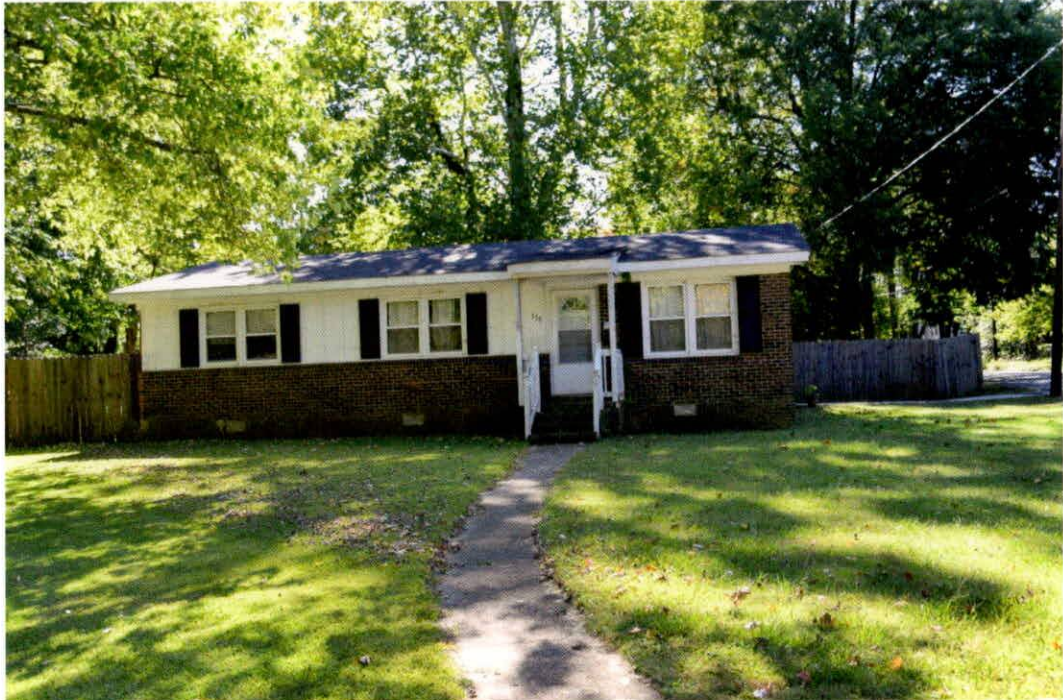
Hip-roofed Ranch with brick and plywood exterior, 1/1 replacement sash, and shed portico at front stoop.

The house retains integrity of location and some integrity of design, materials, and workmanship, but the replacement of windows does reduce those aspects of integrity. The setting is intact, as is the integrity of feeling and association. However, the house lacks architectural distinction for individual listing in the NRHP. The house is not in an area that appears eligible as an NRHP historic district.

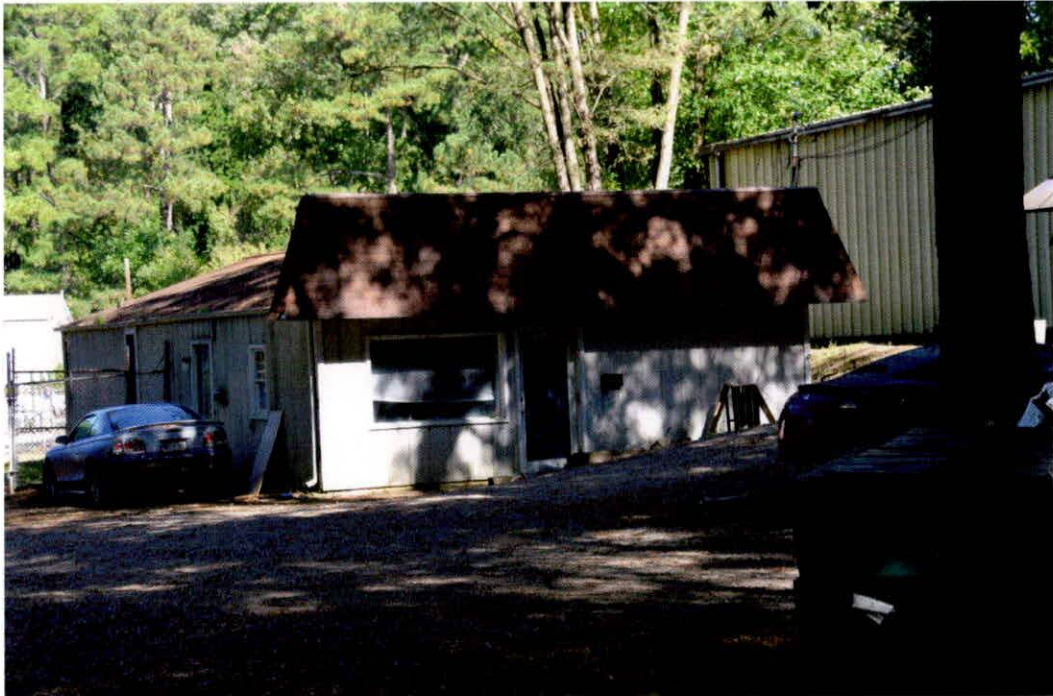
Gable-roofed warehouse with shingled parapet, picture window at façade, 1/1 sash at side elevations, personnel doors at façade and side elevation.

The building retains integrity of location but appears to have lost integrity of design, materials, and workmanship with materials replacements; these changes also reduce integrity of feeling and association. The building is not in an area that appears eligible as an NRHP historic district.

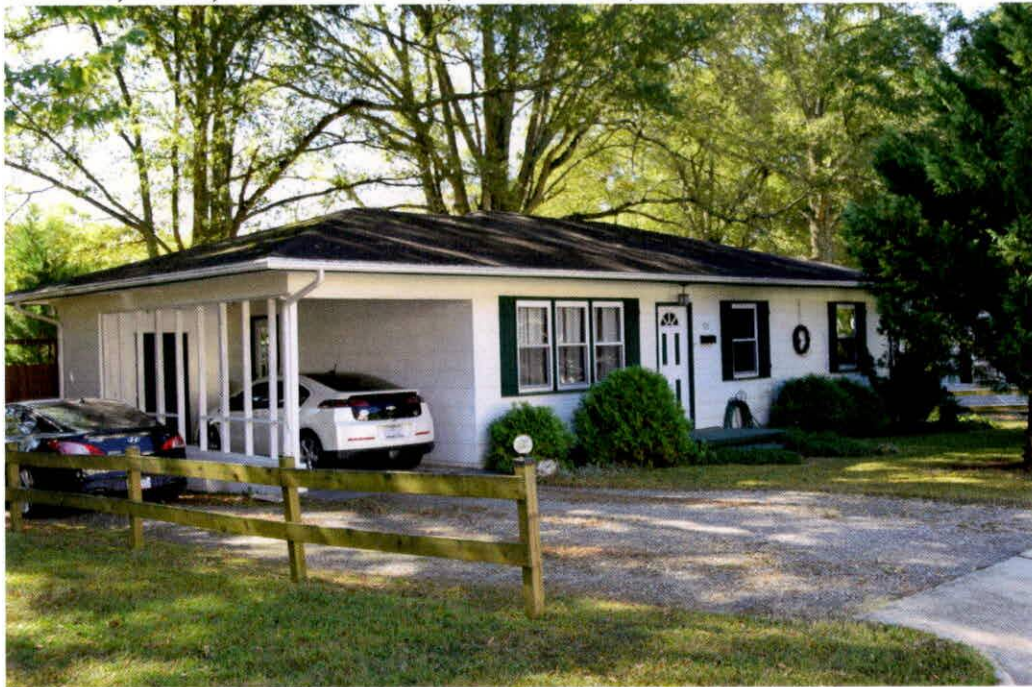
Ranch house with hip roof, replacement door and windows, asbestos-shingle siding, and inset carport.

The basic form of the house is intact, allowing identification as post-war Ranch, but the materials replacements and covering reduce the integrity of design, materials, and workmanship. The location and setting are intact, but the alterations reduce the integrity of feeling and association. The house is not in an area that appears eligible as an NRHP historic district.

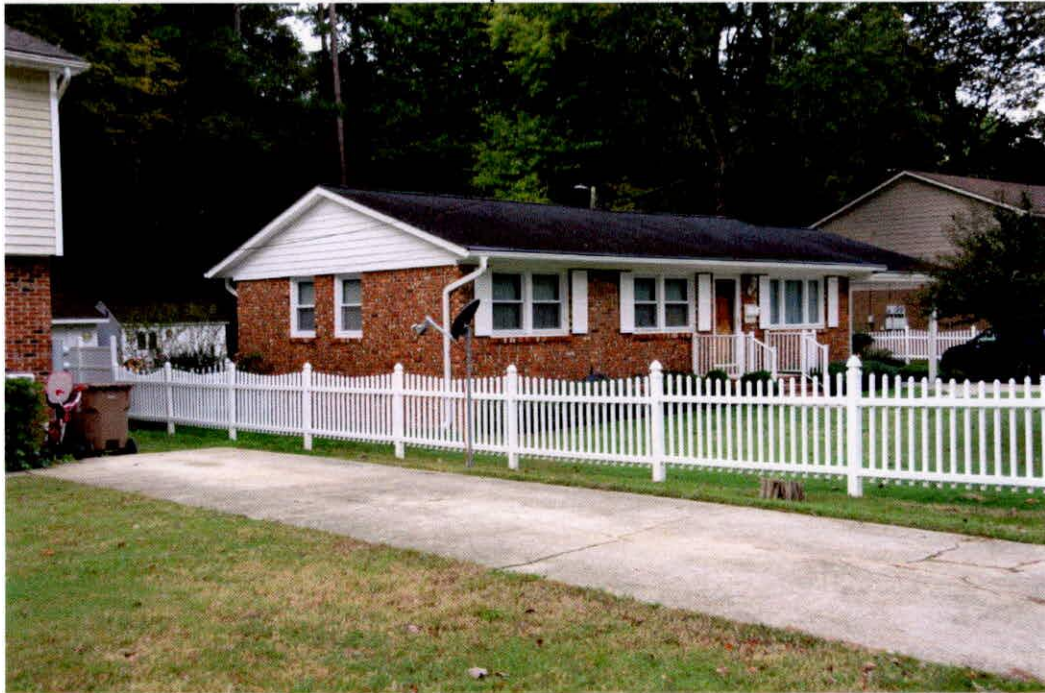
56a. House, 1960. Side-gabled brick Ranch with replacement 1/1 sash, faux shutters, extruded metal balustrade and rails at front stoop, and carport at right end of façade.

The house appears to have integrity of location, and the residential setting appears intact. The integrity of design, materials, and workmanship has been reduced by the replacement of original 2/2 horizontal sash and addition of vinyl siding and extruded metal railings, changes that also reduce the integrity of feeling and association. The house lacks integrity and architectural significance for listing in the NRHP and is not in an area that appears eligible for the NRHP as a district.

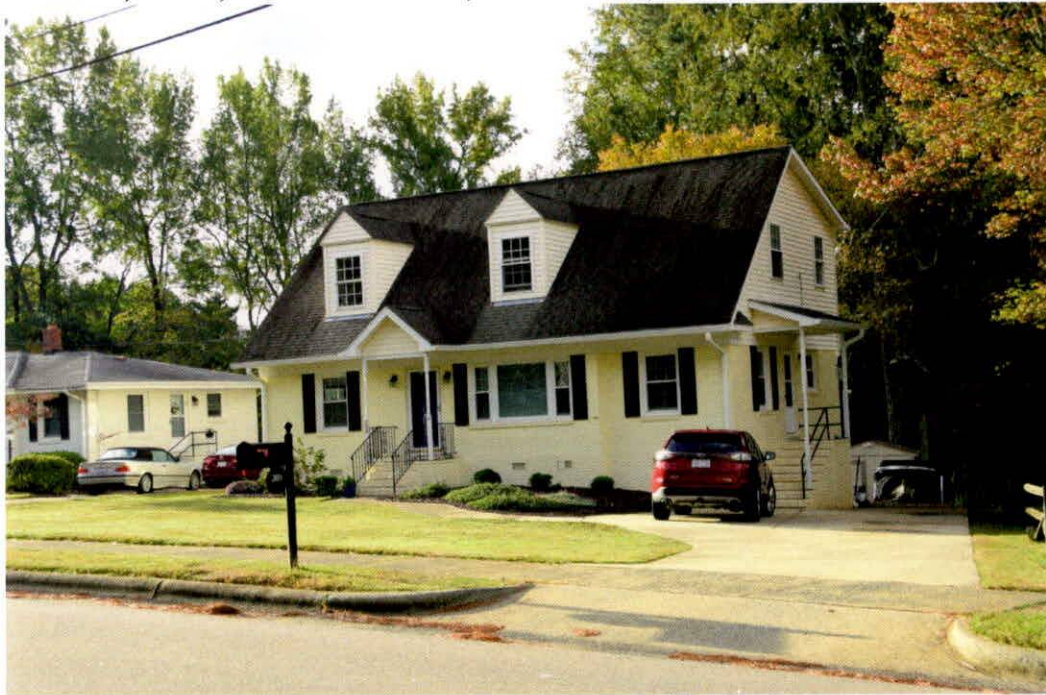
Ranch house with brick exterior that has been radically altered with added half-story side-gabled roof with gabled dormers that replaced original; windows replaced with 6/6 vinyl sash, including picture window sidelights; gabled front portico and side shed-roofed stoop, both on undersized turned columns.

The house retains integrity of location and setting, but the roof and window replacements have eliminated integrity of design, materials, workmanship and therefore feeling and association. The dwelling is not in an area that appears eligible as an NRHP district.

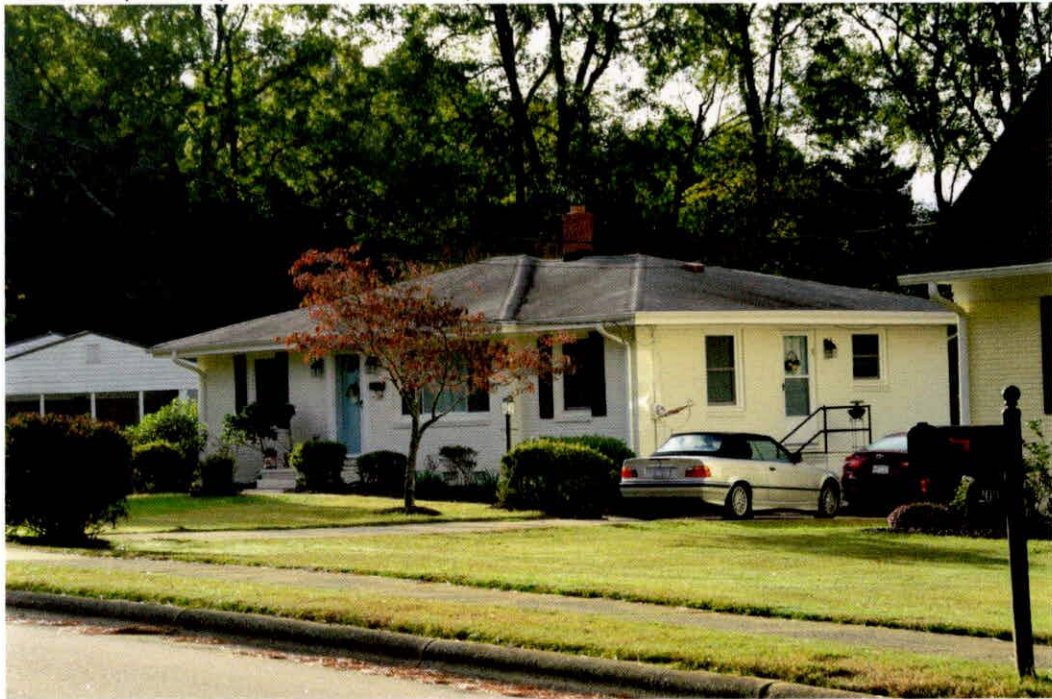
Ranch house with brick exterior; hip roof with deep boxed eave; replacement 1/1 vinyl sash, including sidelights and picture window; and Colonial Revival fluted pilasters at architrave framing replacement front door.

The house retains integrity of location and setting. Window and door replacements reduce integrity of design, materials, and workmanship and subsequently feeling and association. The dwelling is not in an area that appears eligible as an NRHP district.

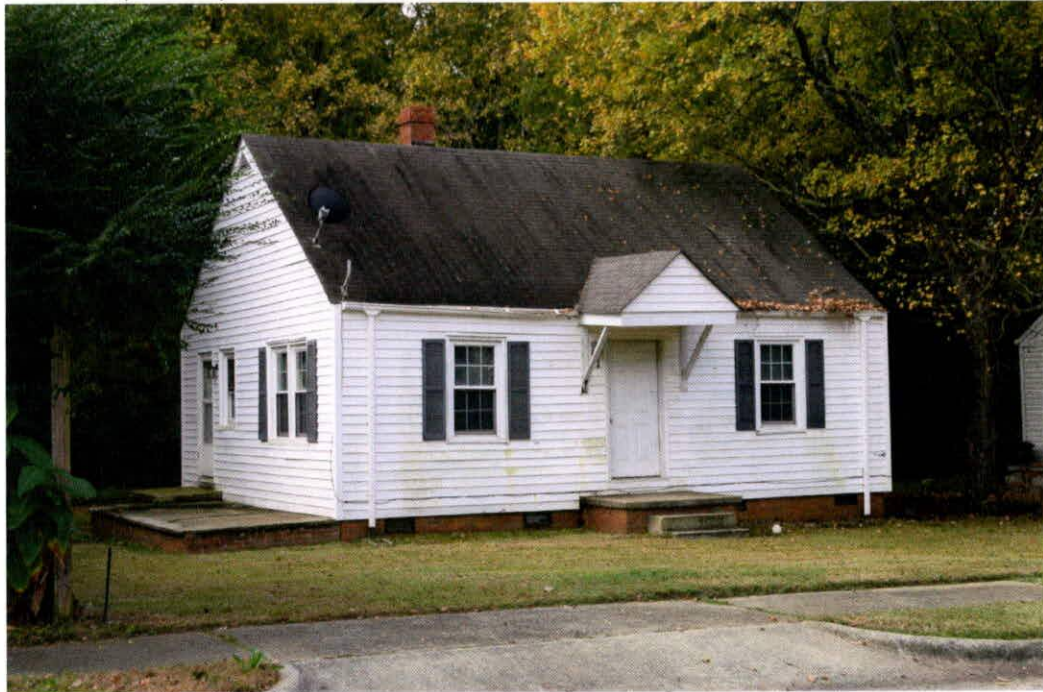
Single-story, side-gabled Cape Cod dwelling with replacement 6/6 sash, bracketed gabled roof over front stoop, replacement front door, and vinyl siding.

The house retains integrity of location and setting, but the replacement windows, door, and added siding reduce the integrity of design, materials, and workmanship, also diminishing integrity of feeling and association. The house is not in an area that appears eligible for the NRHP as a district.

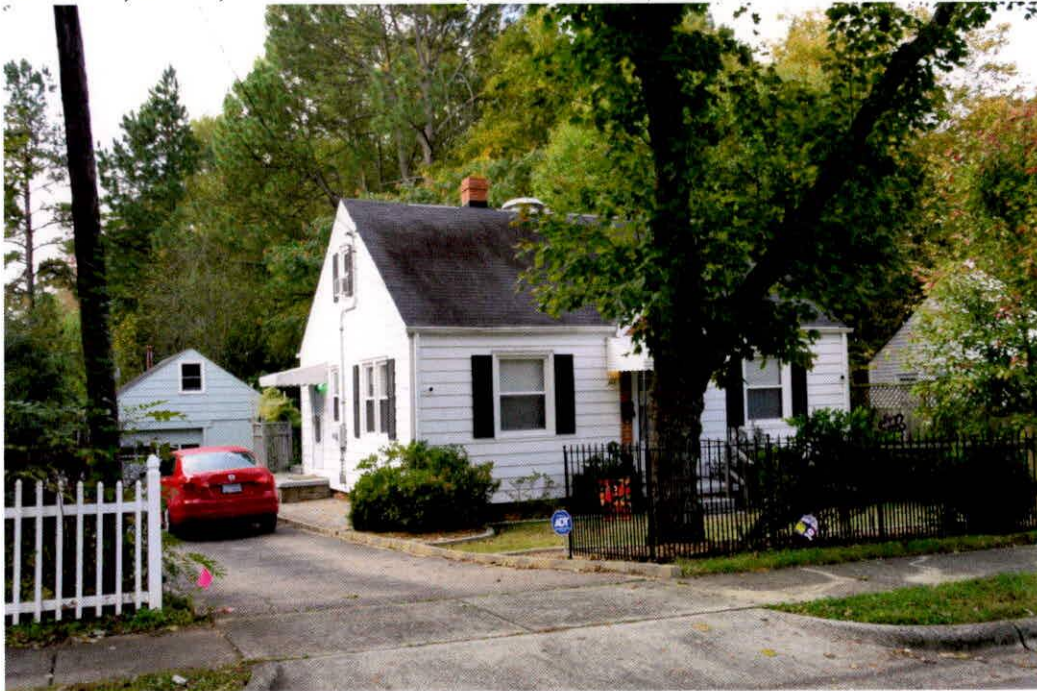
75a. House, 1949. One-and-a-half-story, side-gabled Cape Cod dwelling with replacement 1/1 sash, gabled entry bay with brick veneer and vinyl siding elsewhere.

The house retains integrity of location and setting, but the replacement windows, door, and added siding reduce the integrity of design, materials, and workmanship, also diminishing integrity of feeling and association. The house is not in an area that appears eligible for the NRHP as a district.

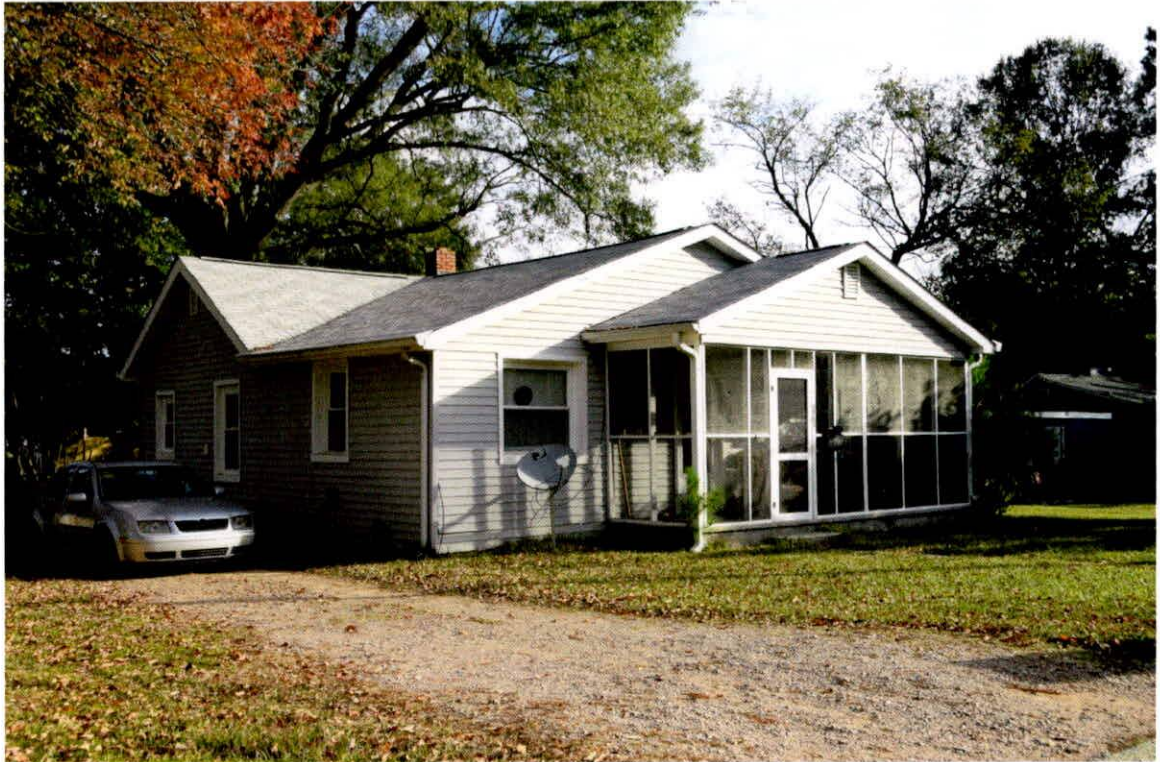
Single-story, cross-gabled dwelling with nested, gabled screened porch at façade; replacement 1/1 vinyl sash; vinyl siding. Wake County GIS reports that the dwelling is of concrete-block construction.

The house retains integrity of location and setting, but replacement windows and added siding have reduced the integrity of design, materials, and workmanship, also reducing integrity of feeling and association. The house is not in an area that appears eligible for the NRHP as a district.
