**NATIONAL REGISTER OF HISTORIC PLACES**

**Hans Rees' Sons Tannery Historic District**

Asheville, Buncombe County, BN0414, Listed 12/29/2025

Nomination by Caitlin Hernstadt and Cindy Hamilton, Heritage Consulting Group

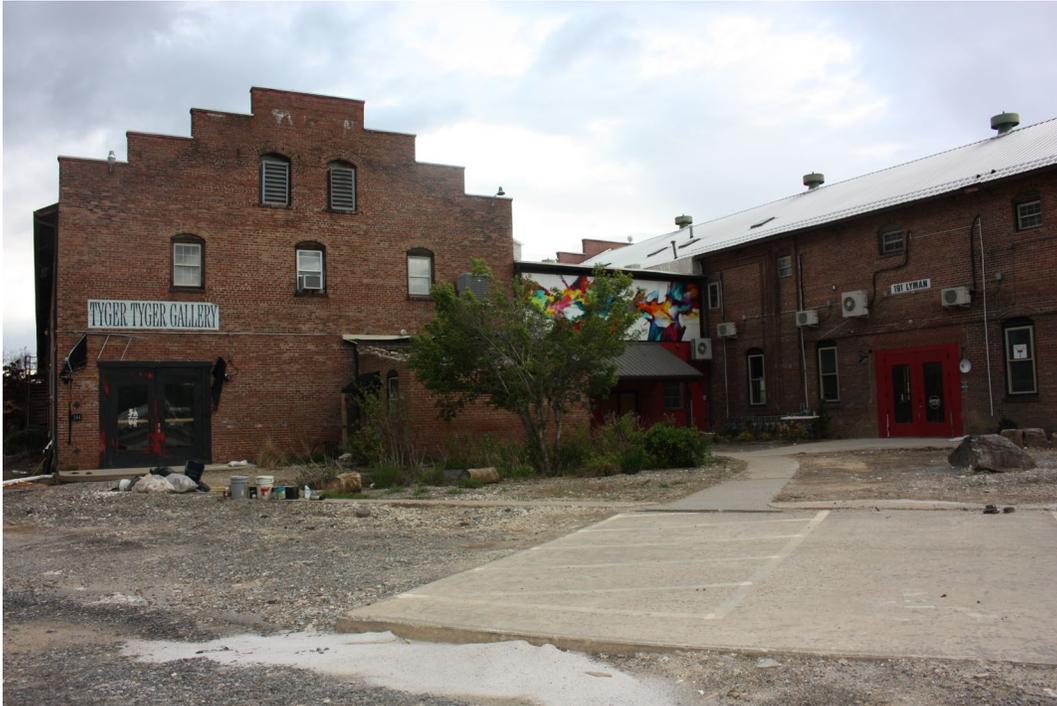
Exterior, Scouring and Rolling House and Curry Shop, view looking northeast.

The former Scouring and Rolling House and Currying Shop, also known as Riverview Stations 2 and 3, consist of two interconnected warehouse buildings, which together comprise one contributing building. The American bond brick buildings were constructed in 1917 after the original Dry House and Currying Shop was destroyed in a 1916 fire. Located south of the Leather Warehouse and west of Lyman Street, these buildings were used for drying and finishing the hides into leather goods. The westernmost building (the former Scouring and Rolling House is connected to the Leather Warehouse by an enclosed walkway at the second floor (mentioned above).

The buildings feature the district's characteristic gable roofs with stepped parapets located at the tops of end walls and internal firewalls. The buildings feature rows of rectangular six-over-six replacement windows set within original brick openings with segmental arches formed by three rows of header bricks and projecting header brick sills. Original door openings feature metal replacement doors. The roof structure of each warehouse is supported by a wood beam truss system. Ventilators and ridge-line vents are visible along the buildings' roofs which are a combination of standing seam metal and asphalt shingles.

The long, narrow two-story brick warehouses are connected via a small two-story hyphen. The hyphen appears on the 1917 Sanborn map, however, between the 1925 and 1950 Sanborn maps, the hyphen appears to double in width. A twenty-five-foot-tall steel water tower holding 25,000 gallons of water once stood directly south of the hyphen. The water tower was removed sometime between 1972 and 1984 according to Sanborn maps and historic aerial photographs. Today the south wall of the hyphen has been extended further south and is nearly flush with the south wall of the Scouring and Rolling House.

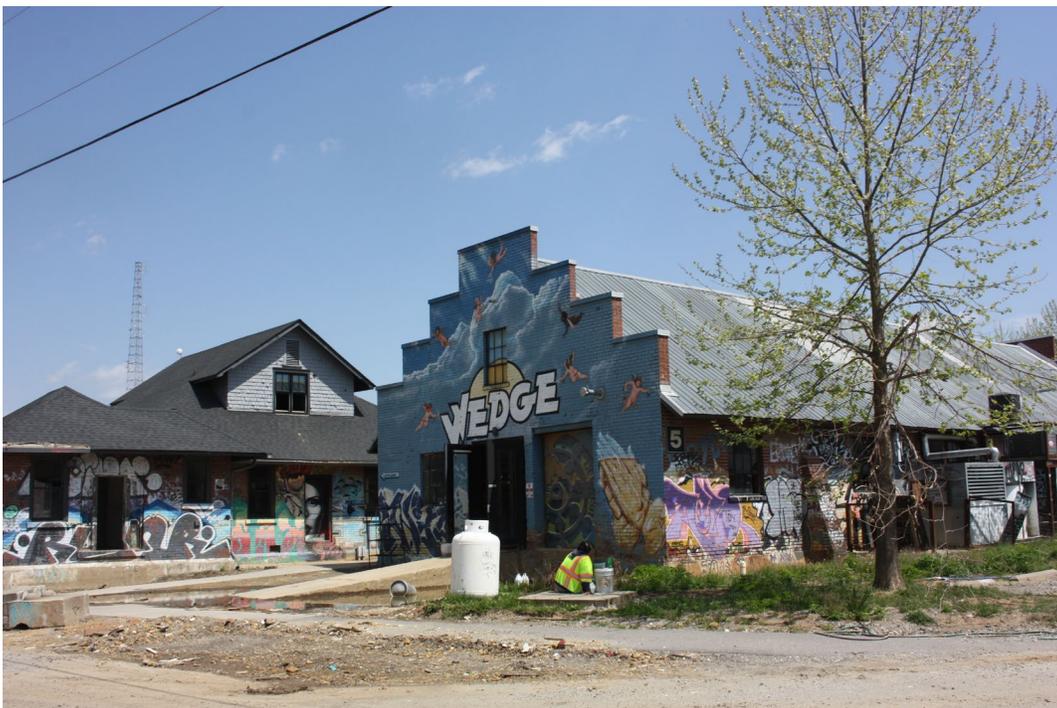
Exterior, Office and Brick Warehouse and Experimental Tan Yard, view looking northeast.

The Tannery Office is located in the northeastern portion of the district just east of the washroom and features multiple additions including the large ca.1929 Brick Warehouse and Experimental Tan Yard. The Tannery Office is a one-and a-half-story brick building that once housed office space for the tannery. It first appeared on the 1907 Sanborn map. The office building is topped by a gable on hip roof covered in asphalt shingles, with areas of the gabled

The large Brick Warehouse and Experimental Tan Yard is a large, multi-part addition located east and south of the original office building. The addition consists of a pair of one-and-one-half-story interconnected brick warehouses, forming an “L” shape, that formerly served as the Experimental and Chrome process buildings according to Sanborn maps and a 1929 blueprint from local Asheville architect Anthony Lord. Both buildings have long rectangular footprints supported by brick buttresses. The buildings have gable roofs covered with metal and feature the characteristic stepped parapet end walls seen on other buildings within the tannery complex. The fenestration pattern appears largely unaltered, and some multi-lite steel sash windows, which appear to be original windows, are intact on the west elevation. The typical windows appear to be painted wood one-over-one sash windows. The Brick Warehouse and Experimental Tan Yard is connected to the northeast corner of the Tannery Office via a one-and-one-half-story gable roof addition. The roof is covered in asphalt shingles, and the north-facing façade is covered in a combination of brick and wood shingle siding. According to Sanborn maps, this addition began as a small L-shaped addition constructed ca. 1929 and was later enlarged to the north with a concrete block addition ca. 1953.<sup>3</sup> After the property was converted into Foundy Street, the office, one-story pyramidal addition, and one-and-one-half-story gable roof addition, were used as a restaurant. The Brick Warehouse and Experimental Tan Yard were used as a brewery.

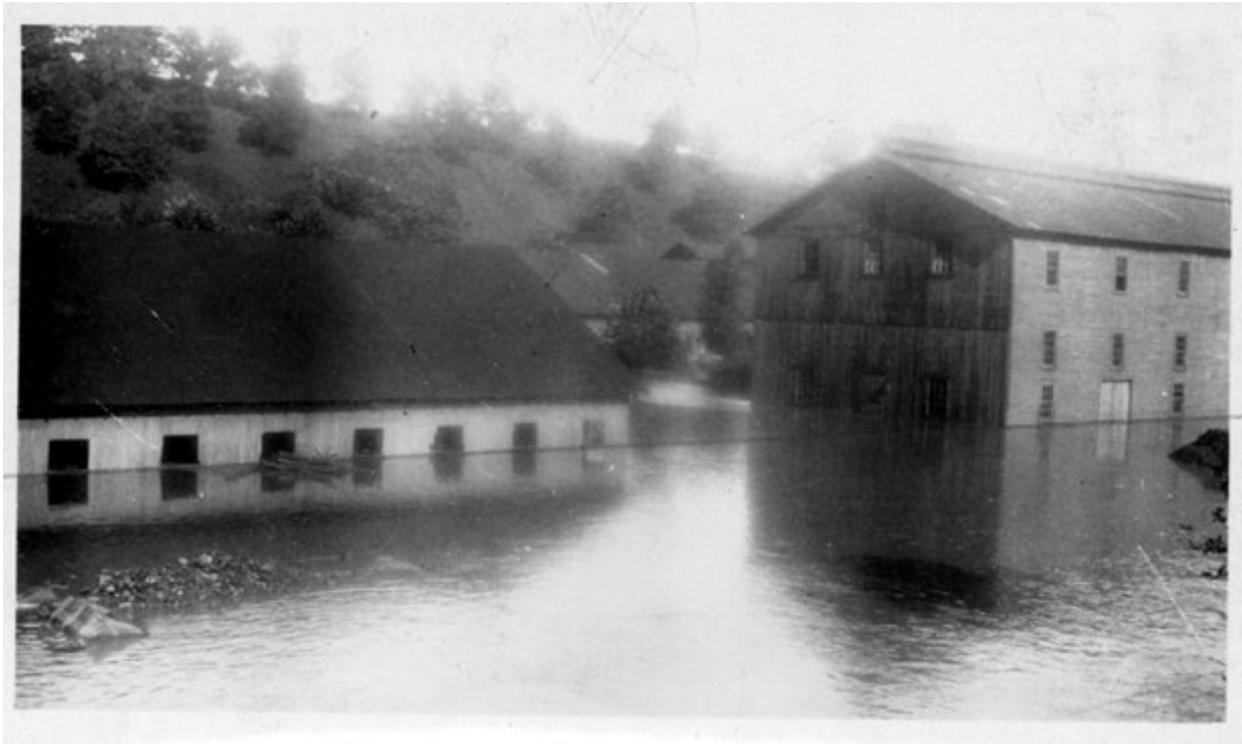
**Figure 3:** Hans Rees' Sons Tannery during a flood in 1928. Lumber shed and leach house in view. (Source: Source: Buncombe County Special Collections, Pack Memorial Public Library, Asheville, North Carolina.)

The area along the French Broad River has a long history of flooding. Due to its many tributaries and the absence of flood control structures, the river is prone to flooding during periods of heavy rain and when runoff from the mountains is high. According to flood analyses by the Tennessee Valley Authority, between 1791 and 1960 there were thirty-seven known floods in which the water rose above banks of the river.<sup>17</sup> Until 2024, the most serious documented flooding occurred in July 1916 when the water level rose approximately 20 feet and created millions of dollars of damage in the thriving commercial and industrial areas of Asheville. This flood destroyed homes, businesses and bridges.<sup>18</sup> In some respects, this 1916 flood marked the end of Asheville's riverfront development. Prior to the flood, new development had already begun moving away from the river and the flooding only cemented this trend.<sup>19</sup> More flooding in 1928, once again inundated Asheville's industrial area including the area surrounding the Hans Rees' Sons Tannery (**Figure 3**). In 2024, Hurricane Helene made landfall

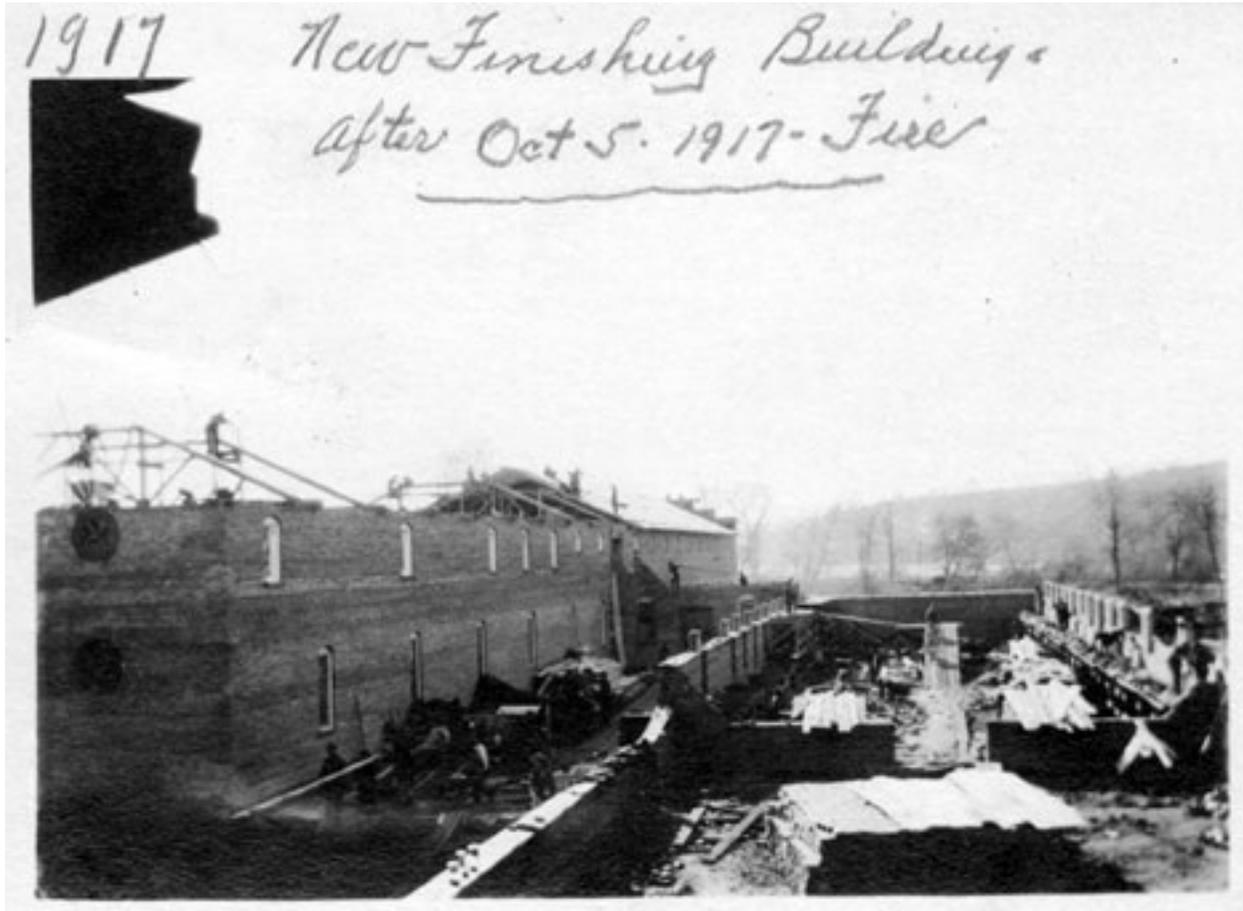
**Figure 5:** Rebuilding of Hans Rees' Sons Tannery after October 5, 1916, fire. Construction of the "new finishing building" (Scouring and Rolling House and Currying Shop). Dated on front 1917 (Source: Source: Buncombe County Special Collections, Pack Memorial Public Library, Asheville, North Carolina.)

Damage from the fire was estimated at between \$200,000 and \$500,000.<sup>31</sup> Luckily the fire department acted quickly and was able to save the plant's other buildings.<sup>32</sup> The tannery had good insurance which helped them to begin rebuilding as soon as debris was cleared.<sup>33</sup> The Scouring and Rolling House and Currying Shop buildings (today known as Riverview Stations 2 and 3) were rebuilt on this location and remain extant today (**Figures 5, 6, and 7**).

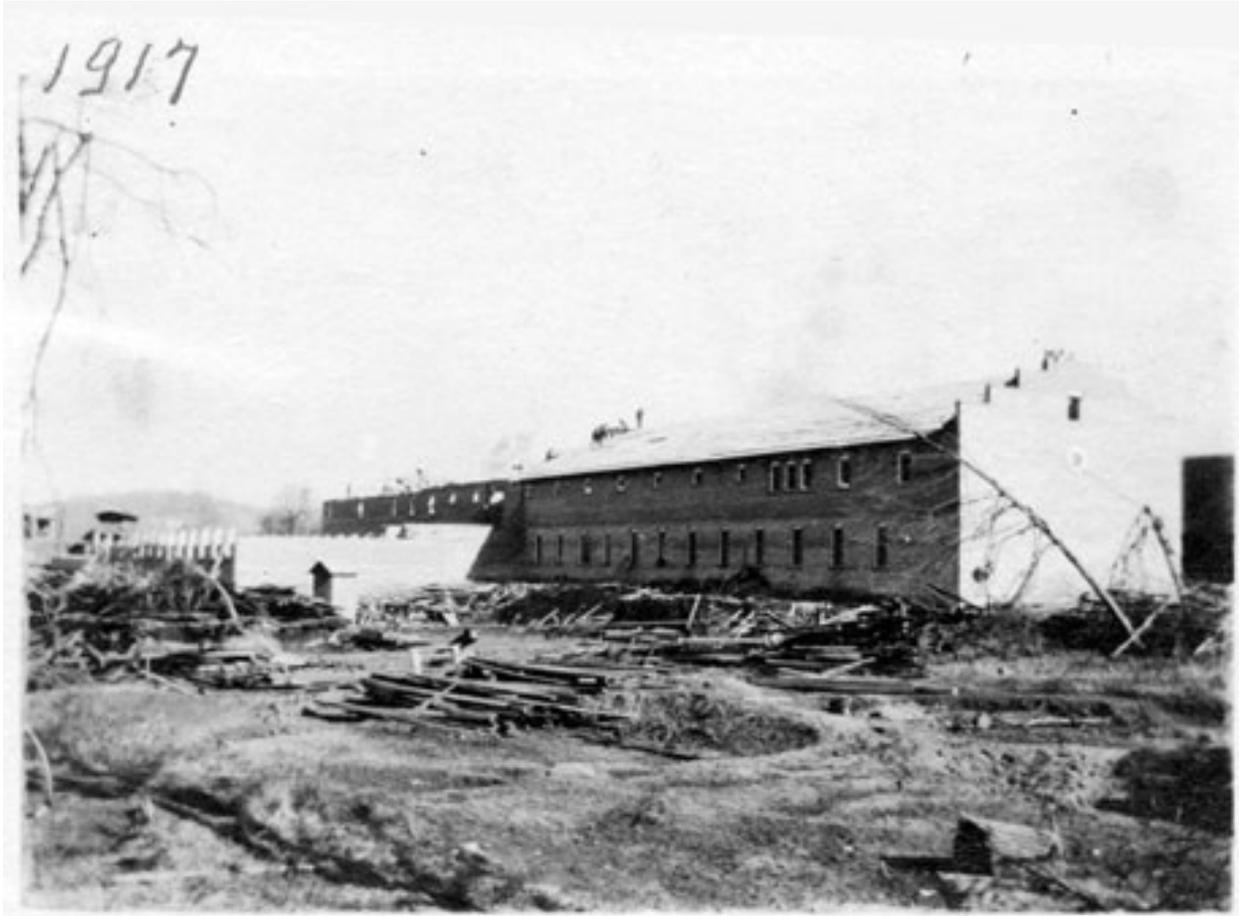
**Figure 6:** Rebuilding of Hans Rees' Sons Tannery after October 5, 1916, fire. Construction of new Scouring and Rolling House and Currying Shop. Dated on front 1917 (Source: Source: Buncombe County Special Collections, Pack Memorial Public Library, Asheville, North Carolina.)

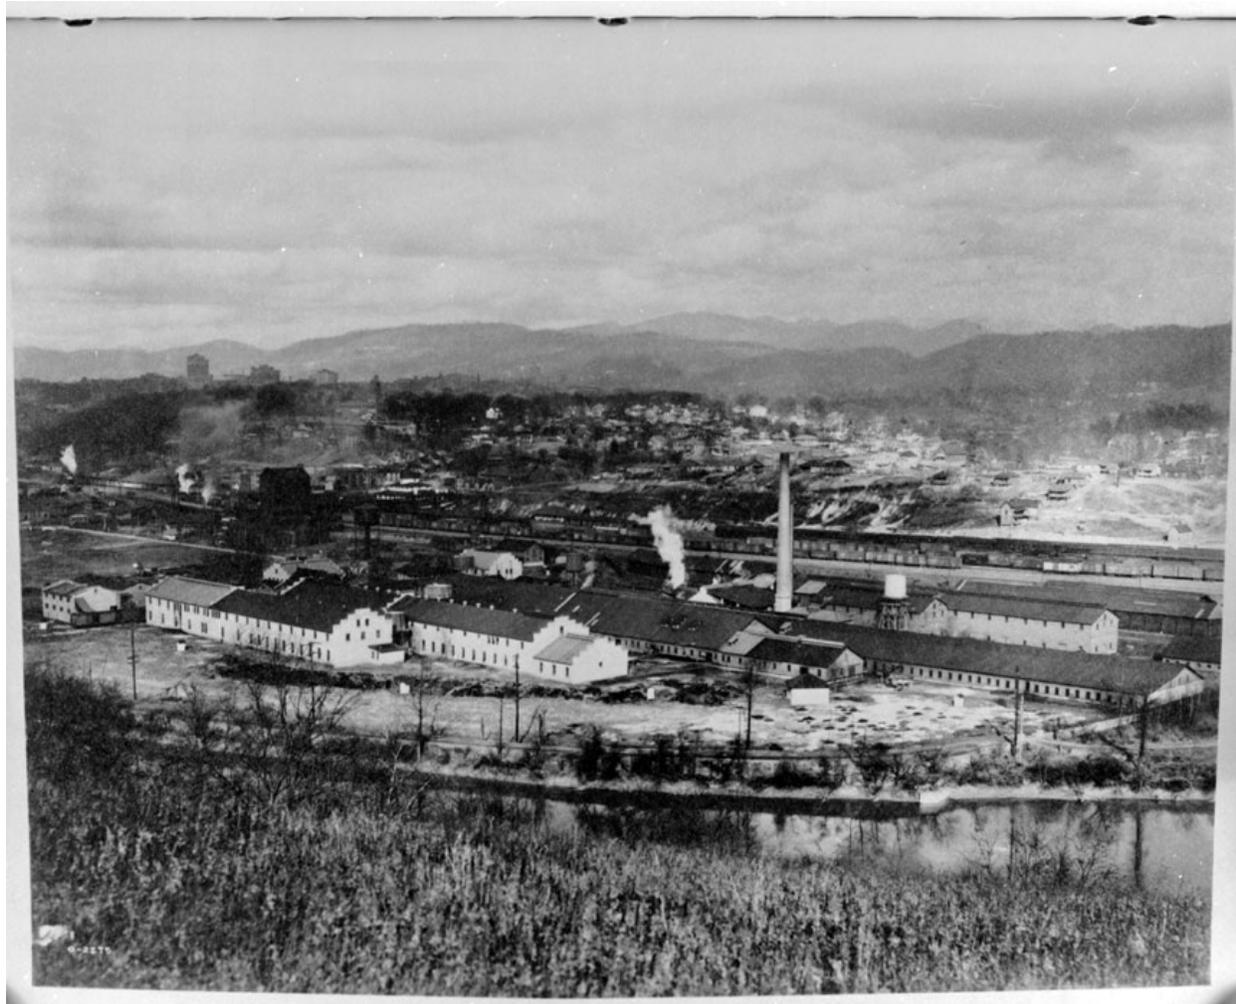
**Figure 7:** View of Hans Rees' Sons Tannery, 1929. (Source: Buncombe County Special Collections, Pack Memorial Public Library, Asheville, North Carolina.)
