SUBJECT: P-5734 Trinity Road Grade Separation, Cary, Wake County, ER 19-1879

**Phase I Architectural Survey and  
Historic Structures Survey Report  
Trinity Road Improvement Project,  
Wake County, North Carolina**

TIP# P-5734  
WBS# 48150.1.1

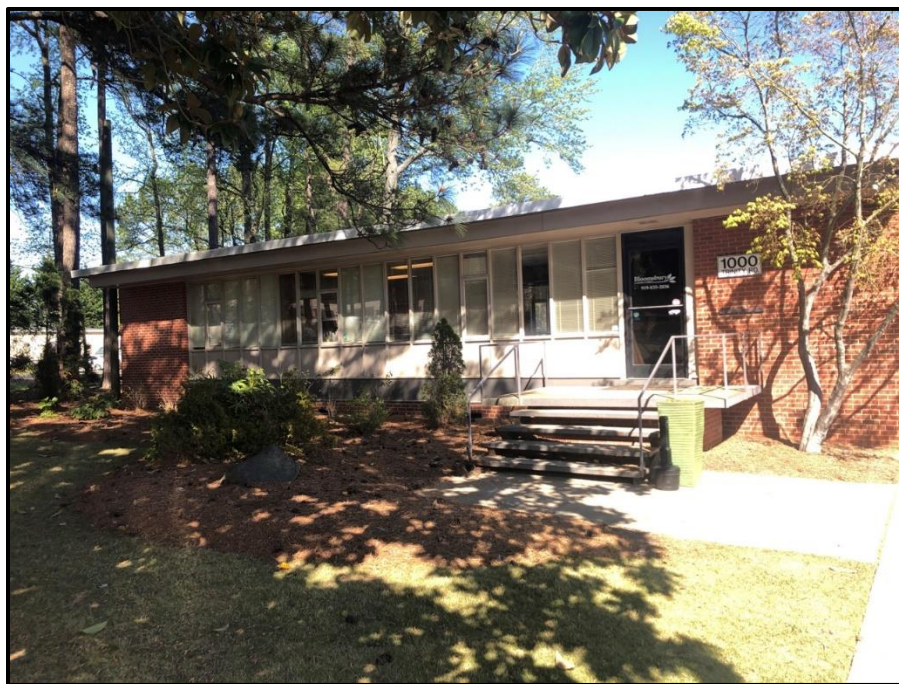
The commercial building, constructed in 1962, is sited on a 2.77-acre parcel on the east side of Trinity Road and north of the railroad tracks. The one-story building features a bank of 18 narrow windows with a metal and glass commercial-style entry door. Small panels are present under each window. The banks of windows are mirrored on the rear of the building; however, the entry doors are paired, and the rear elevation features a small open shed-roofed ell. The exterior of the building is clad in brick veneer. The building also features a slightly pitched shed roof with wide overhangs characteristic of its Mid-Century style (Figure 3). A modern, open shed with metal-clad gable roof is located to the east of the primary resource. Although the resource is a relatively intact example of a Mid-Century commercial building, the building does not exhibit distinction of type or designed by a noted architect. Instead the building reflects a common design for Mid-Century structures. Therefore, the property does not appear to possess sufficient significance to be eligible for the National Register.

Figure 3 Commercial Building (WA6438), 1000 Trinity Road, Looking Northeast.

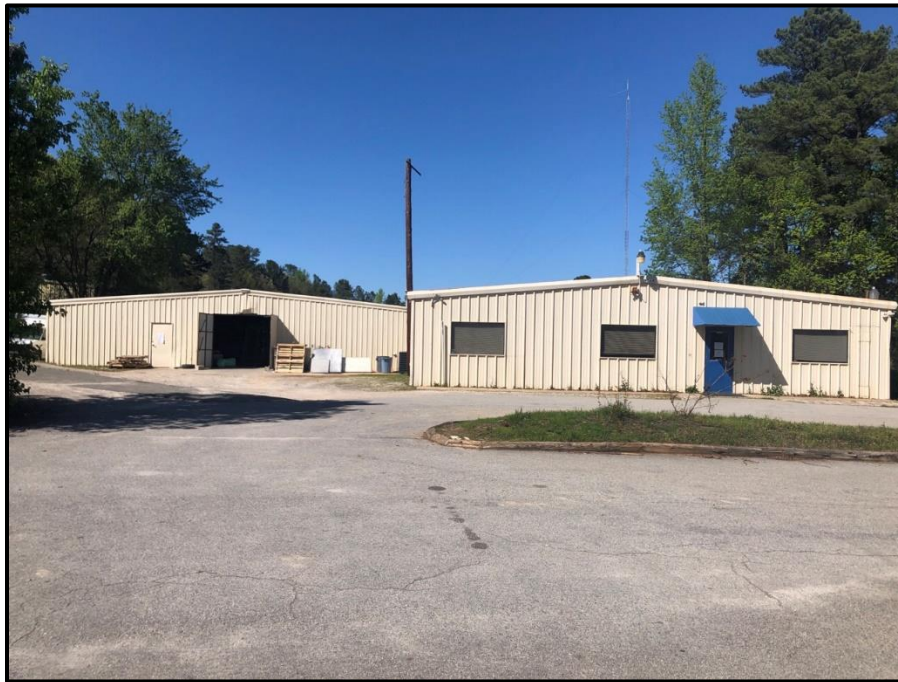
The commercial building, constructed in 1970 on approximately 1.55 acres, is located on the west side of Trinity Road. The structure is one story with four bays and a shallow pitched front gable roof. The exterior walls have been recently clad in metal siding (Figure 4). Fenestration includes a single-leaf metal entry door and single-light rectangular fixed windows. The tax parcel also includes a warehouse building (c. 1980) immediately to the west of the commercial building, a large vehicle shed (c. 1980) with off-set garage bay to the southwest (991 Trinity Road), and a large warehouse (c. 2000) also to the southwest (981 Trinity Road). The three secondary resources are clad in metal siding and feature gable roofs. The building constructed in 1970 has been altered with the addition of the metal siding and does not appear to possess sufficient significance or integrity to be eligible for the National Register.

**Figure 4 ATC Building (WA8797), 1001 Trinity Road, Looking North.**

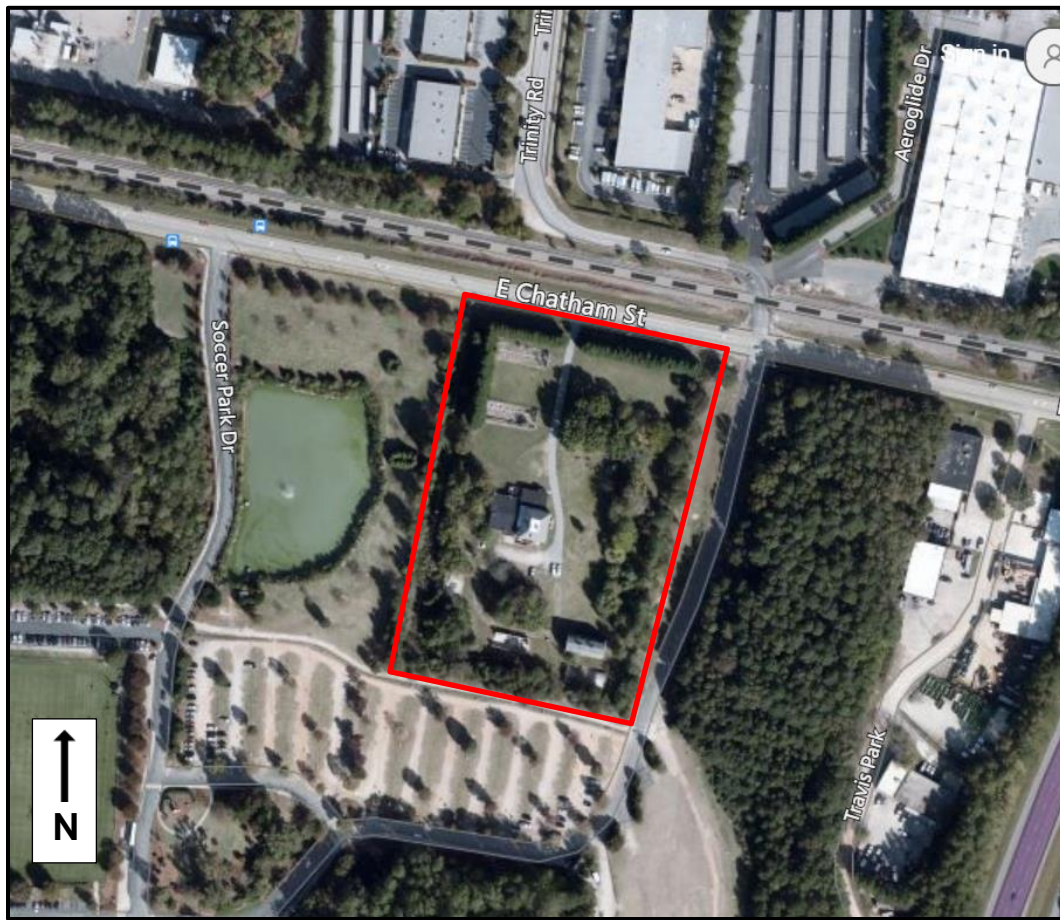
Figure 5. Aerial Depicting Landscape Surrounding Resource WA2054 (Bing Maps 2020).

The facility sits back from the road on a relatively level lot and is accessed by a paved driveway which leads past the main laboratory building to the barn to the southeast. According to aerial photographs, the driveway was originally circular but was modified between 1972 and 1983 (Nationwide Environmental 2020). The current landscape features a tree line surrounding the state agricultural complex, which comprises approximately 7 acres (Figure 5). To the south/southwest of the complex is a large recreational area with paved parking, playing fields, and soccer stadium constructed around 2000. Prior to the installation of the soccer complex, the parcel consisted of open and wooded areas (Nationwide Environmental 2020). To the north of the agricultural complex, across E. Chatham Road, is an area of mid-twentieth century and modern commercial and industrial development.

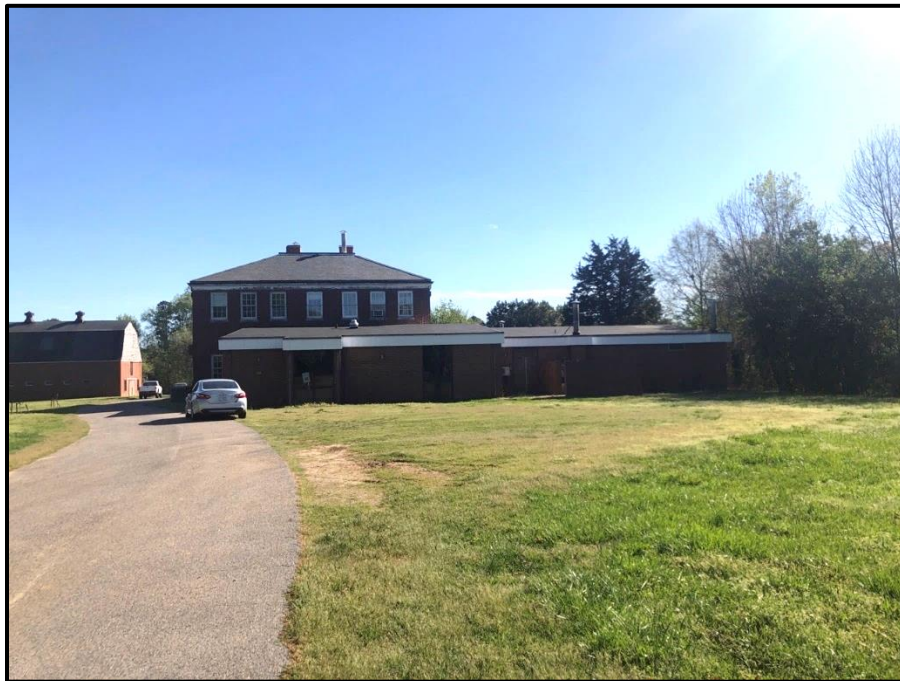
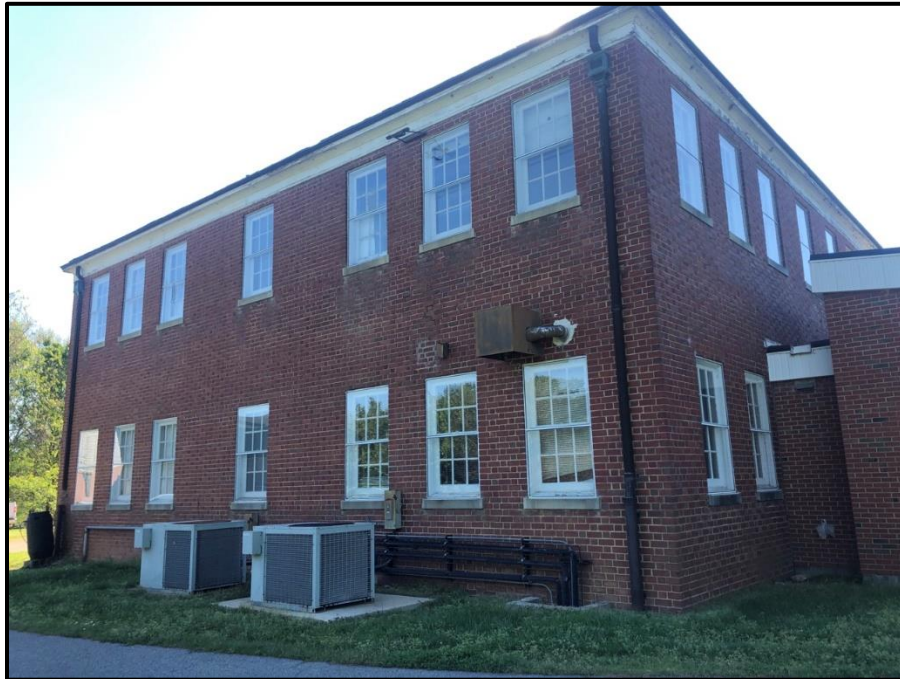
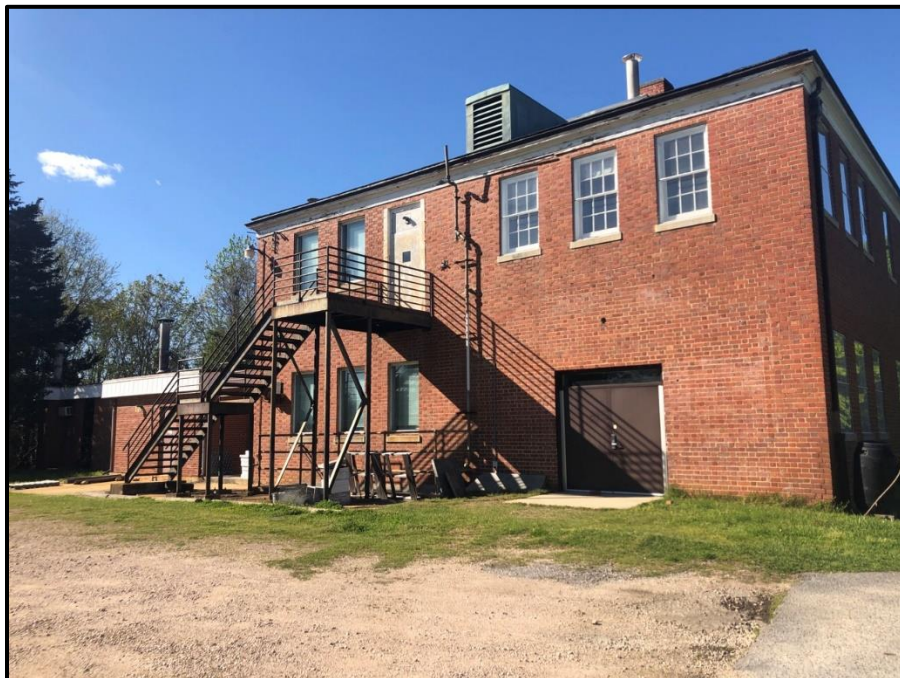
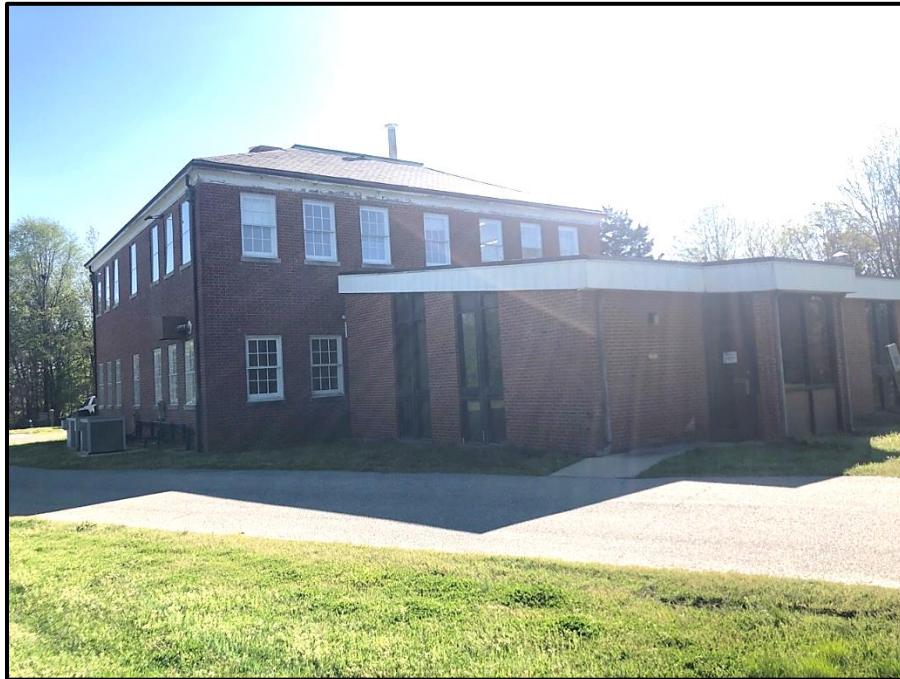
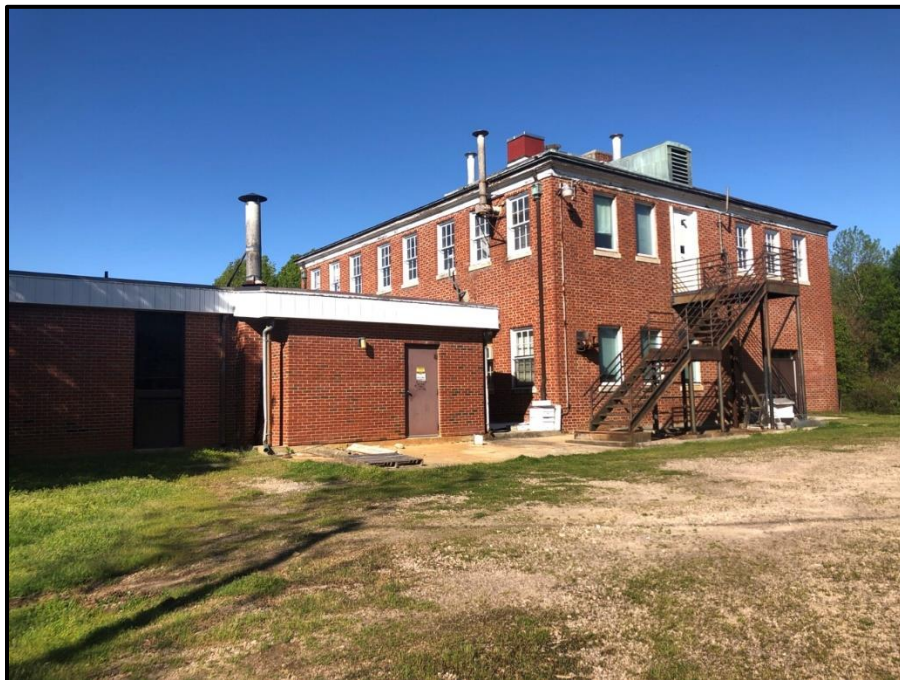
The main laboratory building for the former Hygiene Farm is a two-story, brick building with asphalt shingle-clad hip roof. The brick walls are laid in a Flemish bond pattern. The building, designed in the Colonial Revival style, features an interior central brick chimney, wood cornice, and six-over-six wood sash windows with masonry sills. On the south elevation is a garage bay door and a fire escape which is accessed by a single-leaf metal door with transom. Between 1972 and 1983, the one-story addition was constructed onto the north and west elevations after the facility was transferred to the North Carolina Department of Agriculture's Plant Industry Division. The addition features brick clad exterior walls, shed roof, and tall, paired fixed metal windows (Figures 8-12).

**Figure 8 State Laboratory of Hygiene Farm's Main Laboratory Building, Looking South.**

**Figure 9 State Laboratory of Hygiene Farm's Main Laboratory Building, Looking West.**

**Figure 10 State Laboratory of Hygiene Farm's Main Laboratory Building, Looking Northwest.**

**Figure 11 State Laboratory of Hygiene Farm's Main Laboratory Building, Looking Southwest.**

**Figure 12 State Laboratory of Hygiene Farm's Main Laboratory Building, Looking Northeast.**

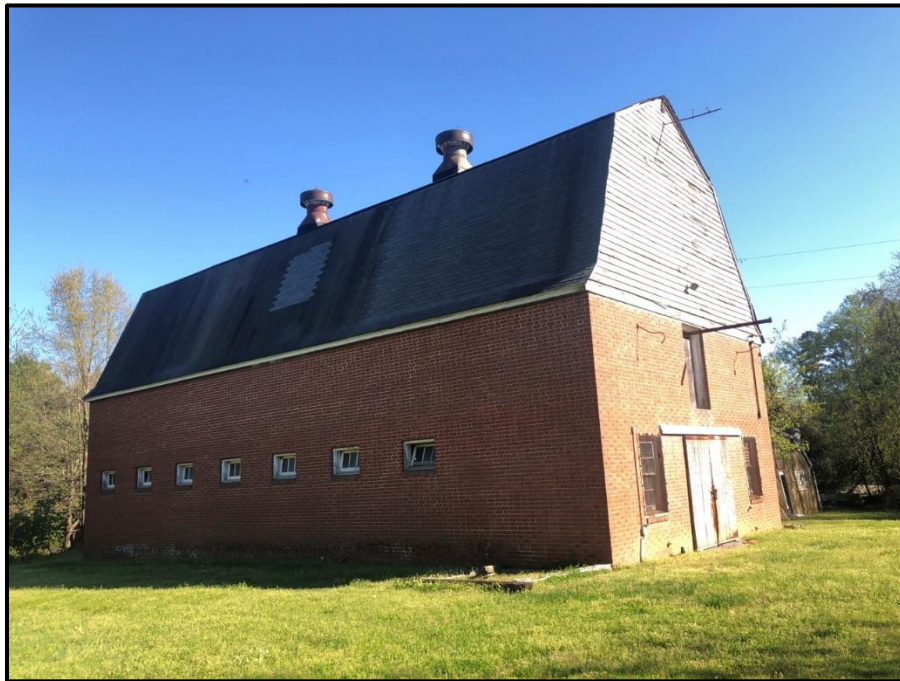
The surviving barn is a two-story brick structure with exterior walls laid in a Flemish bond pattern, similar to the main laboratory building, with the exterior walls of the loft clad in weatherboards. The building features a steep gambrel roof clad in asphalt shingles with two metal vents projecting from the ridgeline. The western end of the barn features three bays on the first floor consisting of central paired corrugated metal doors flanked by six-over-six wood sash windows with brick sills. A plywood hay loft door, with remnants of the pulley system, is located above the sliding doors. The eastern end of the building also features paired sliding doors with a hay loft door above; however, no windows are present. Along the north and south elevations of the barn are small, wood three-light hopper windows located just below the level of the second floor (Figure 13).

**Figure 13. Barn, Looking Southeast.**

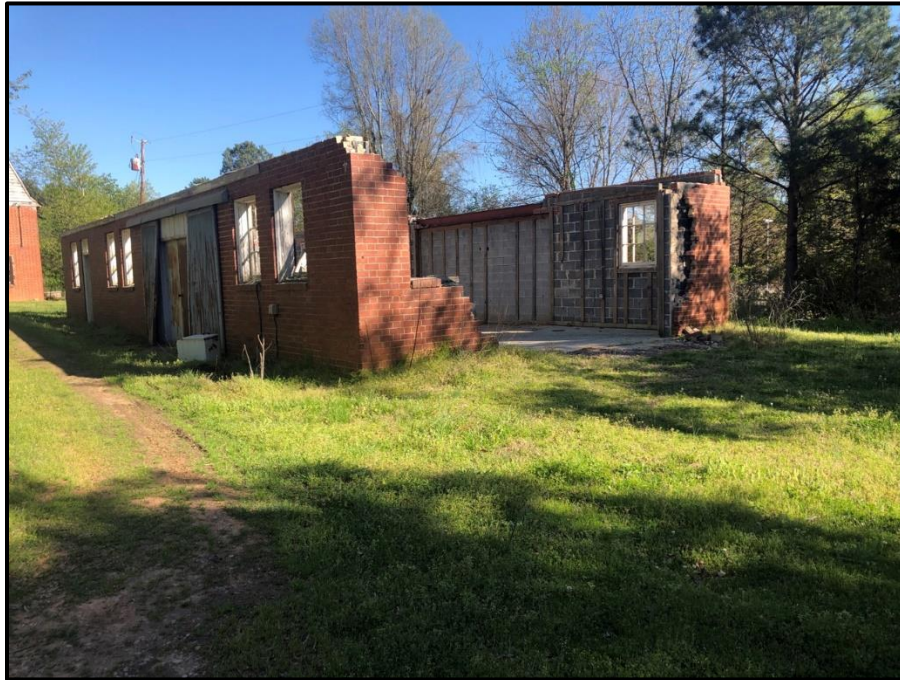
Remnants of a building are located to the west/northwest of the surviving horse barn. The building, specified as a milk house in the tax data, may have functioned as the original sheep barn, which was constructed at the same time as the horse barns and main laboratory building. The building is one story; however, the roof is no longer extant. The walls are cinder block with brick veneer laid in a Flemish bond pattern and the floor is poured concrete. The northern elevation of the building features seven bays. The second bay features a single-leaf pedestrian entry door with transom above, while the fifth bay houses paired metal doors with sliding doors. The remaining bays are nine-light wood hopper windows with brick sills. Mirroring the paired doors on the north elevation is a filled in concrete block section of wall on the south elevation, which appears to have originally been the location of livestock doors (Figure 14).

**Figure 14 Remains of a Barn, Looking Southeast.**

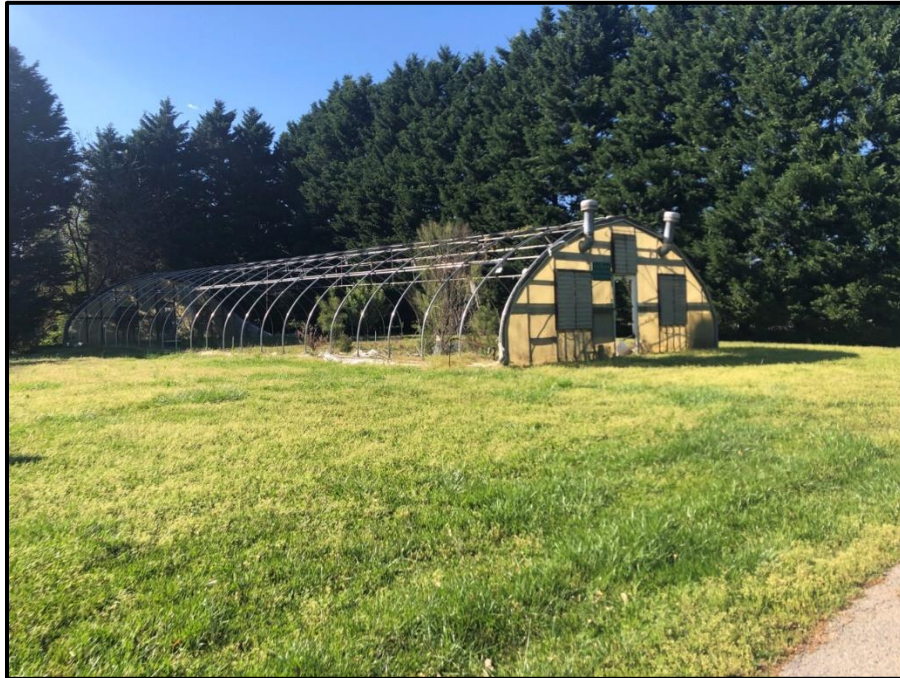
The greenhouse, according to aerial photographs, was constructed between 1983 and 1993. The building is a one-story, metal frame building with the remnants of a fiberglass end wall on the eastern end of the structure. The eastern end also features a central entry, metal vents which project above the roofline, and louvered wall vents. The building has been abandoned (Figure 15).

**Figure 15 Greenhouse 1, Looking Northwest.**

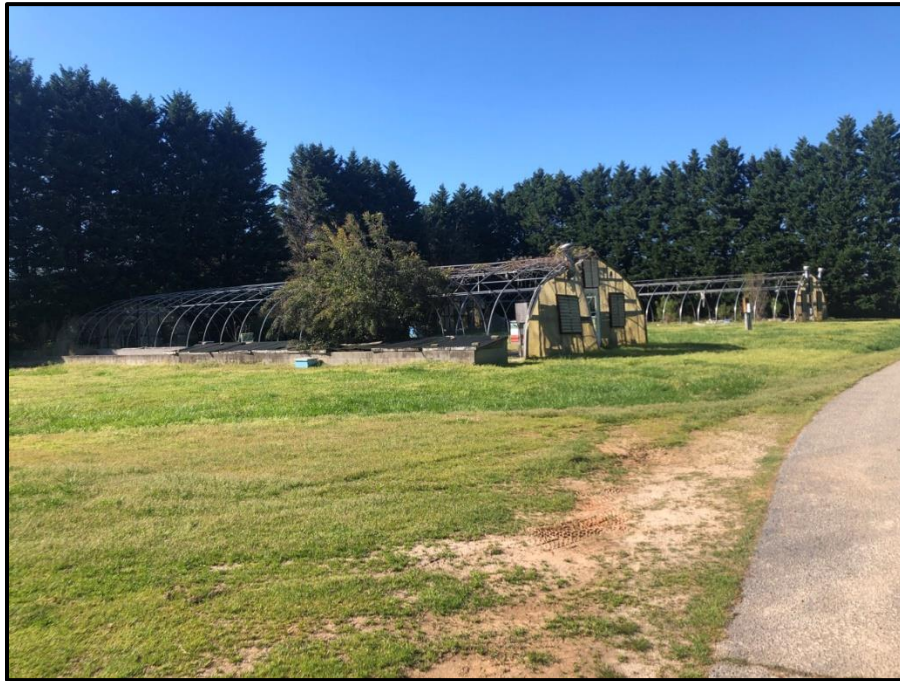
The greenhouse (2), according to aerial photographs, was constructed between 1983 and 1993. The building, located to the south of Greenhouse 1, is a one-story, metal frame building with the remnants of a fiberglass end wall on the eastern end of the structure. The eastern end also features a central entry, metal vents which project above the roofline, and louvered wall vents. Along the southern elevation of the structure is a series of low concrete block cold frames. The building has been abandoned (Figure 16).

**Figure 16 Greenhouse 2, Looking Northwest.**

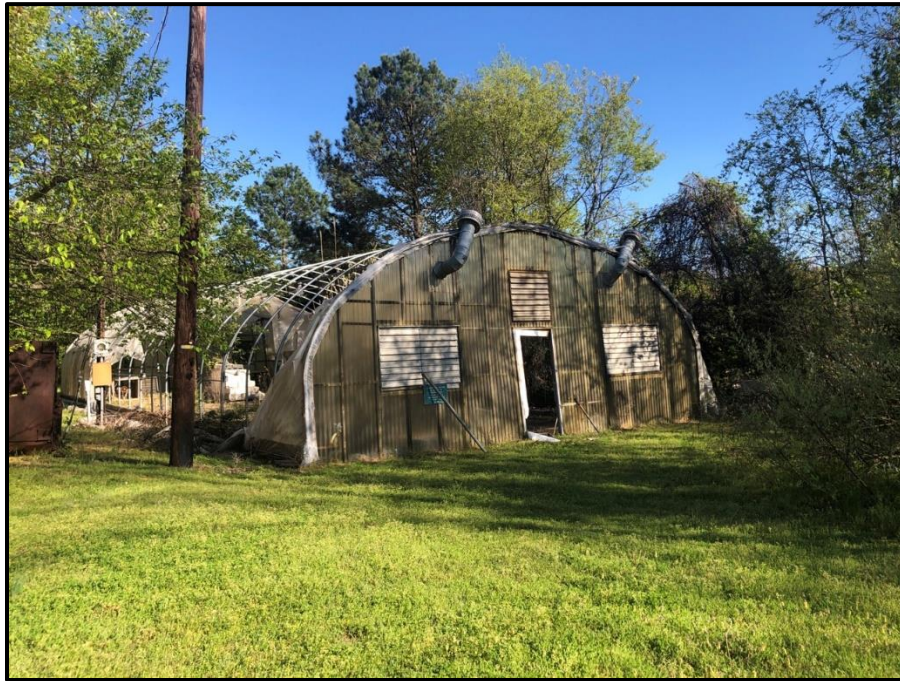
The greenhouse (3), according to aerial photographs, was constructed between 1983 and 1993. The building is similar to greenhouses 1 and 2 and is a one-story, metal frame building; however, the structure appears to be broader in width. The building also has remnants of a fiberglass end wall on the western end of the structure and features a central entry, metal vents which project above the roofline, and louvered wall vents. The building has been abandoned (Figure 17).

**Figure 17 Greenhouse 3, Looking Southeast.**

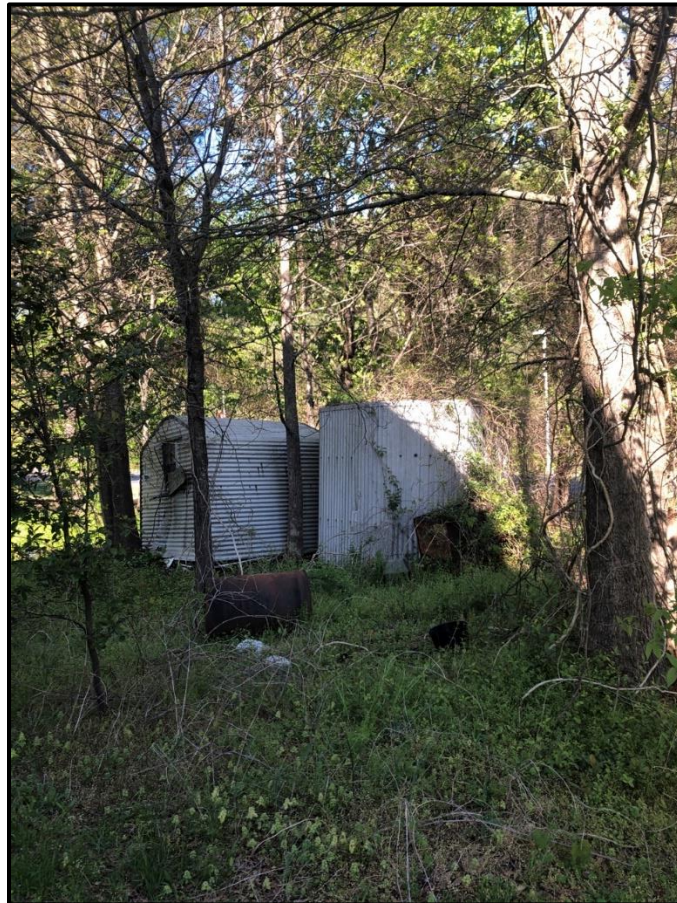
The sheds, which are located in a wooded area to the south of the barn, include a pre-fabricated shed with corrugated metal walls and gable roof and a corrugated metal shed with a shed roof. The latter is partially engulfed in vines (Figure 18).

**Figure 18 Sheds, Looking Northeast.**
