# Historic Structures Survey Report

**Convert At-Grade Intersection to Interchange at US 64 and NC 751**

**Wake and Chatham Counties**

**TIP No. R-5887**

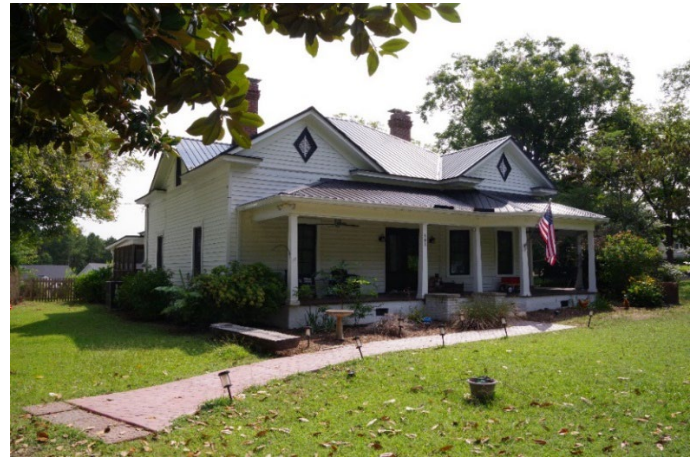
Image 1. Goodwin House facade, facing east

Constructed circa 1920, the one-and-a-half story Goodwin House is a frame cottage with minimal late Queen Anne stylistic elements such as diamond gable vents and corbelled brick chimneys. The square core of the house is covered by a non-historic metal hipped roof that is pierced by twin interior corbelled brick chimneys. Cross gables are present on the north and south elevations, twin projecting gables are present at the asymmetrical façade. The roof features an overhang, and sharp corner returns mark the gables. The exterior of the house has recently been altered by the nearly comprehensive installation of non-historic 1/1 windows, replacement front door, and comprehensive application of vinyl siding. The asymmetrical façade features a partial wrap-around shed roof porch carried on historic tapered wood columns. Non-historic front doors are set within the center, and a projecting bay is present at the southeast corner. Based on the size of the front door opening, the original door likely possessed flanking sidelights. The porch is accessed by brick stairs, the ceiling is covered with historic beadboard, and the porch floor appears to be a combination of historic and non-historic tongue and groove wood (Images 1, 3-4).

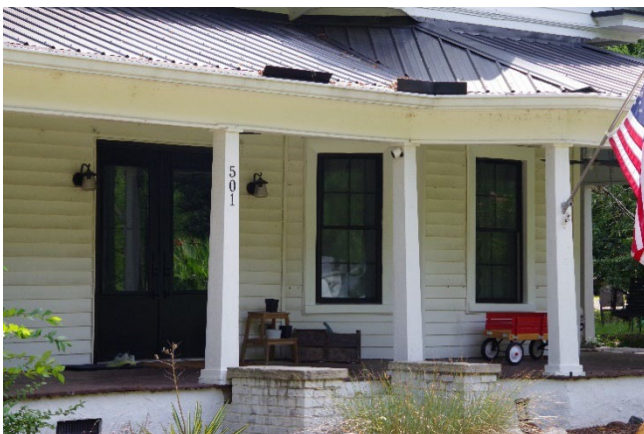
Image 3. Façade replacement doors and windows

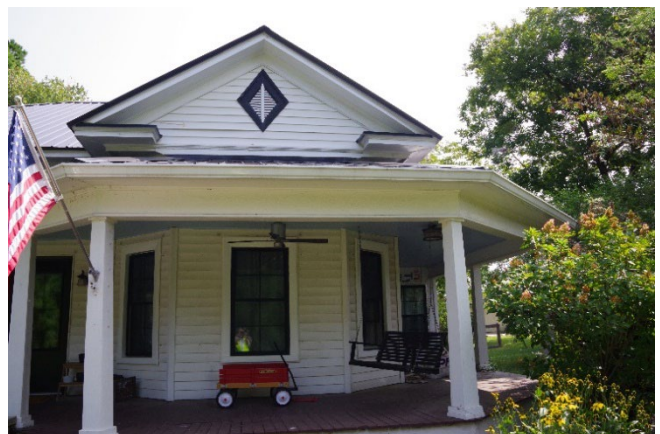
Image 4. Façade porch detail

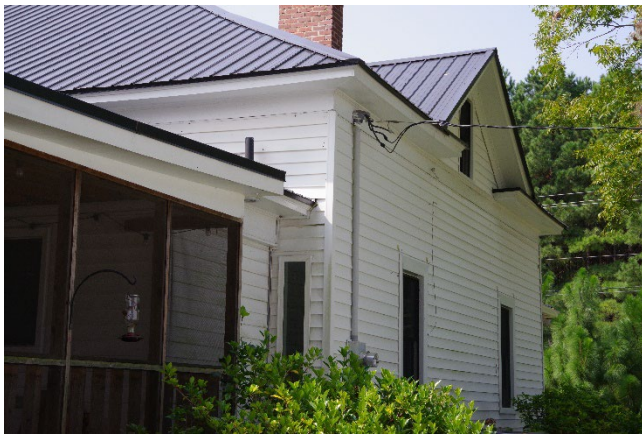
*Image 5. Rear oblique, facing southwest*

The north elevation is plain with two windows at the first floor and a smaller window in the upper half story (Image 5).

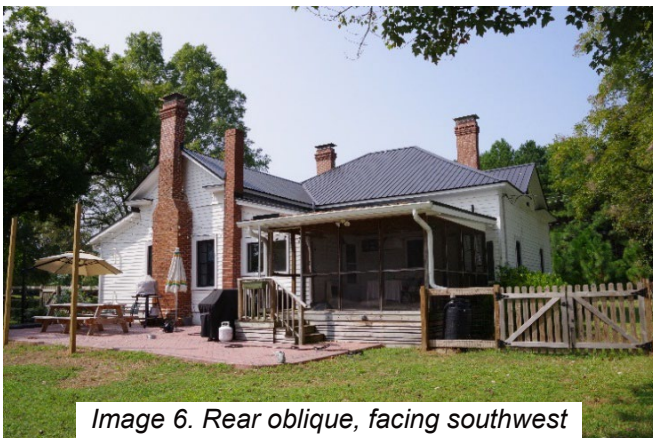
Viewing the house from the rear (east elevation) reveals design alterations to the original footprint. A historic, and likely original, projecting rear ell extends from the southeastern corner with enclosed shed roof extensions on either side. The enclosed shed roof extensions are symmetrical and were likely open porches when constructed. The ell is capped by an exterior brick chimney which has been repointed from the roofline up and is flanked by non-historic windows. The corbelling of that chimney is identical

to the two interior chimneys within the core of the house. A smaller square chimney is at the northeastern corner of the rear ell and likely corresponds with the shed roof extension at the same location. Presumably a porch enclosure, this section features large, single pane windows, and a non-historic door opens to a shed roof screened porch addition. A non-historic stamped concrete patio has been constructed along the rear of the house for cooking and entertaining (Images 6-7).

*Image 6. Rear oblique, facing southwest*

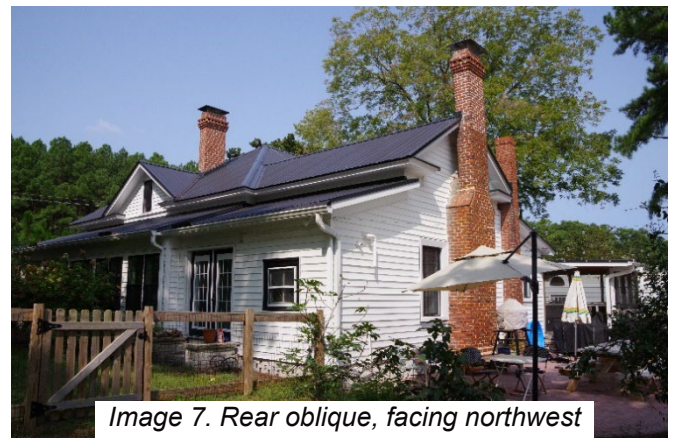
Original elements of the house are present along the south elevation (Images 7-9). Portions of the original wood weatherboard siding were visible at the time of field survey as renovations are underway. Stucco

*Image 7. Rear oblique, facing northwest*

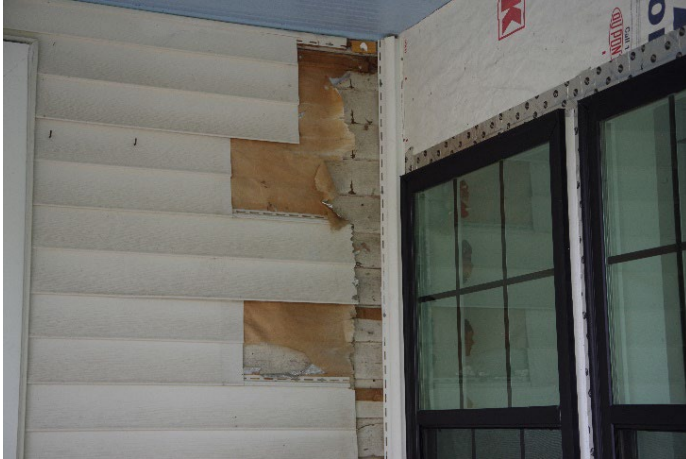
*Image 8. Exposed original wood weatherboard siding*

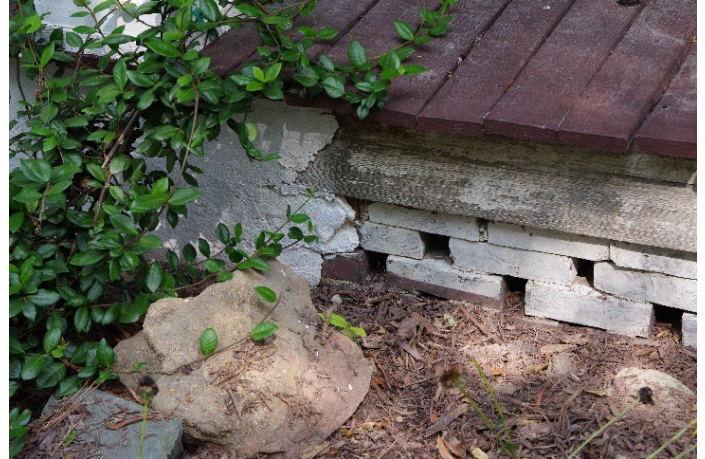
foundation parging has worn away at one area and the original wood porch deck beam is visible above a potentially historic-age vented brick screening.

*Image 9. Foundation detail at south elevation*

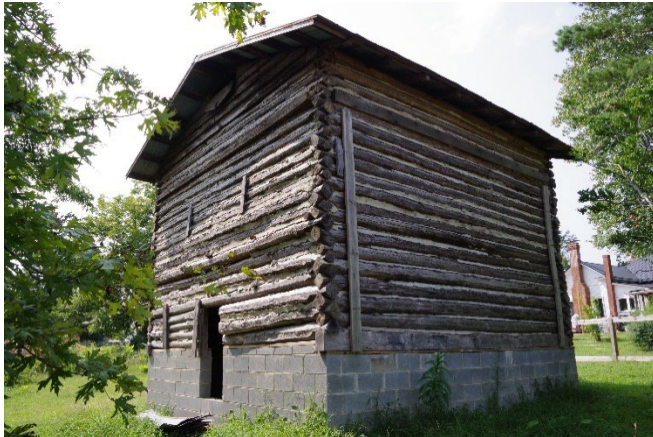
The Goodwin tobacco barn is located at the northeast corner of the parcel (Images 16-17). While the date of construction for the barn was not determined, it is consistent with local agricultural construction well into the 20<sup>th</sup> century, consisting of log construction, which was inexpensive and practical for retaining heat to cure tobacco. The structure is further identifiable as an older tobacco barn based on its small size and ventilators in the gable ends.<sup>1</sup> According to a 2022 real estate listing for the property and review of aerial imagery, the barn was relocated approximately 90 feet to the west from its historic location to accommodate adjacent residential development. Aerial imagery reveals that at its former location, the barn once featured shed roof extensions at the north and east elevations. These were removed by 2020, prior to its relocation. Field survey observations, specifically the presence of wood boards that the shed

extensions would have been attached to, support that this structure is the same as the structure viewed in the 2018 aerial. The structure rests on a replacement, non-historic concrete block foundation with door openings at the front and rear (east and west elevations). The building features a metal roof and a mixture of historic chinking and modern concrete between some of the logs. The interior of the building is open and there are 3 vertical rows of 6 wood poles to hang tobacco (three rooms wide and six tiers tall).<sup>2</sup>

*Image 16. Tobacco barn, facing south*

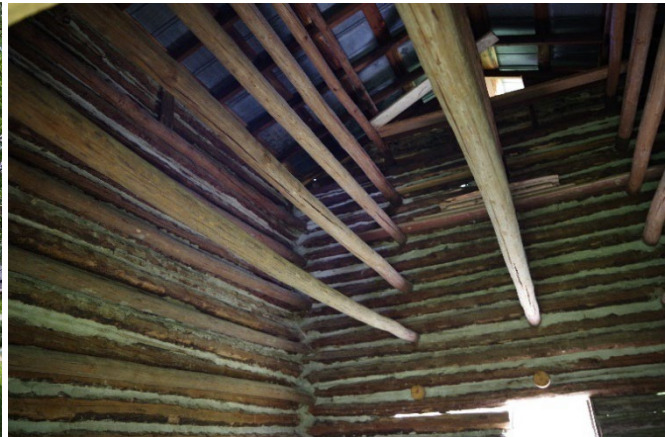
*Image 17. Tobacco barn interior*

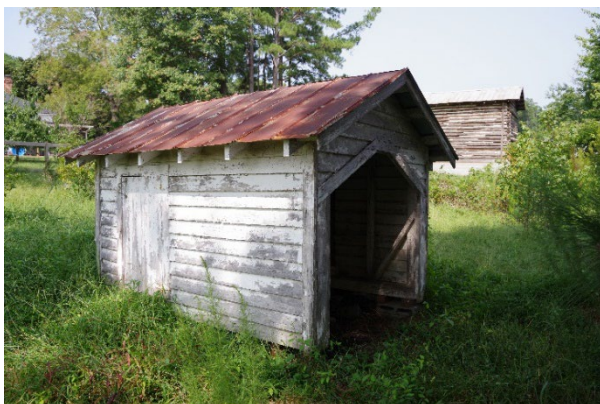
A small wood outbuilding with a historic metal roof is at the southeastern portion of the property (Image 18). The exact use of the building is unknown, but it appears to have been used for storage as there is an enclosed portion at the west and an open portion at the east. A non-historic wood frame chicken coop is located south of the house in the front yard. The rear yard is partially enclosed by a non-historic wood and wire fence; there are no outbuildings located within the fenced area. Review of aerial imagery indicates a non-historic metal garage, and a non-historic metal carport were installed circa 2004.<sup>3</sup>

*Image 18. Historic storage outbuilding, facing northwest*

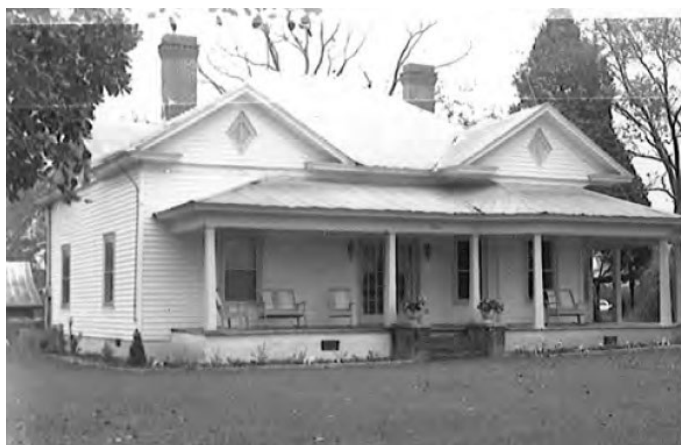
Image 20. 1989 Photograph (Image from WA1078 Survey Form)

Wake County was comprehensively surveyed in 1988-1991 by Kelly Lally. Lally's survey informed a National Register of Historic Places Multiple Property Documentation Form (MPDF) titled "Historic and Architectural Resources of Wake County, NC (c. 1790-1941)" by Kelly Lally and Todd Johnson, as well as the publication of the book, *The Historic Architecture of Wake County, North Carolina* in 1994, by Lally.<sup>4</sup> Wake County was surveyed and contextualized again in 2005-2006 by Edwards-Pitman Environmental Inc. In 2017, select areas of Wake County were surveyed and contextualized by hmwPreservation as part of an architectural survey update of historic resources in the Long- and Short-Range Urban Service Areas of Apex, Fuquay-Varina, and Holly Springs, the Apex Non-Urban Service Area, and the Falls Lake Water Supply Watershed of Northwest Wake County. While documented by all three survey and reporting efforts, the Goodwin House was not recommended for further study or as a NRHP-eligible resource (Images 20-21).

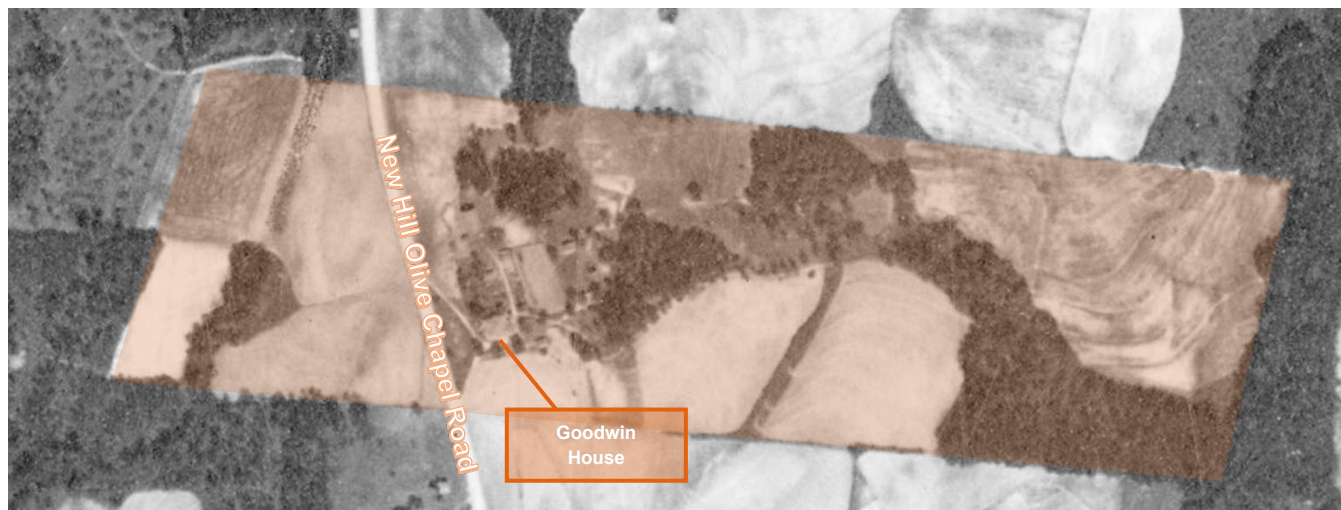
*Image 23. 1938 (Image from UNC University Libraries)*

According to United States Census data, Goodwin had established a family-operated farm by 1930, as his occupation is listed as a farmer.<sup>8</sup> Aerial photography of the property during this period shows terraced fields, row crops, and several outbuildings (Image 23). While specific metrics and identification of crops grown on the Goodwin property were not determined, tobacco was presumably the primary crop due to the presence of the extant tobacco barn. This presumption is further supported by the 2017 Wake County

Aerial photography indicates minimal changes to the topography and field arrangements between 1938 and 1959 (Images 23 and 25). However, the creation of two ponds and the construction of additional supporting agricultural outbuildings, some of which were associated with Robert Lee's house occurred.

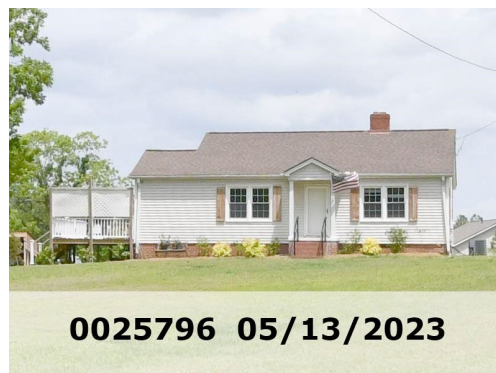
*Image 24. Robert Lee Goodwin's House  
(Image from Wake County Tax Assessor)*

Consistent with national trends, the farm was subdivided over the years amongst Goodwin's heirs. Approximately 0.81-acre was subdivided from the farm in 1952 and deeded to Robert Lee Goodwin, who subsequently constructed a house on the parcel in 1953, south of the Goodwin House. A Minimal Traditional House, Robert Lee's house has been heavily altered through the comprehensive installation of non-historic materials and a porch addition (Image 24). Robert Lee Goodwin died in 1993. This subdivided portion of the property has not functioned as part of the original landholdings since its subdivision from the original farm tract during the 1950s and has therefore not been included as part of the Goodwin House evaluation.

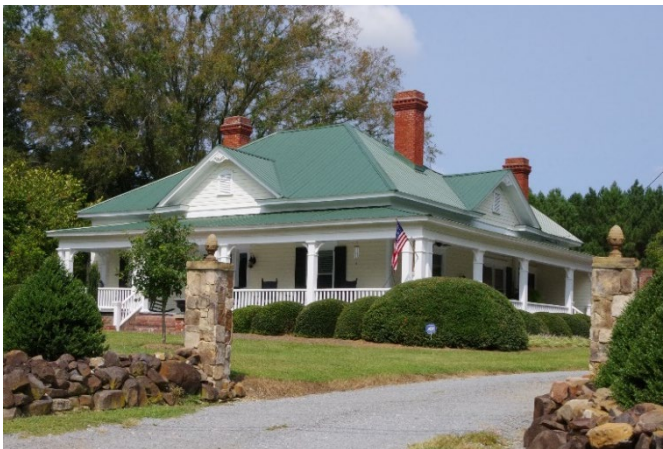
Image 27. Allie Lawrence Farm (WA1097)

The Allie Lawrence Farm (WA1097) at 4028 Old US 1 Highway is a nearby, state-listed early-20<sup>th</sup> century farm complex that retains numerous agricultural outbuildings, house, and cemetery (Image 27). The hip-roofed house was constructed around 1915 and features tall interior corbelled brick chimneys, a partial wraparound porch, gable returns at the roofline, a bay window, and façade door flanked by sidelights. Like the Goodwin House, windows have been replaced. However, the house possesses higher material integrity through the retained front door and sidelights and exposed original novelty board siding. Of the

outbuildings, there are three tobacco barns in their original locations but are covered by overgrown vegetation.<sup>9</sup>

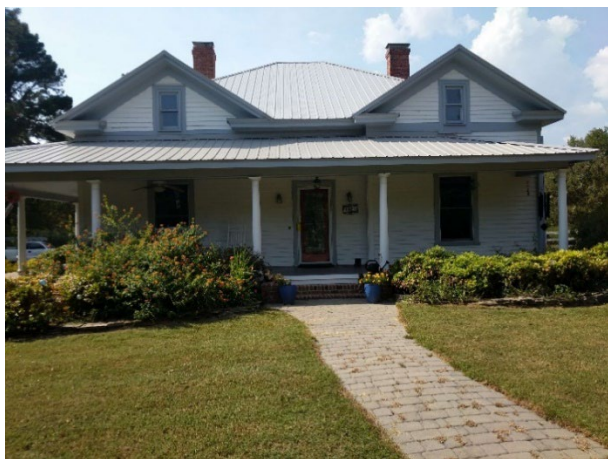
*Image 28. CH 222 (Image from Chatham County Tax Assessor)*

Located approximately four miles north of the Goodwin House, CH222 is an early one-and-a-half story 20<sup>th</sup> century frame cottage (Image 28). Minimal Queen Anne stylistic elements are present, including a tall, corbelled brick interior chimneys, partial wraparound porch, and a complex hipped roofline with projecting gables. The design of CH222 is more modest compared to the Goodwin House, as it lacks a bay window and appears to have never featured sidelights at the façade door. At the time of the 1982 field survey, side porch additions, like those on the Goodwin House, had not been enclosed.<sup>10</sup> However, 2007 Google Streetview imagery reveals both enclosure and removal of side porches at the south elevation. Based on the 2022 Chatham County Tax Assessor's photo, the façade windows appear to be historic 1/1 wood frame units and the façade door is a non-historic wood and lead glass replacement.

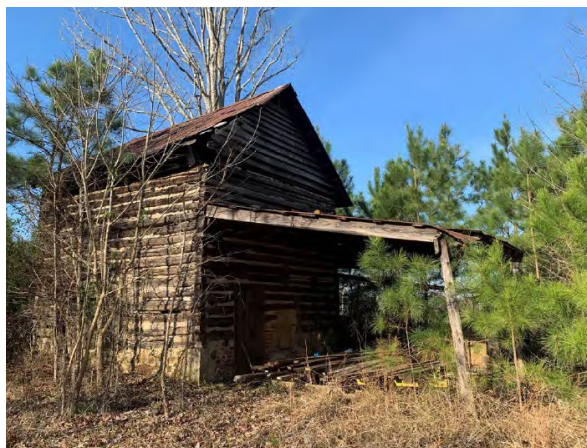
*Image 29. Excel and Elsie Green Farm Tobacco Barn (WA7194) (2022 Image from Wake County Historic Farm Context (1918-1968) and Survey Update)*

The log tobacco barn with stone foundation associated with the Excel and Elsie Green Farm (WA7194) is typical of early 20<sup>th</sup> century tobacco barn construction in Wake County (Image 29). Like the Goodwin tobacco barn, this example features a shed roof extension at the north side. The Excel and Elsie Green Farm consisted of a 50-acre farm with a 1925 Craftsman Bungalow and various agricultural outbuildings surrounding it at the time it was surveyed in 2011.<sup>11</sup> However, like many small farmsteads in the area, this resource has been recently razed to make room for new development. According to aerial imagery, the log tobacco barn is the only remaining structure.

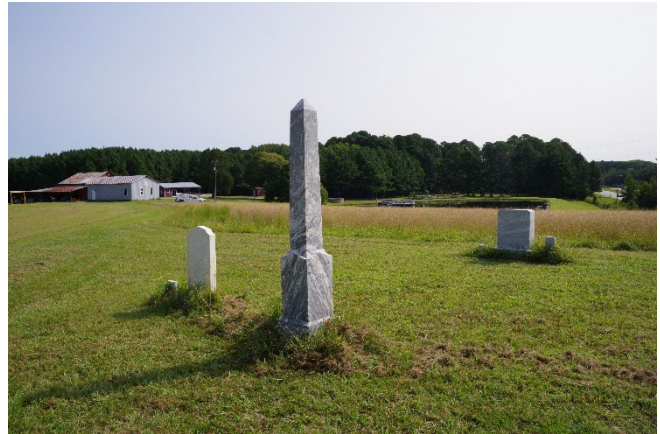
Image 30. Howell Family Cemetery, facing east

The Howell Family Cemetery (WA7915) is located in a field, approximately 130 feet north of US 64 (Images 30-31). The land was formerly owned by the Howell family, which included a circa 1900 two story triple-A house and some agricultural outbuildings (WA1033). The house has been razed but the barn is extant. Non-historic houses and outbuildings have recently been constructed near the original building locations, north of the cemetery. According to the property owner, the headstones were recently cleaned by a restorationist. Additionally, the owner noted that footstones have been moved next to headstones to allow for mowing. All markers are oriented to the west and there is no apparent plan or formal landscaping present.

A white marble tombstone immediately north of the obelisk marks Sylvia Catherine Perry's (1836-1918) grave, the daughter of Jesse and Eliza (Image 30 and 33). The crowned tablet marker features inscribed ivy and vine above the text inscriptions. The marker appears to have been broken and repaired.

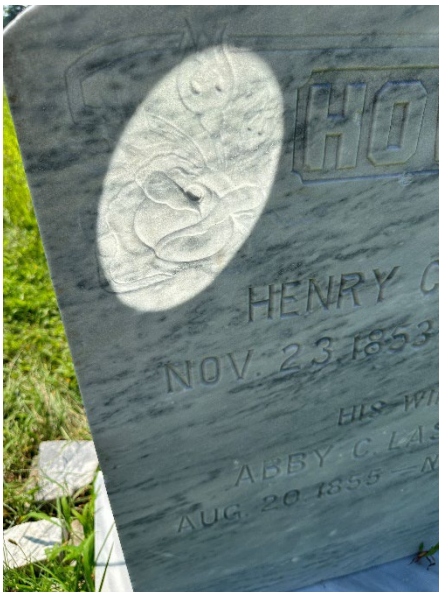
Image 32. Floral detail (Image from Overton)

Farther east is a granite rounded square tablet headstone for Henry C. Howell (1853-1929) and his wife Abby C. Lassiter (1855-1917) (Image 32). The marker features inscribed floral reliefs flanking the surname.

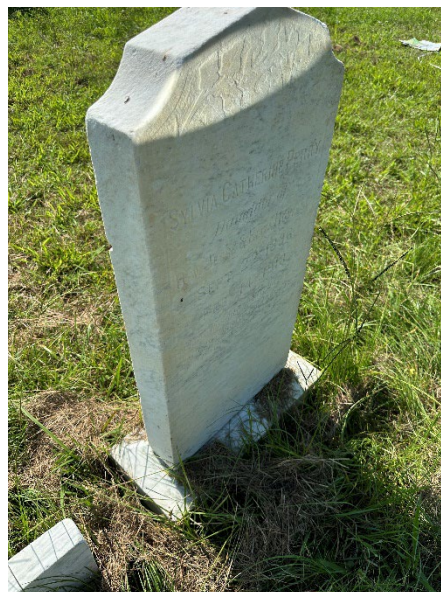
Image 33. Vine detail (Image from Overton)

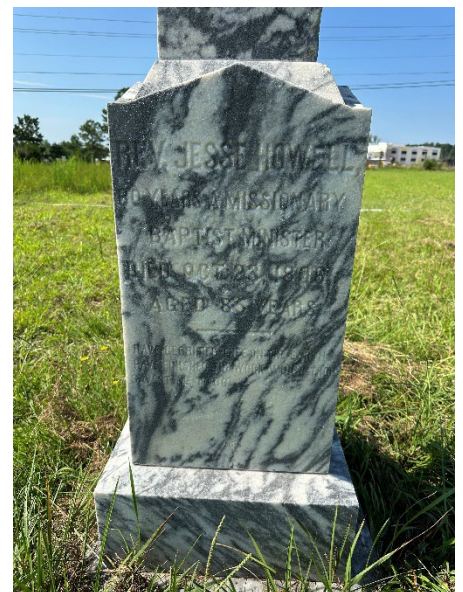
Image 34. Obelisk detail (Image from Overton)

While the small family cemetery consists of three grave markers, a single gneiss obelisk and two markers of professionally cut marble and granite, at least five people are believed to be interred based on inscriptions on the grave markers. The obelisk marks both Jesse Howell Jr. and wife Eliza Wilson Howell's burials. The obelisk bears inscriptions on all sides. The base of the obelisk reads "Erected by their friends to the memory of Rev. Jesse Howell and Wife." Additional text on the obelisk reads "Rev Jesse Howell 60 years a missionary Baptist minister died Oct 28, 1896, aged 85 years" (Image 34). Eliza's life is marked as ending on November 10, 1895, aged 82 years. The tower of the obelisk was broken but has been repaired.

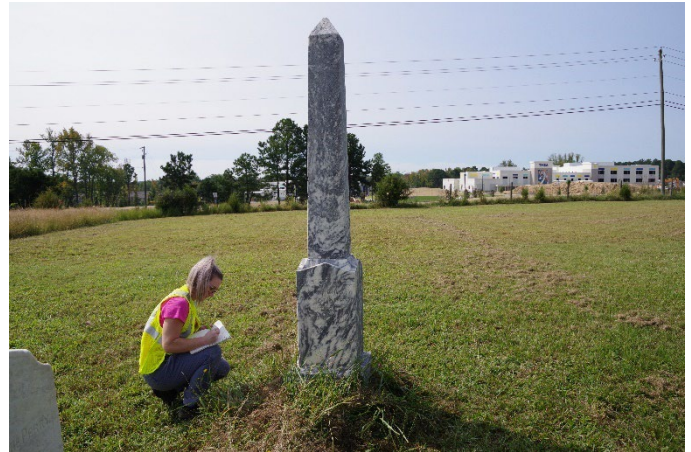
Image 36. Scale of obelisk, facing south

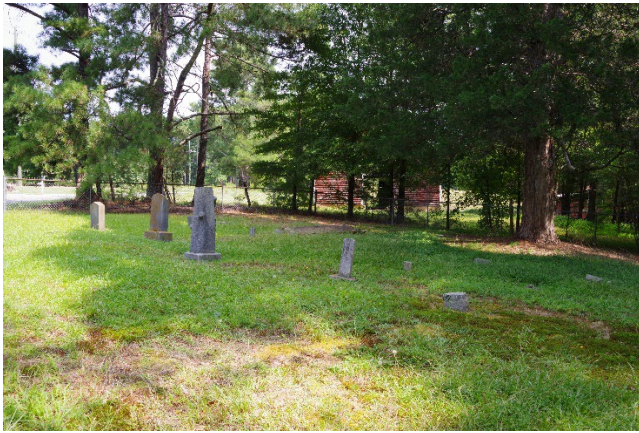
Image 37. Bennett Family Cemetery (WA 1097)

The Allie Lawrence Farm (WA1097) at 4028 Old US 1 Highway is a nearby, state-listed early-20<sup>th</sup> century farm complex that retains numerous agricultural outbuildings, house, and cemetery. Those interred at the cemetery are members of the Bennett family, prior owners before the Lawrences. The cemetery sits across the street from the house, near agricultural buildings, and is enclosed by a chain link fence. Like the Howell Family Cemetery, the Bennett Cemetery contains a variety of headstone types, with six markers with inscriptions dating between 1900-1937, and is laid out in rows with markers facing southeast (Image 37).

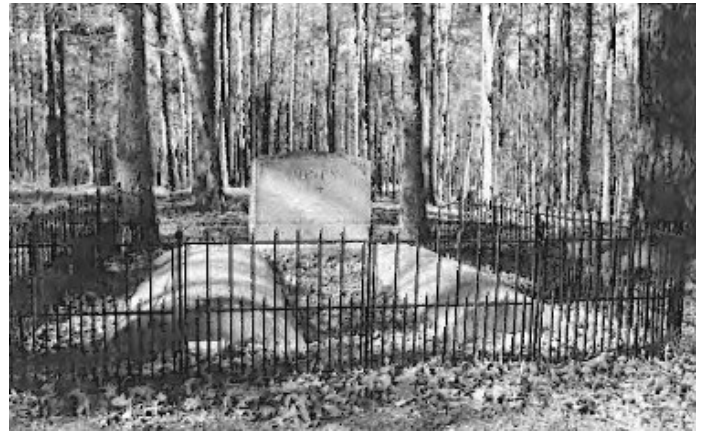
Image 38. Jones Family Cemetery (WA 7797) (Image from 2017 Survey Form)

Dating to 1894, the Jones Family Cemetery (WA7797) is located approximately 10 miles north of the Howell Family Cemetery, along the north side of Avent Ferry Road, just east of New Hill-Holleman Road. Like the Howell Family Cemetery, any buildings associated with those interred in the cemetery are no longer extant, though the land remains in the Jones family. The Jones Family Cemetery contains the burials of William Benton Jones (1827-1884) and Martha M. A. Norris (1834-1910), both of which are marked by partially above-ground concrete vaults, which have been enclosed by a non-historic metal fence (Image 38). A modern, manufactured grave marker has been added to mark the burials.<sup>18</sup>
