**North Carolina Department of Natural and Cultural Resources  
State Historic Preservation Office**

Re: Feasibility Study for Downtown Multi Modal Transit Center, Cary, Wake County, ER 19-0950

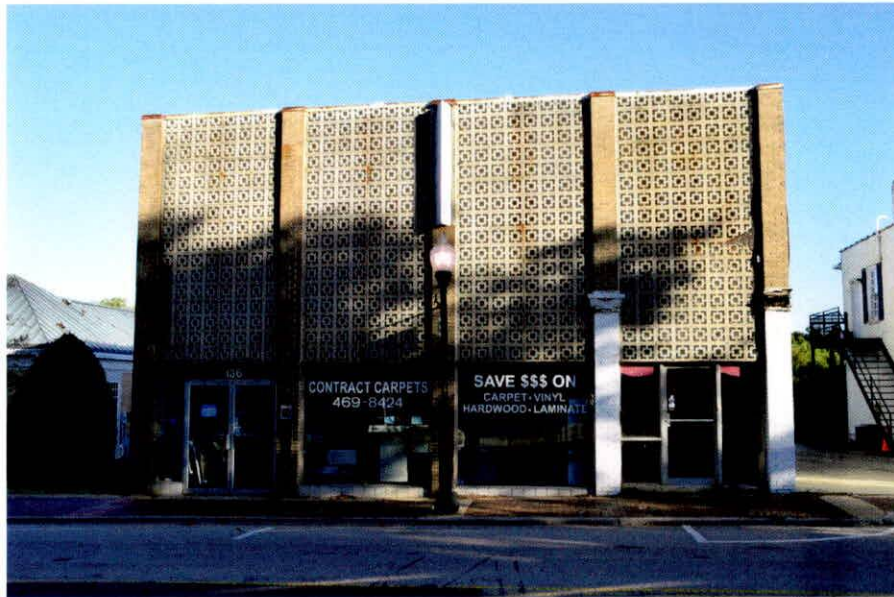
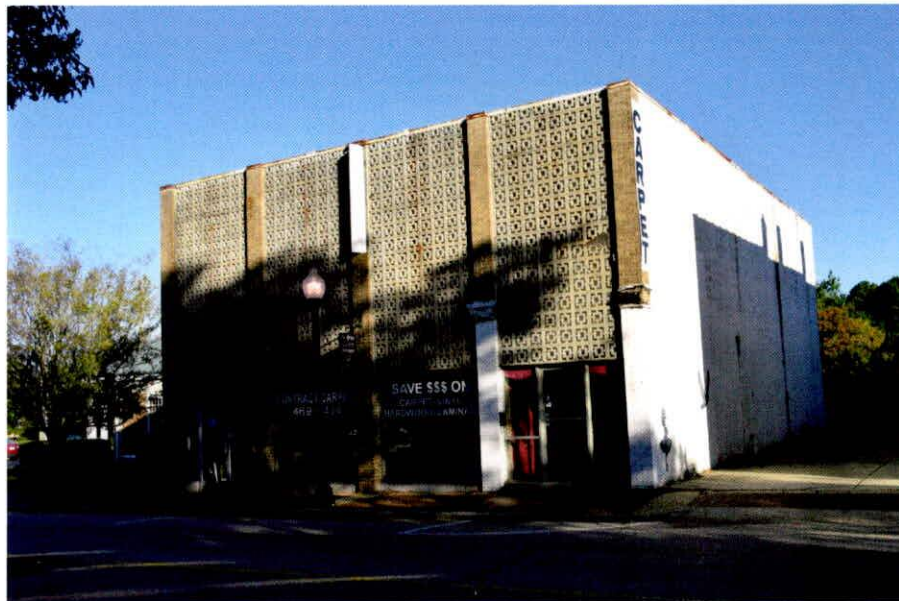
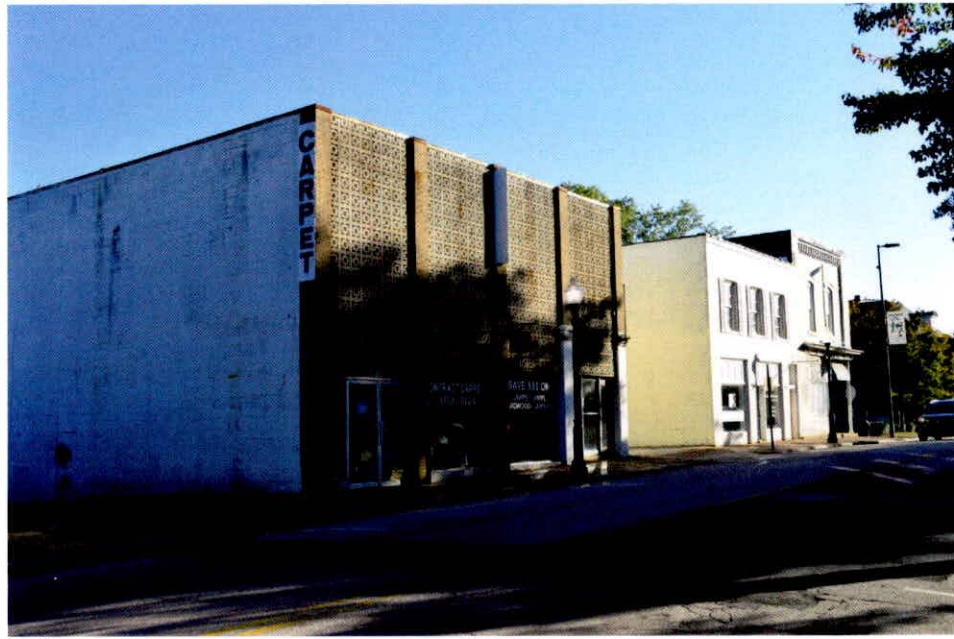
*Inventory #3*

Mid-twentieth century, two-story, concrete-block Modernist commercial building with breezeblock screen above extruded aluminum storefront. Storefront bays separated by brown-brick pilasters and grounded with tile-covered concrete curbs. Pilasters and tile curbing are at the interior as well as the exterior. Breeze-block with interlocking square pattern covers the entire second story between pilasters; a fine metal screen covers the breezeblock to keep birds from nesting. Entrance at left side is into first-floor store; entrance at right side is into stairwell to second story. Stairwell is metal, half-turn, open-riser stair in concrete-block stairwell. Minimal alterations appear limited to the pilasters: the two framing the stairwell entrance have been painted white at the first story and column capitals added. The upper portion of the center pilaster has been removed to accommodate a slender, vertical signboard that is not currently in use.

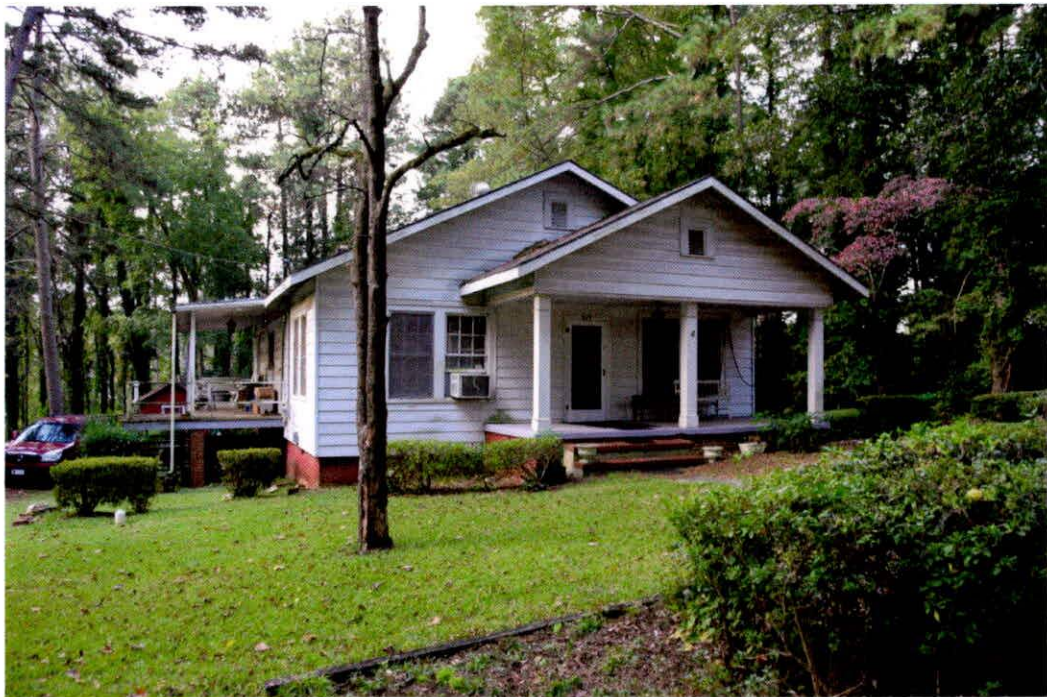
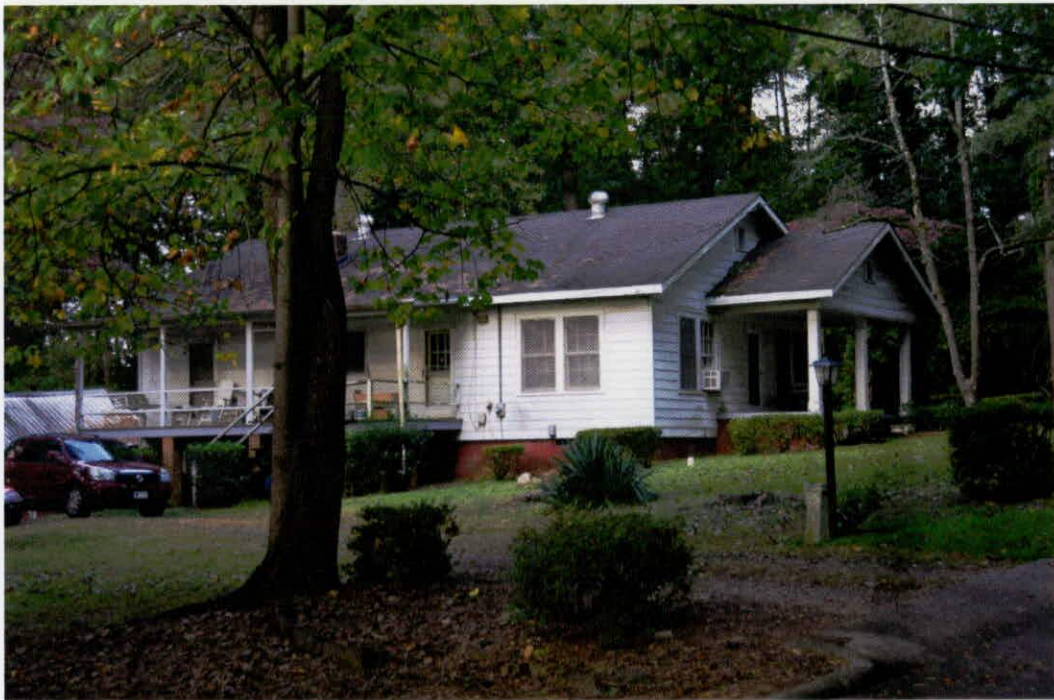
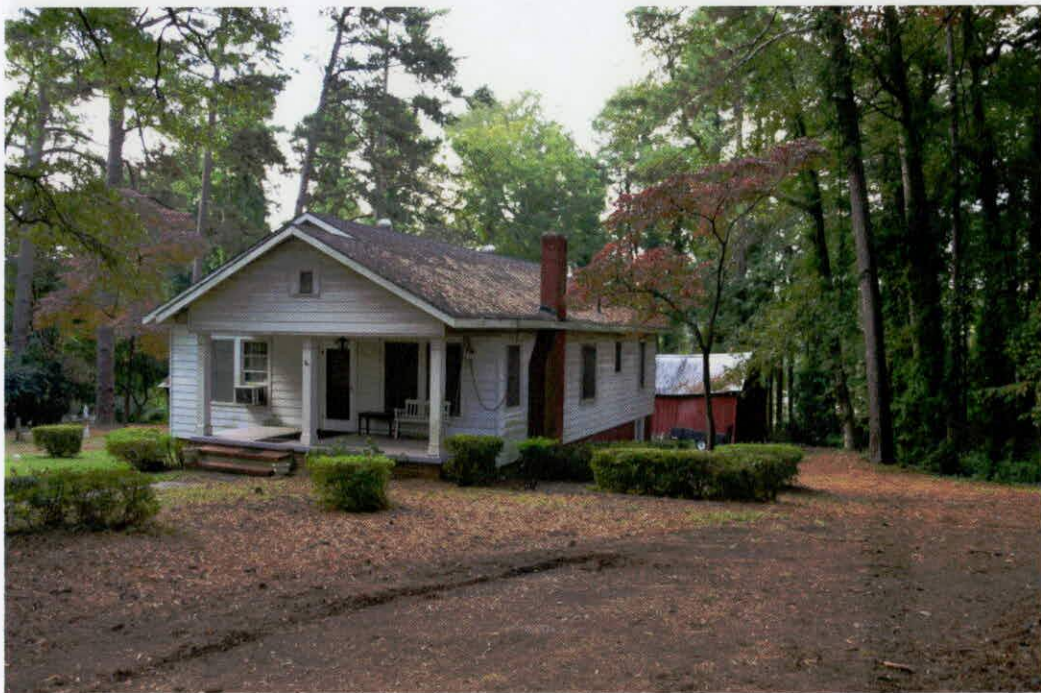
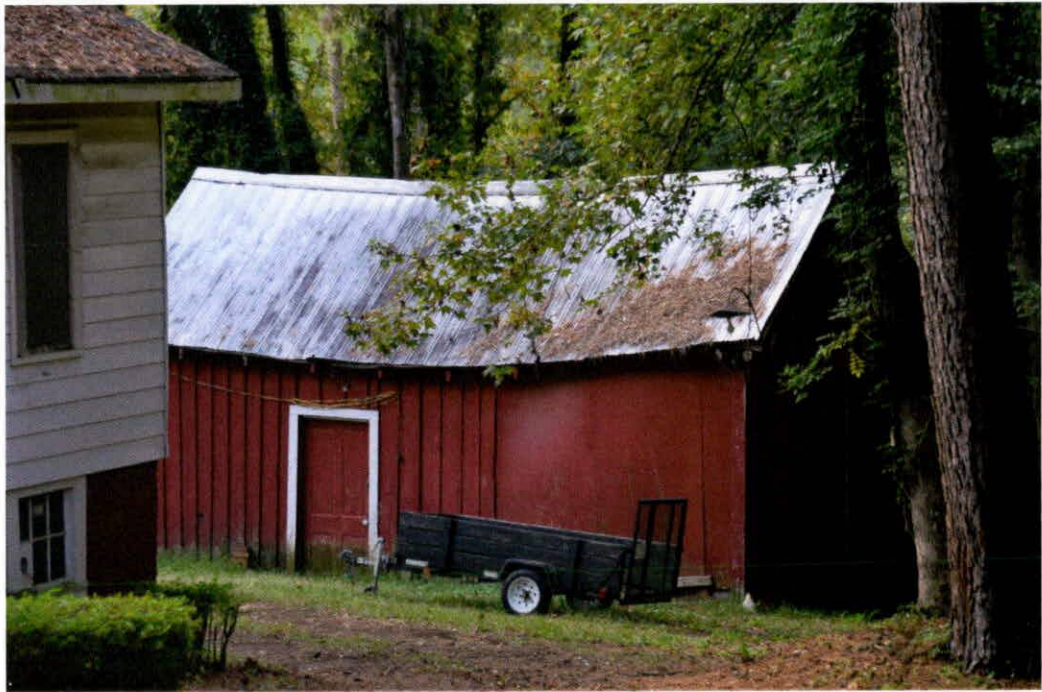
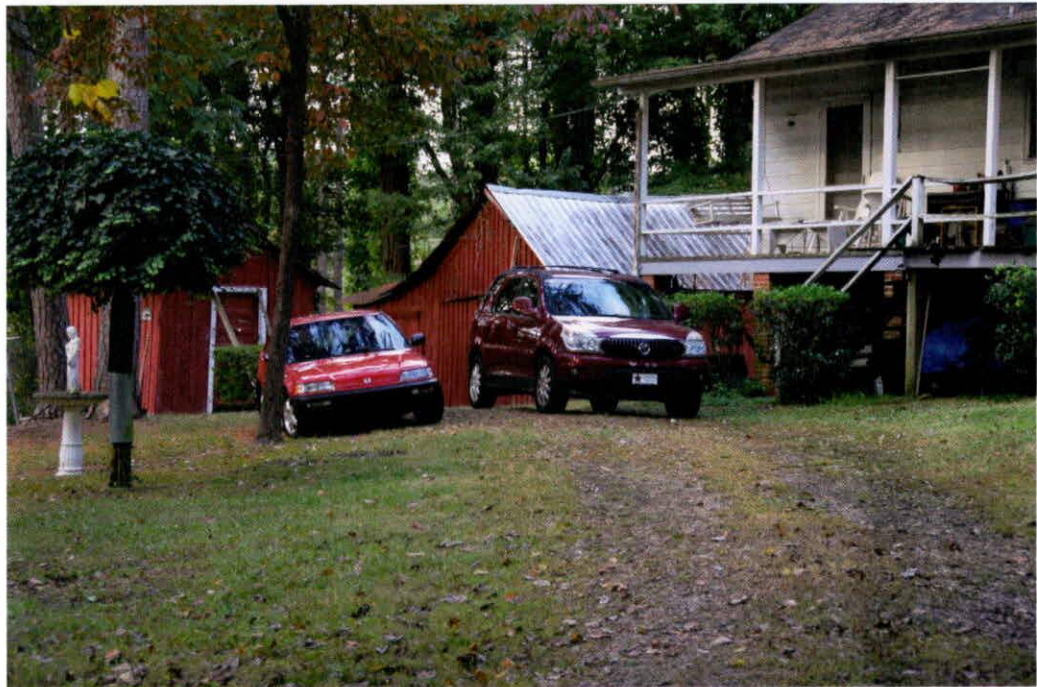
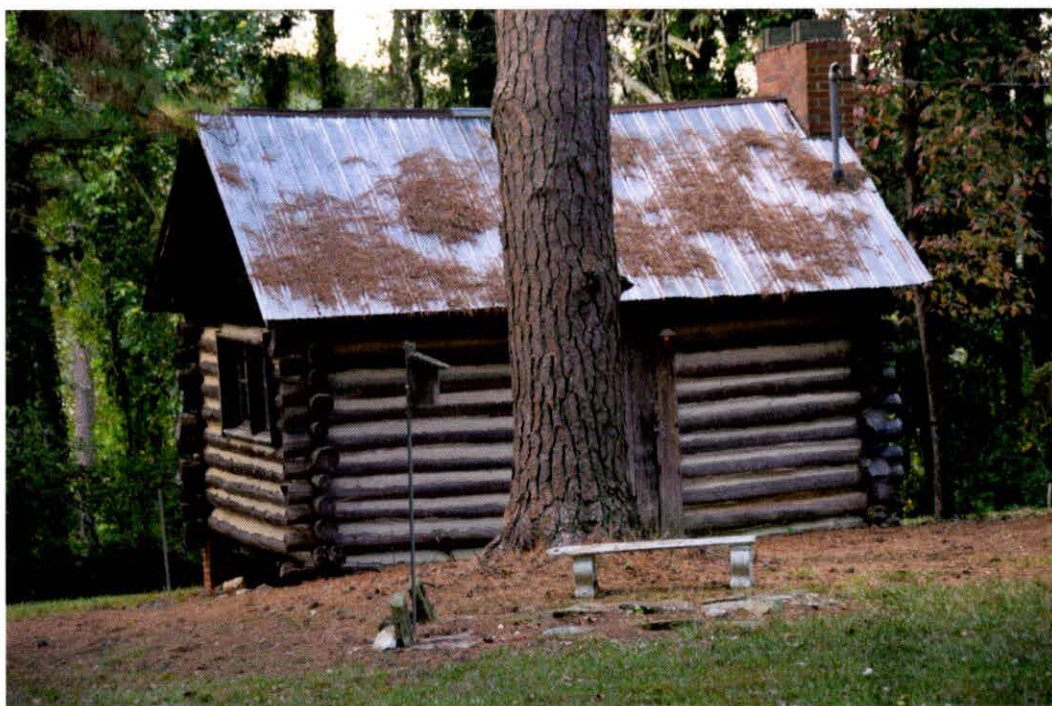
*Inventory #91*

*91a. House, ca. 1929.* Front-gabled bungalow on partial basement with 6/6 sash set singly and in pairs; aluminum siding; offset gabled front porch on squared posts; louvered rectangular vents in gable ends; added shed porch on brick piers at east side elevation.

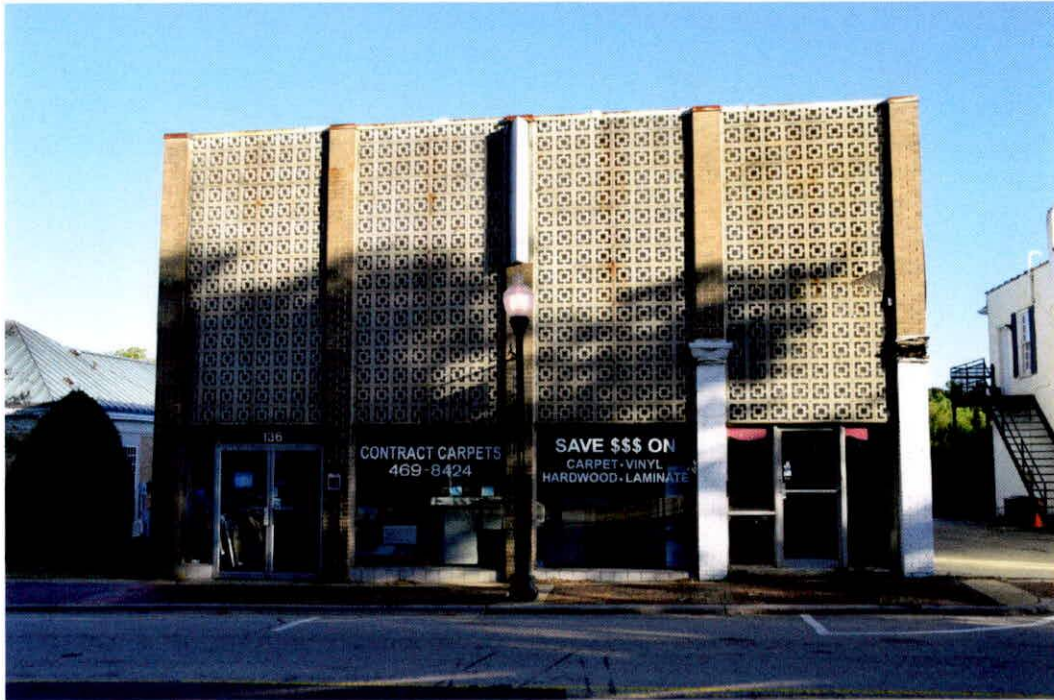
3. WA8217, Commercial Building, 134-136 W. Chatham Street, 0764414597, 1965.

Mid-twentieth century, two-story, concrete-block Modernist commercial building with breezeblock screen above extruded aluminum storefront. Storefront bays separated by brown-brick pilasters and grounded with tile-covered concrete curbs. Pilasters and tile curbing are at the interior as well as the exterior. Breeze-block with interlocking square pattern covers the entire second story between pilasters; a fine metal screen covers the breezeblock to keep birds from nesting. Entrance at left side is into first-floor store; entrance at right side is into stairwell to second story. Stairwell is metal, half-turn, open-riser stair in concrete-block stairwell. Minimal alterations appear limited to the pilasters: the two framing the stairwell entrance have been painted white at the first story and column capitals added. The upper portion of the center pilaster has been removed to accommodate a slender, vertical signboard that is not currently in use.

Despite minimal, and in some cases reversible, alterations to pilasters, the majority of the building's form, materials, and Modernist architectural style are evident. This means integrity of design, materials, and workmanship are intact. The original location translates to an intact integrity of location. The integrity of setting may require more research into the appearance of this commercial strip at mid-century—was this new commercial building erected when the commercial strip was still substantially intact, or had demolitions already begun? The latter seems likely given the erection of a supermarket on the neighboring block in 1958, which would have necessitated demolition of older buildings there. Regardless of the setting issue, the integrity of

The building appears to be individually eligible for the NRHP as a rare, intact Modernist downtown commercial building dating to the mid-twentieth century under the contexts Cary as a Transportation Corridor and Impact of RTP on Growth of Cary (ca. 1959-1970). The commercial district on Chatham Street emerged in the nineteenth century, and the growth of Cary resulting from the development of Research Triangle Park gave the town an economic boost in the 1960s. This building shows that the suburban boom encouraged re-investment in the downtown commercial district. The building is not in an area that appears to be eligible as a NRHP historic district. Architecturally, Cary's other example of mid-century commercial design in the downtown commercial district, the grocery store on the neighboring block (WA7284), does not retain sufficient integrity for listing in the NRHP. (Hanbury 8-10, 17-20)

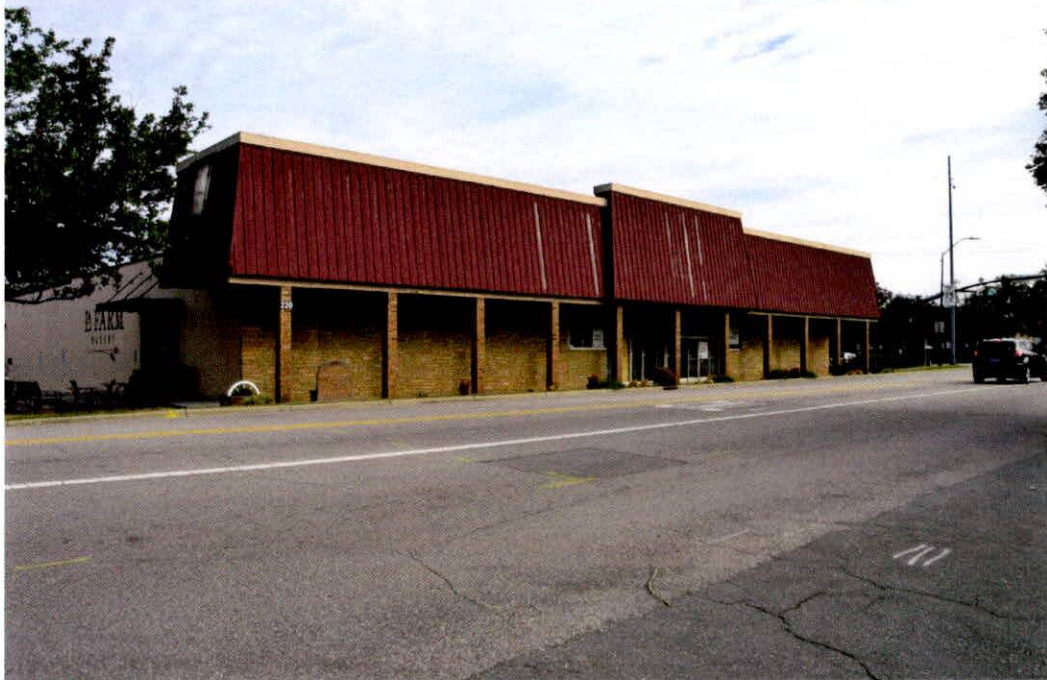
4. *WA7284, Supermarket, 220 W. Chatham Street, 0764411518, 1958.*

One-story, Modernist, concrete-block supermarket with stone veneer at façade surrounding centered extruded aluminum storefront. Added metal-clad mansard roof extends over sidewalk and is supported by squared brick columns. Current occupant relocated the customer entrance to the west side elevation, consisting of a garage door and personnel door under a flat metal canopy. The main entry at the façade remains but is not in use. The east side elevation has a mural of Cary's history dating to 2003, and the west side elevation has been painted and includes a painted sign for the business.

The building retains its original or early random-ashlar façade, which reflects its midcentury Modernist style. However, the massive mansard roof so dominates the façade that it has severely reduced the integrity of design. Much integrity of materials and workmanship remains, but the mansard's dramatic effect on the architectural style also reduces integrity of feeling. The setting is likely quite similar to the mid-century period, when parking lots became important to commercial buildings, and the integrity of location is intact. Overall, however, the building lacks sufficient integrity of design and feeling to be eligible for the NRHP due to the overpowering effect of the added mansard roof. The building is not in an area that appears to be eligible as a NRHP historic district.

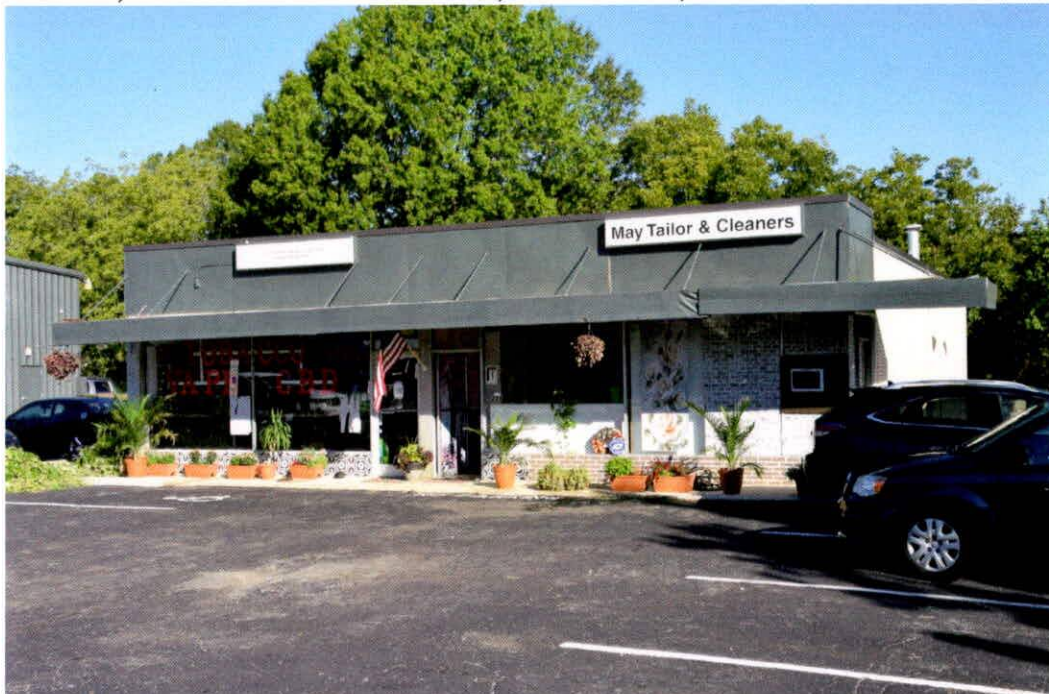
5. *WA8218, 258-260 W. Chatham Street, 0764318572, 1962.*

One-story, two-storefront commercial building with brick veneer and low parapet roof. Brick, tile, and metal sheathing has been added at façade; extruded aluminum storefronts likely original. Added canopy shelters the storefronts. There is a corrugated metal rear addition. The side elevations have brick laid in a variation of common bond, in which every sixth course alternates stretcher and header bricks. Other courses are all stretcher bricks.

The location is original and the immediate setting behind a parking lot is likely intact, but other alterations have reduced the overall integrity of the building. The building is a simple, standard commercial type of the mid-twentieth century, so the alterations to the façade have compromised the design, materials, and workmanship of the building and consequently the integrity of feeling and association. It is not in an area eligible that appears to be as an NRHP historic district.

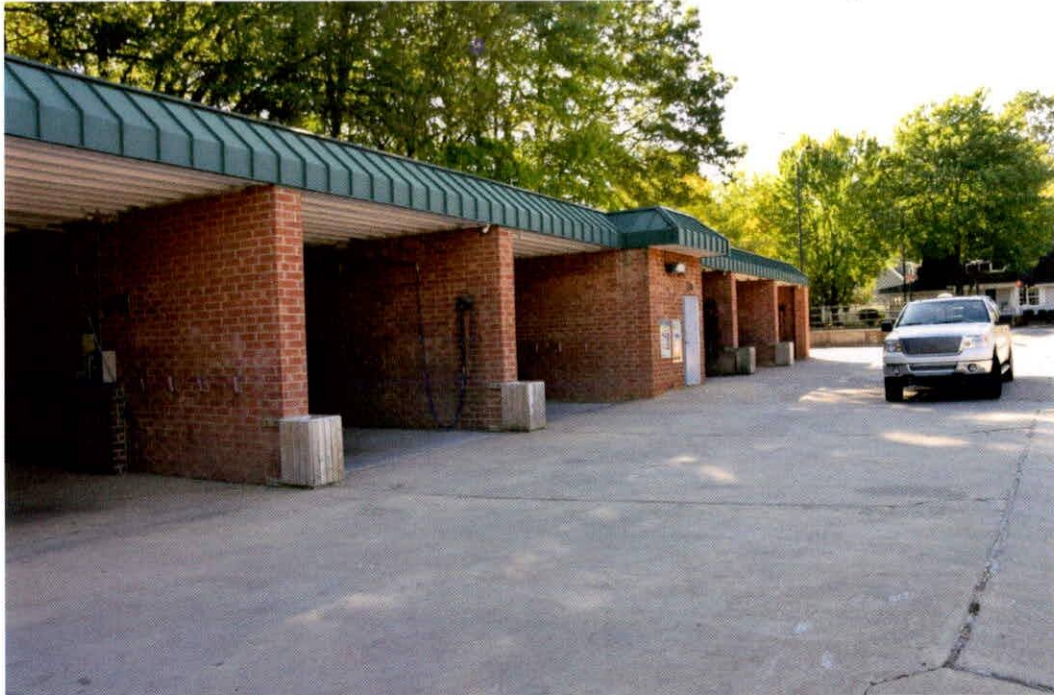
8. WA8221, *Supreme Car Wash, 102 N. Dixon Avenue, 0764219407, 1966.*

Single-story structure on large concrete pad with small center mechanical room flanked by open bays with sprayers for washing cars. Flat roof is supported by wood joists; mansard roof added around 2003. Brick veneer added to concrete-block exterior in the 1970s. Recessed alcove at mechanical room enclosed when brick veneer applied. Original signage removed with roadways were expanded; current owner reported that the Pepsi-Cola Company paid for the car wash sign, including advertising for Pepsi on the signage. The concrete-block alcove interior retains turquoise paint on lower courses of concrete block, white paint above—likely the original color scheme of the car wash. Current owner reports that the self-service car wash was established by three Smith brothers in the 1960s, after they researched a similar business operating in Graham, NC. The car wash was a side business for all three brothers. According to the owner, industry publications report that the first self-service car wash opened in Oklahoma in 1962, but he believes that the business in Graham opened around the same time.

The building is a simple, standard commercial type of the mid-twentieth century, so the alterations and added materials have compromised the design, materials, and workmanship of the building. The location is original and the immediate setting is likely intact, but other alterations have reduced the overall integrity of feeling and association of the building. It is not in an area that appears to be eligible as an NRHP historic district.

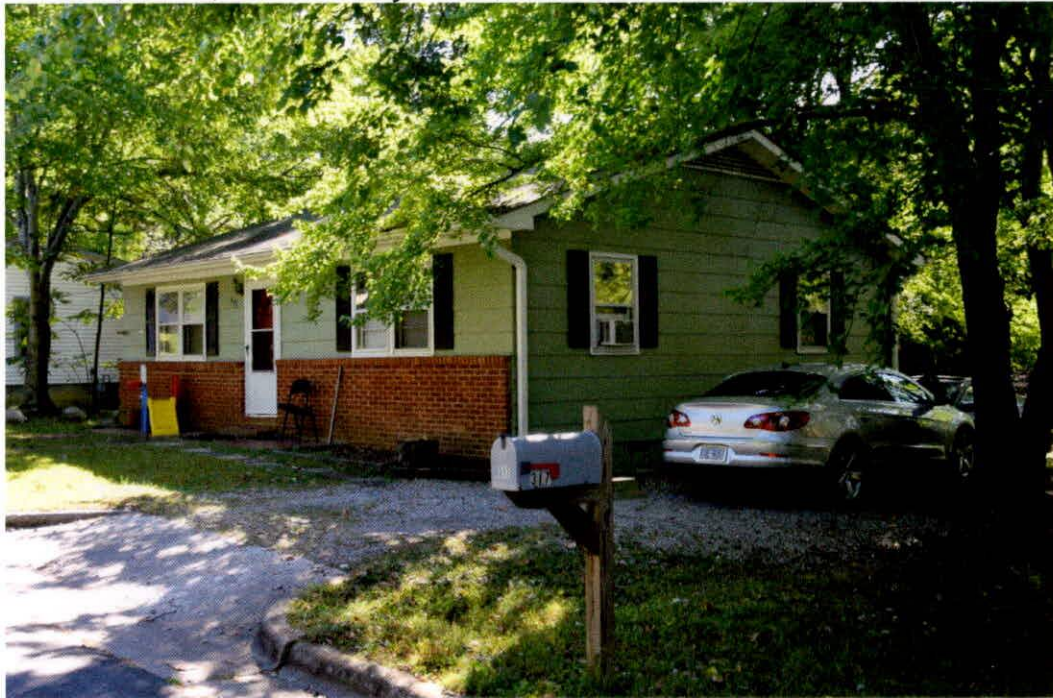
10. WA8223, House, 317 Holloway Street, 0764219834, 1971.

Side-gabled, frame Ranch house with aluminum siding and brick skirting at façade, 2/2 horizontal sash with faux shutters, and slightly overhanging eaves.

The house appears to have intact integrity in terms of location, design, setting, materials, workmanship, association, and feeling. However, it does not appear to have architectural or historic significance to warrant individual listing in the NRHP. The house is not in an area that appears to be eligible as an NRHP historic district.

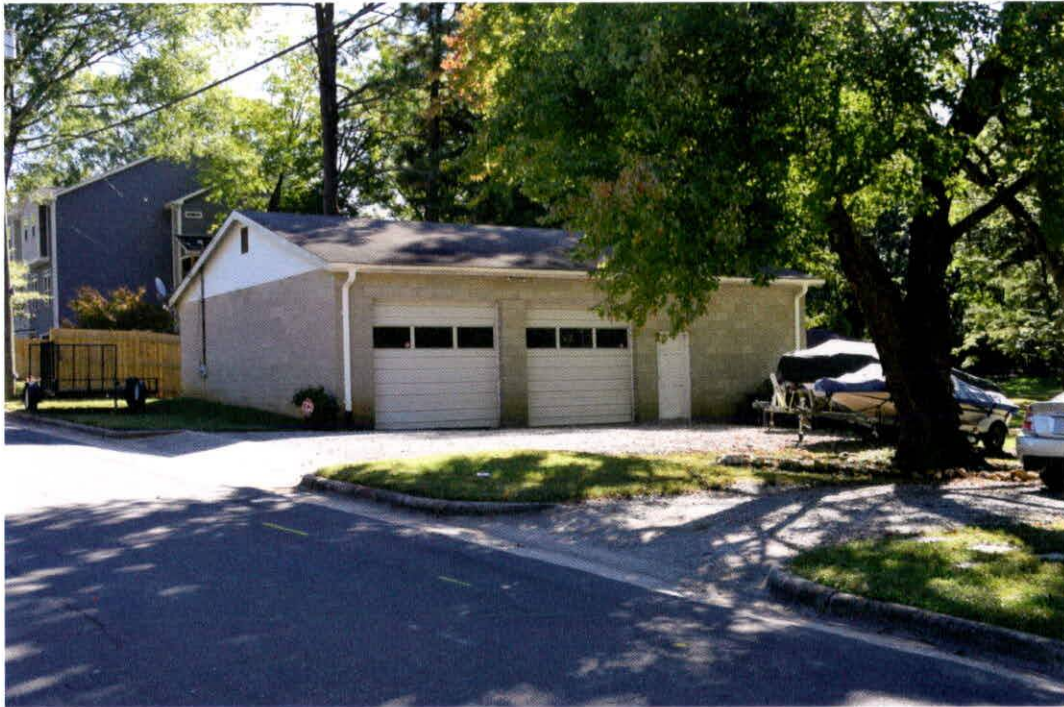
*16b. Garage, ca. 1980: Concrete-block, side-gabled, two-car garage with façade perpendicular to the street; stands east of the house. Single-leaf paneled personnel door in south end of façade, next to overhead-lifting garage door. Plywood with centered vent in gabled ends above concrete wall. Asphalt roofing.*

The house retains integrity of location, but application of vinyl siding and construction of the nearby large garage has reduced its integrity of materials, workmanship, and setting. The vinyl siding and replacement porch make assessment of the original form of the porch and rear section difficult, so the integrity of design appears to be reduced as well. These changes also reduce the integrity of feeling and association. The house is not in an area that appears to be eligible as an NRHP historic district.

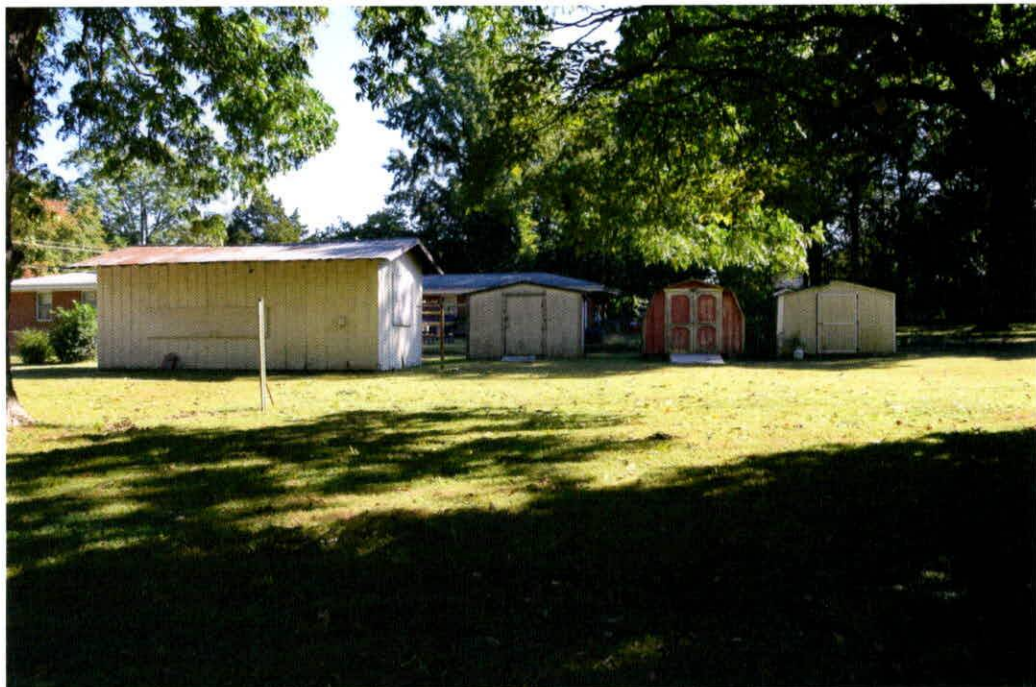
19c. Shed, 1950. Frame, front-gabled shed with metal sheathing.

The siding, replacement windows, and side addition have reduced the integrity of materials, design, and workmanship. Integrity of location is presumably intact; the integrity of setting has been somewhat compromised addition of large carport and prefabricated sheds in rear yard. Reduction of integrity in all these areas has reduced integrity of feeling and association. The house is not in an area that appears to be eligible as an NRHP historic district.

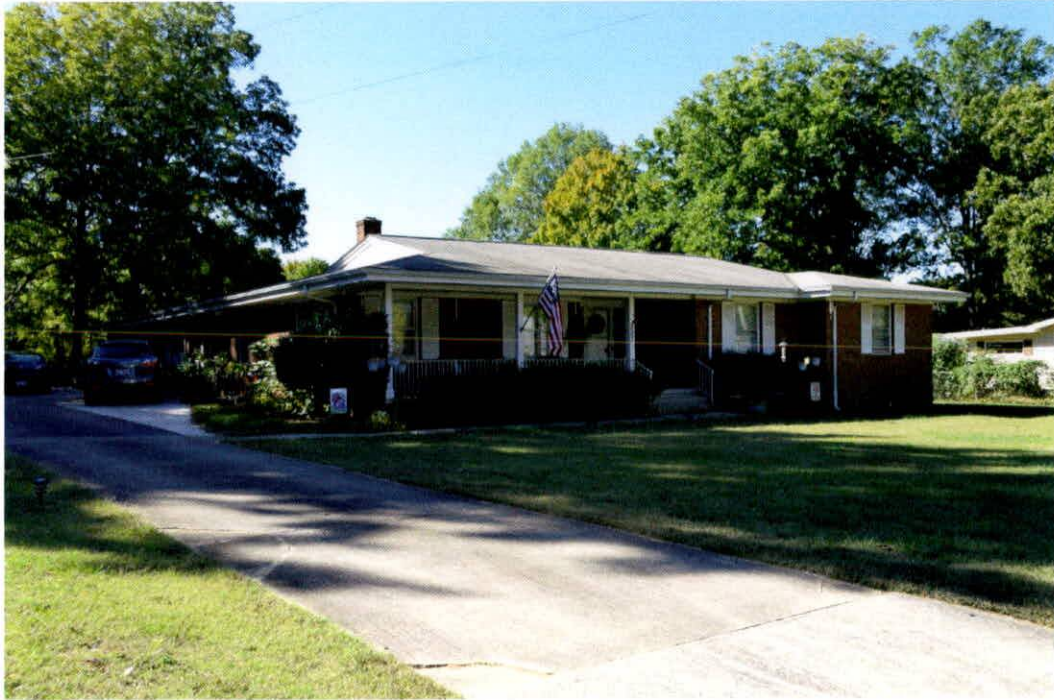
15. WA8225, House, 227 Hillsboro Street, 076315876, 1963.

Ranch house with gable-on-hip roof, L-plan with two-car garage in ell to rear, running-bond brick exterior. Mid-twentieth century elements include 2/2 horizontal sash, integrated planter at façade, and wide sidelights with large lights flanking the front door.

The house appears intact, retaining integrity of location, design, setting, materials, workmanship, feeling, and association. However, the house lacks architectural significance to qualify for the NRHP and has no known historical significance for the same. Although this house and several neighboring dwellings on this side of the street do retain architectural

integrity, as a collection they do not appear to be eligible as an NRHP historic district due to the small size of the collection, their lack of cohesiveness, and the compromised setting surrounding the collection. There are large commercial buildings at the east end of the block, and older Queen Anne-style dwellings on both sides of the street. The mid-century houses read as post-war and later suburban-style infill.

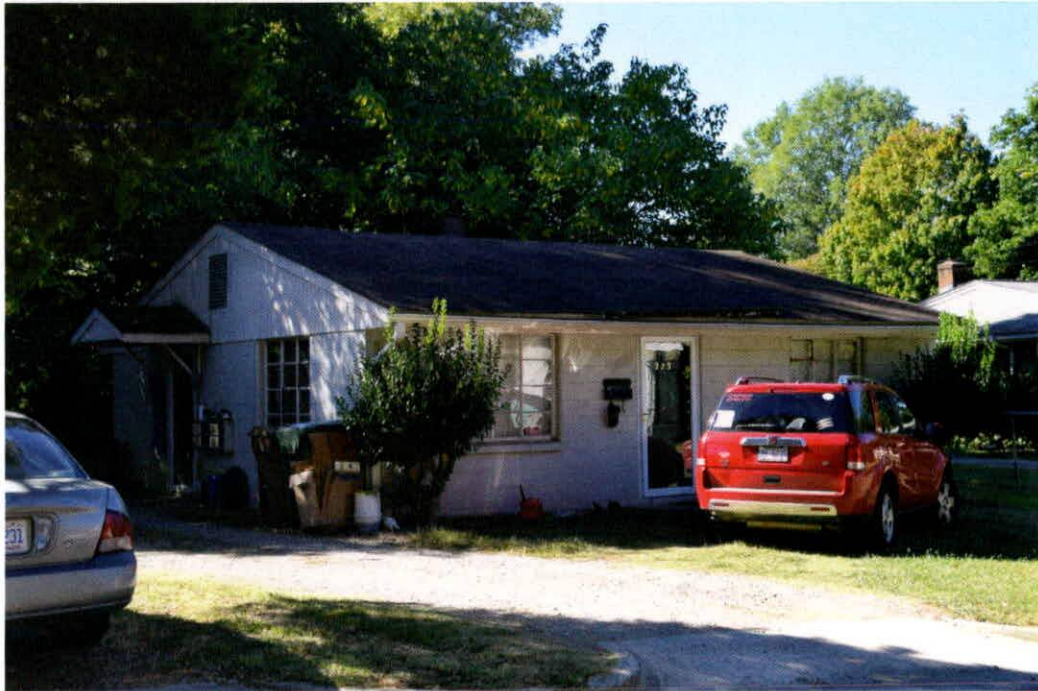
16. WA8226, House, 223 Hillsboro Street, 0764316961, 1955.

Concrete-block, side-gabled Ranch house with metal casement windows and plywood in gable ends.

The house appears intact, retaining integrity of location, design, setting, materials, workmanship, feeling, and association. However, the house lacks architectural significance to qualify for the NRHP and has no known historical significance for the same. Although this house and several neighboring dwellings on this side of the street do retain architectural integrity, as a collection they do not appear to be eligible as an NRHP historic district due to the small size of the collection, their lack of cohesiveness, and the compromised setting surrounding the collection. There are large commercial buildings at the east end of the block, and older Queen Anne-style dwellings on both sides of the street. The mid-century houses read as post-war and later suburban-style infill.

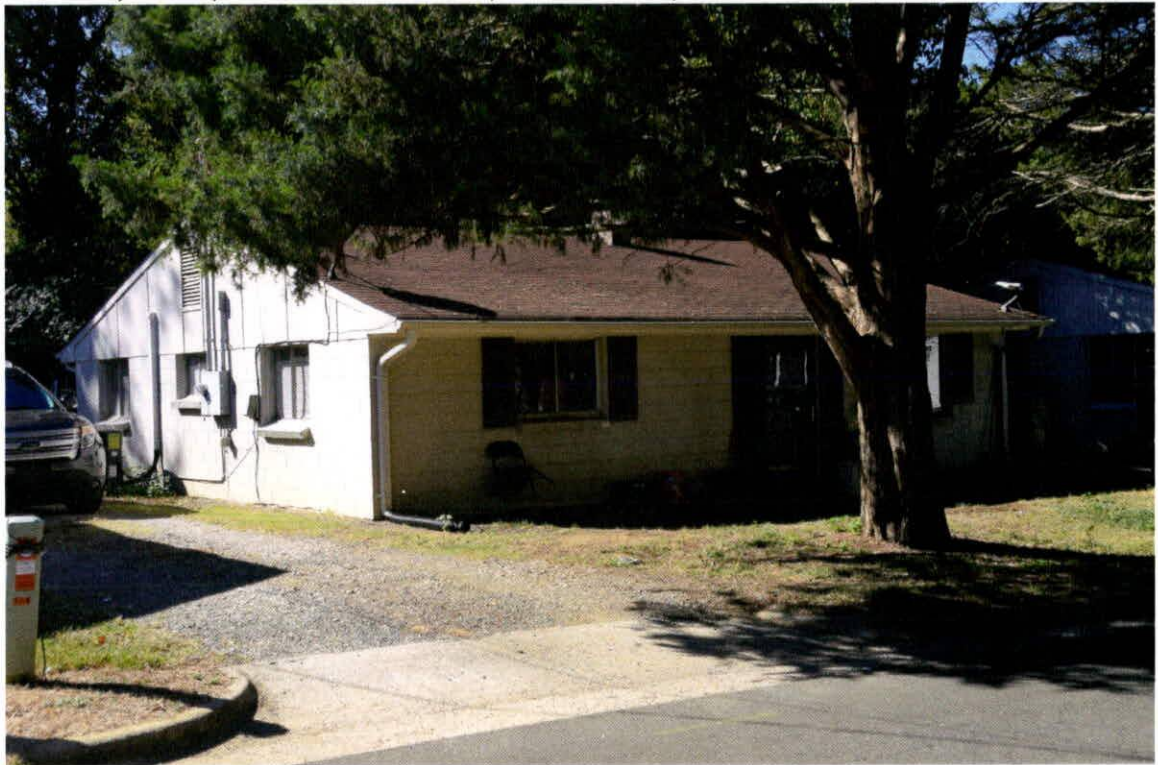
17. WA8227, House, 221 Hillsboro Street, 0764317911, 1955.

Concrete-block, side-gabled Ranch house with aluminum slider windows, faux shutters, and plywood in gable ends.

The house appears intact, retaining integrity of location, design, setting, materials, workmanship, feeling, and association. However, the house lacks architectural significance to qualify for the NRHP and has no known historical significance for the same. Although this house and several neighboring dwellings on this side of the street do retain architectural integrity, as a collection they do not appear to be eligible as an NRHP historic district due to the small size of the collection, their lack of cohesiveness, and the compromised setting surrounding the collection. There are large commercial buildings at the east end of the block, and older Queen Anne-style dwellings on both sides of the street. The mid-century houses read as post-war and later suburban-style infill.

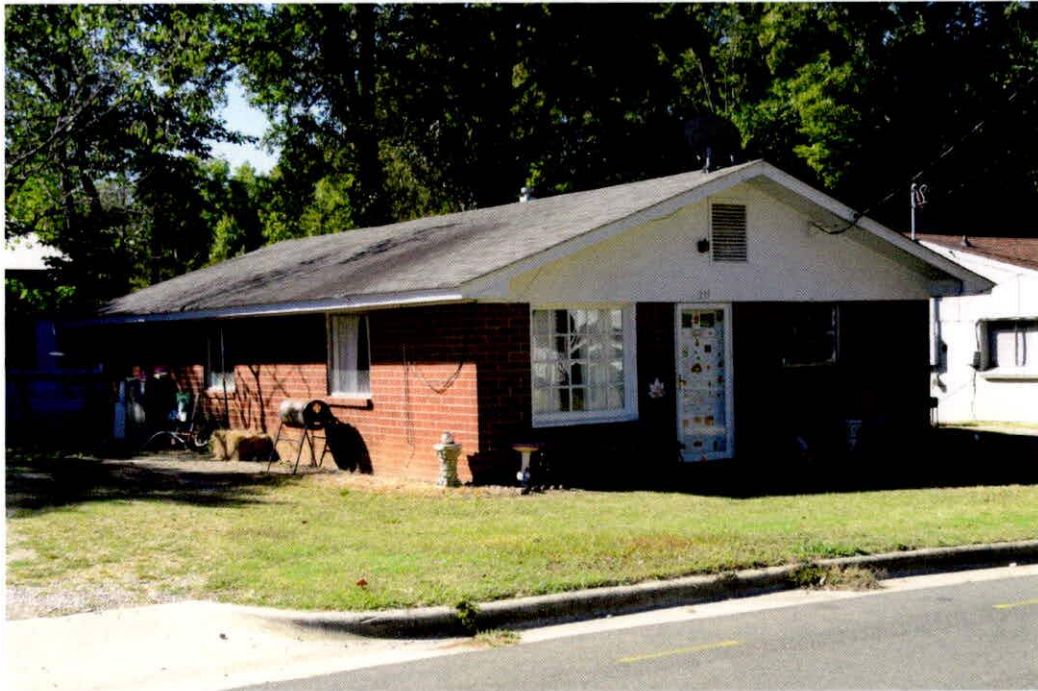
18. WA8228, House, 219 Hillsboro Street, 0764317961, 1956.

Brick-veneered front-gabled single-story house with plywood and vent in the gable ends, aluminum slider windows, and one large multi-pane window at façade.

The house appears intact, retaining integrity of location, design, setting, materials, workmanship, feeling, and association. However, the house lacks architectural significance to qualify for the NRHP and has no known historical significance for the same. Although this house and several neighboring dwellings on this side of the street do retain architectural integrity, as a collection they do not appear to be eligible as an NRHP historic district due to the small size of the collection, their lack of cohesiveness, and the compromised setting surrounding the collection. There are large commercial buildings at the east end of the block, and older Queen Anne-style dwellings on both sides of the street. The mid-century houses read as post-war and later suburban-style infill.

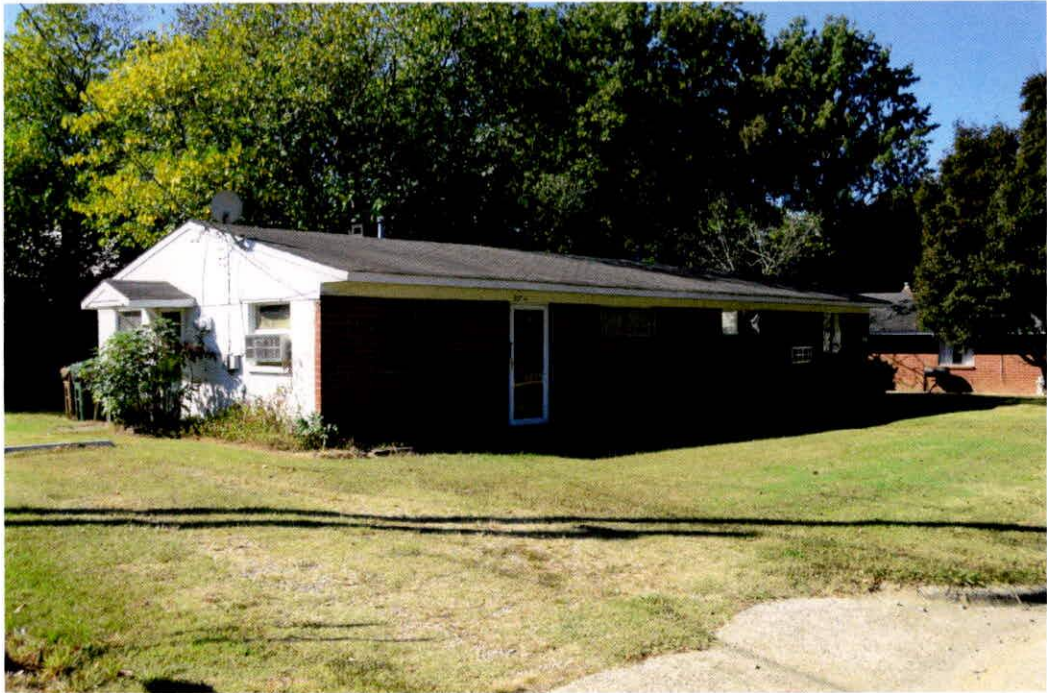
19. WA8229, House, 217 Hillsboro Street, 0764318940, 1955.

Concrete-block and brick-veneered side-gabled single-story house with plywood and vent in the gable ends and aluminum slider windows.

The house appears intact, retaining integrity of location, design, setting, materials, workmanship, feeling, and association. However, the house lacks architectural significance to qualify for the NRHP and has no known historical significance for the same. Although this house and several neighboring dwellings on this side of the street do retain architectural integrity, as a collection they do not appear to be eligible as an NRHP historic district due to the small size of the collection, their lack of cohesiveness, and the compromised setting surrounding the collection. There are large commercial buildings at the east end of the block, and older Queen Anne-style dwellings on both sides of the street. The mid-century houses read as post-war and later suburban-style infill.

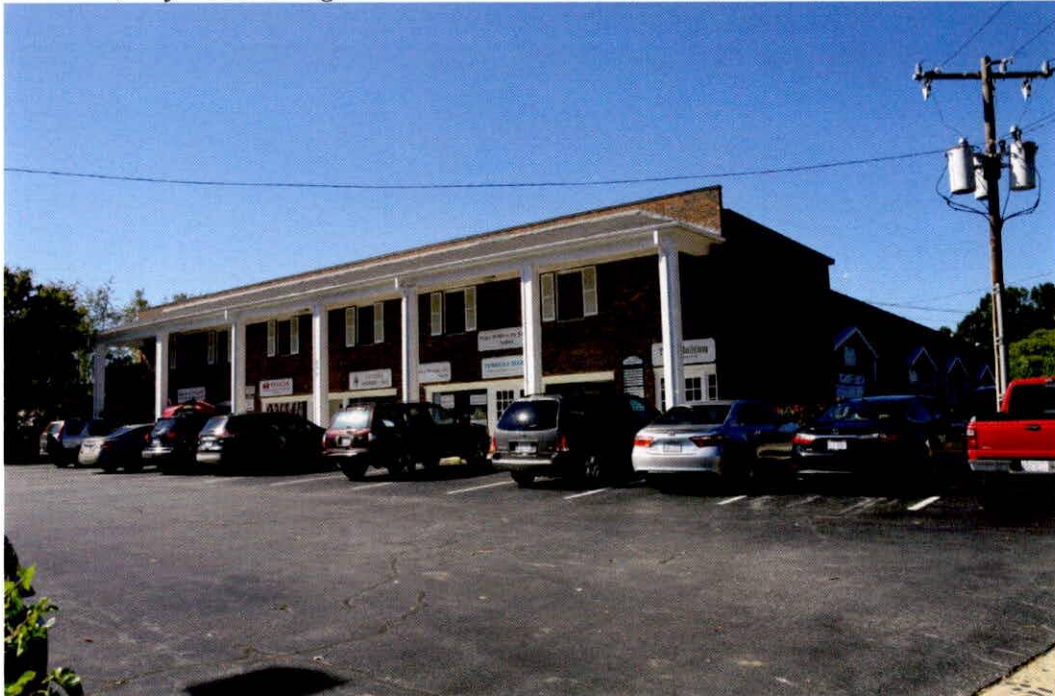
21. WA8230, Taylor Building, 203 Harrison Avenue, 0764410876, 1973.

Retail/warehouse brick-veneered building with two-story, flat-roofed front section housing three storefronts sheltered by two-story height flat-roofed porch and second-floor office space accessed by stair at north end of facade; rear section is warehouse with separate storage-area bays. Storefronts have Colonial Revival details such as dentil molding and French doors. Faux shutters at 6/6 sash; running bond brick exterior. Flat roof with parapet with metal coping at façade. Garage bays along the north side elevation feature recessed entries or overhead lifting doors, each bay outlined with pilasters under faux gabled beams. Shopkeeper in Turkish grocery reports that the building is in its original form.

The building is generally intact, preserving integrity of location, design, materials, and workmanship. The setting is presumably the same as at the time of construction, and the integrity of feeling and association is intact. The building, however, lacks architectural or historic significance for individual listing in the NRHP. The building is not in an area that appears to be eligible as an NRHP historic district.

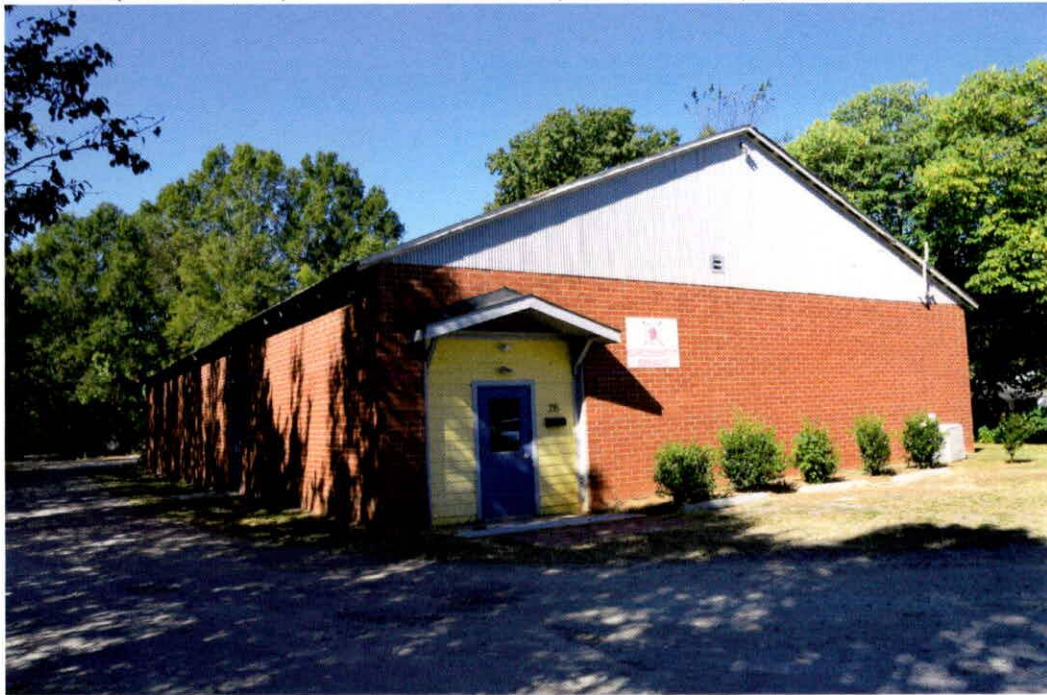
22. WA8231, Warehouse, 215 Hillsboro Street, 0764317890, 1955.

Single-story, brick-clad warehouse with gabled roof, exposed wood roof joists, metal roof, and no windows. Doors are at each gable end. In the west gable end, a single-leaf personnel door is retrofitted into a former equipment entry. The larger opening is now filled around the smaller door and clad with cementitious siding under a bracketed gable-roofed canopy. The west side has a personnel door as well as a garage entry with overhead-lifting door under a similar bracketed canopy. Running-bond brick walls and corrugated metal in gable ends.

The building has integrity of location, but so little architectural interest that changes to the entry at the west side adversely affect integrity of design. While integrity of materials and workmanship may be intact and the setting appears largely intact, there is little else to indicate or enhance integrity of feeling or association. The building lacks architectural or historic significance for individual listing in the NRHP and is not in an area that appears to be eligible as an NRHP historic district.

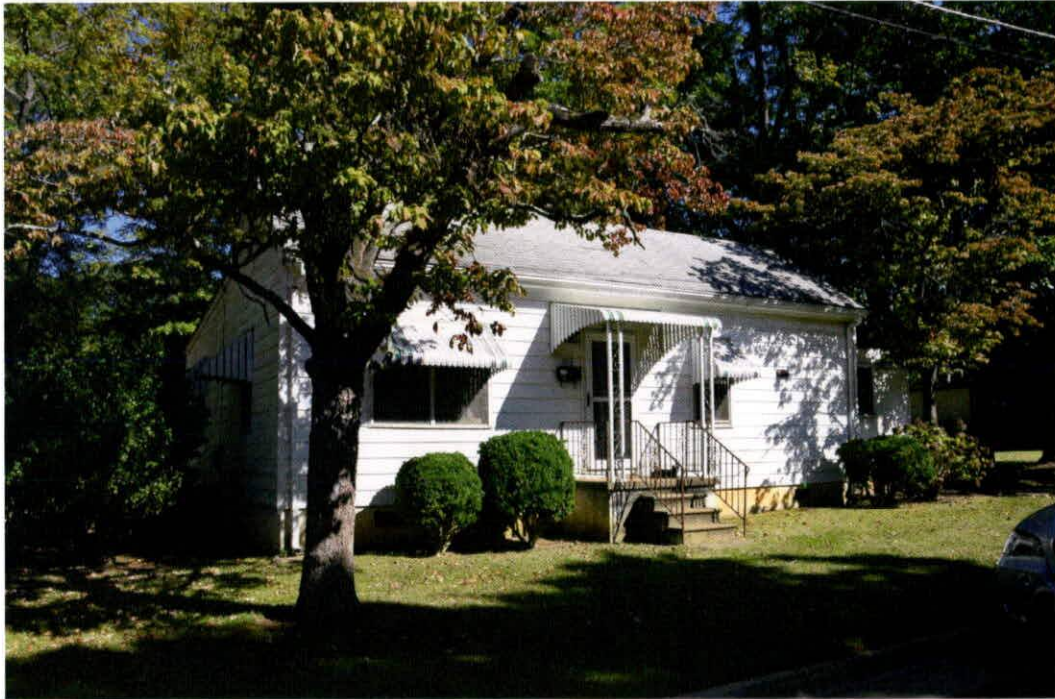
23. WA7160, House, 222 Hillsboro Street, 0764327116, ca. 1955.

Side-gable Minimal Traditional house with aluminum siding and 6/6 sash. The house has a one-bay-wide stoop sheltered by a shed-roofed metal awning and a side-gabled wing.

The building retains integrity of location and design, but integrity of materials and workmanship are somewhat compromised by the addition of aluminum siding. While its immediate setting is intact, the larger setting of the street is transitioning from residential to commercial. The integrity of feeling and association is also reduced. The building lacks architectural or historic significance for individual listing in the NRHP. The building is not in an area that appears to be eligible as an NRHP historic district.
