**North Carolina Department of Natural and Cultural Resources  
State Historic Preservation Office**

Re: Feasibility Study for Downtown Multi Modal Transit Center, Cary, Wake County, ER 19-0950

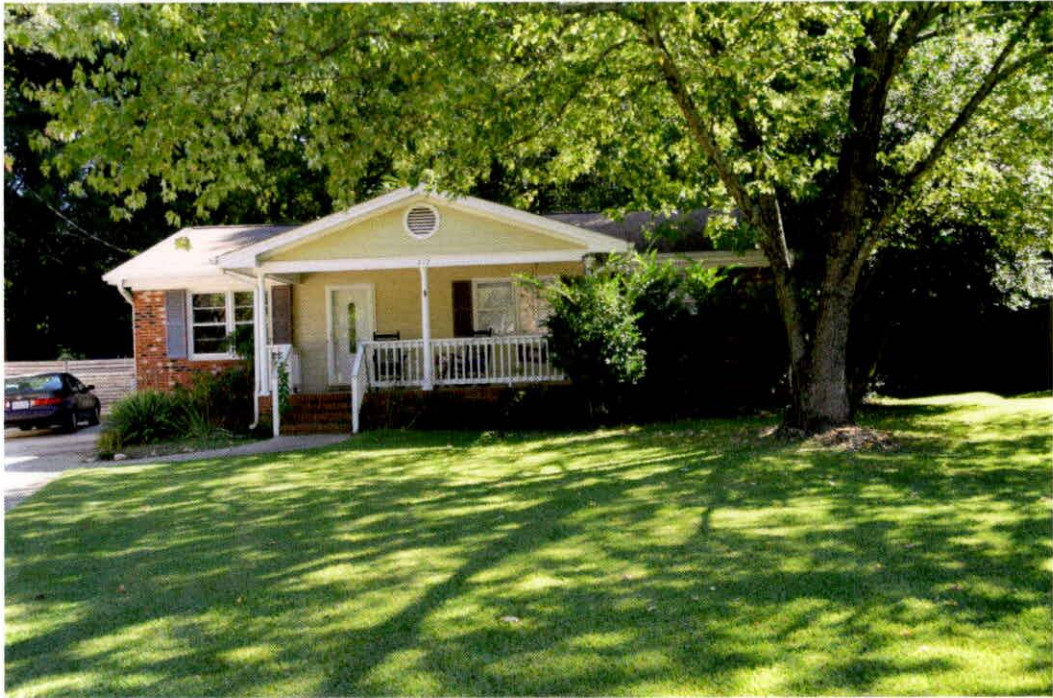
27. WA8233, House, 312 N. West Street, 0764324243, 1970, 2014.

Side-gabled Ranch house with gabled front porch, brick exterior with cementitious lap siding at façade and porch gable, 2/2 horizontal sash, and faux shutters.

The house retains integrity of location and integrity of design, materials, and workmanship. The setting is intact, as is the integrity of feeling and association. However, the house lacks architectural distinction for individual listing in the NRHP. The house is not in an area that appears eligible as an NRHP historic district.

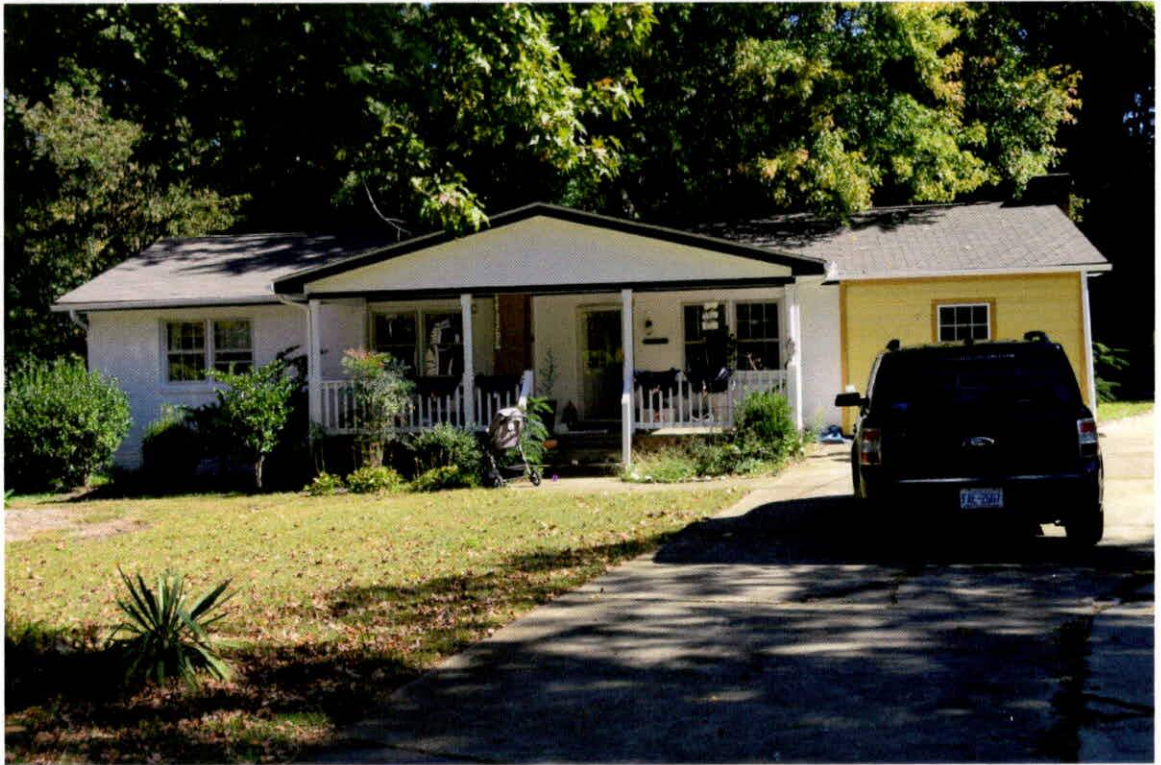
28. WA8234, House, 314 N. West Street, 0764324333, 1970, 1970, 2003.

Side-gabled Ranch house with added gabled front porch, brick exterior, enclosed garage, and 6/6 sash.

The house retains integrity of location and the setting is intact. The house has lost integrity of design, materials, and workmanship due to alterations, which also diminish integrity of feeling and association. The house is not in an area that appears eligible as an NRHP historic district.

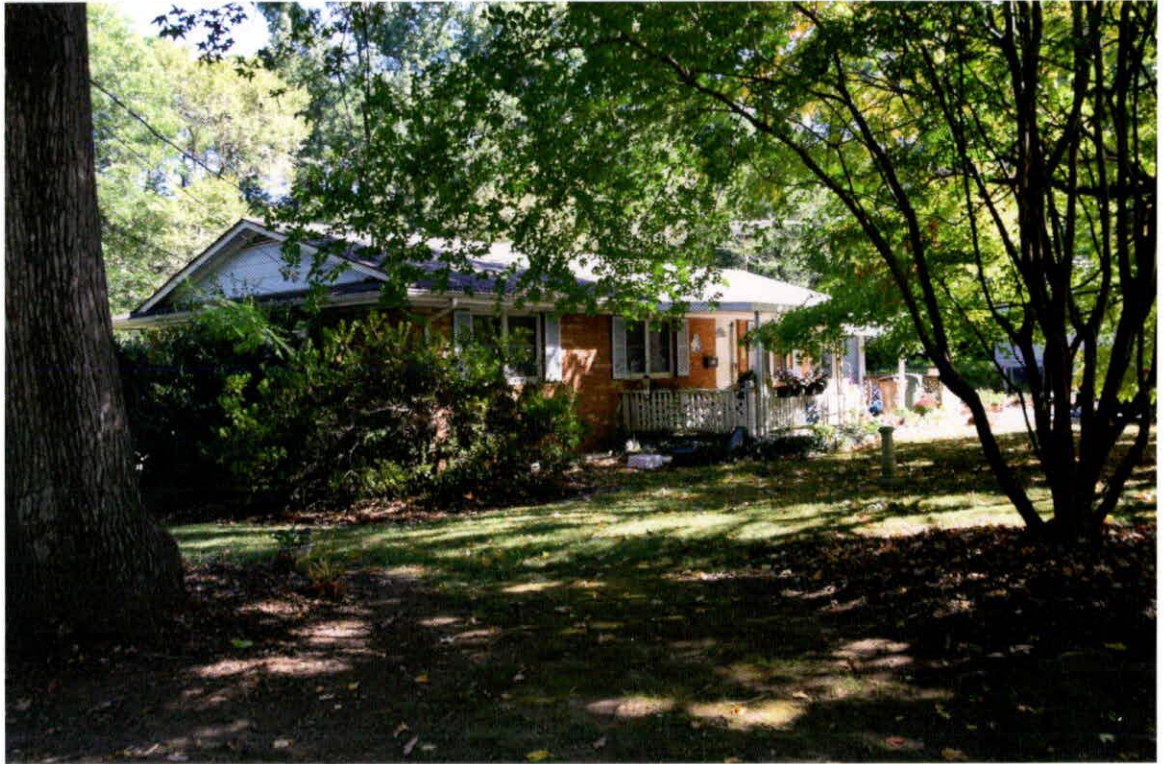
29. WA8235, House, 316 N. West Street, 0764323337, 1970.

Gable-on-hip-roofed Ranch house with 2/2 horizontal sash, brick exterior, garage at one end of the façade, added metal shed-roofed porch.

The house retains integrity of location and the setting is intact. The house has lost integrity of design, materials, and workmanship due to alterations, which also diminish integrity of feeling and association. The house is not in an area that appears eligible as an NRHP historic district.

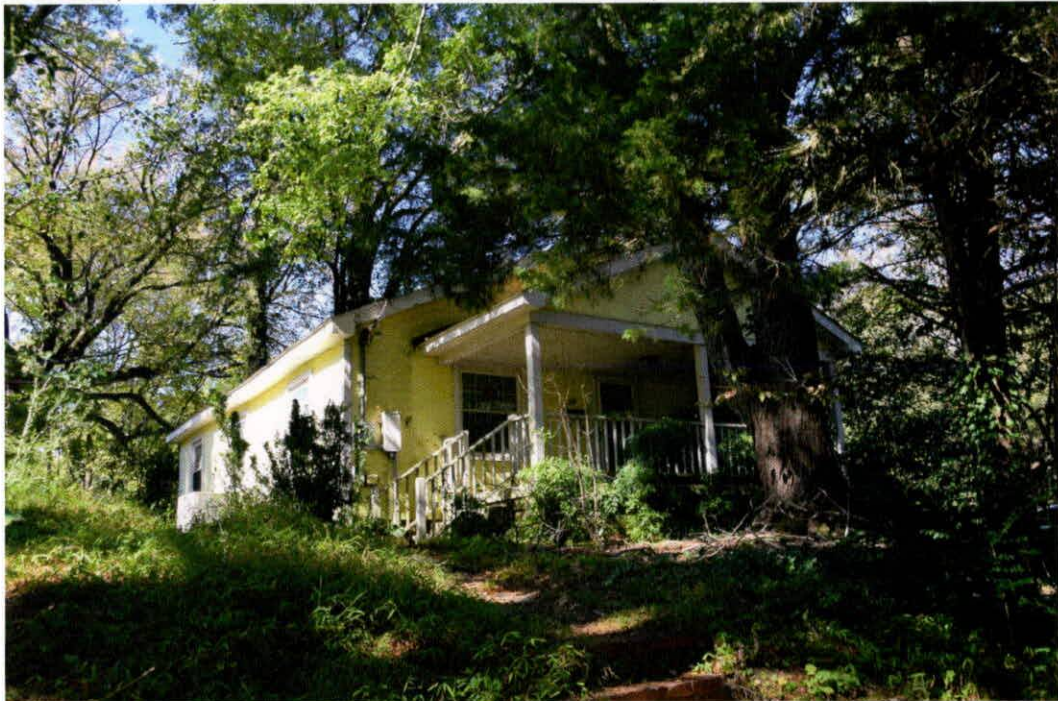
30. WA8236, House, 319 N. West Street, 0764321482, 1957.

Front-gabled bungalow with front-gabled porch on squared posts, asbestos-shingle siding, 8/8 and 6/6 replacement sash, side addition with plywood siding.

The house retains integrity of location and the setting is likely intact. The house has lost integrity of design, materials, and workmanship due to alterations, which also diminish integrity of feeling and association. The house is not in an area that appears eligible as an NRHP historic district.

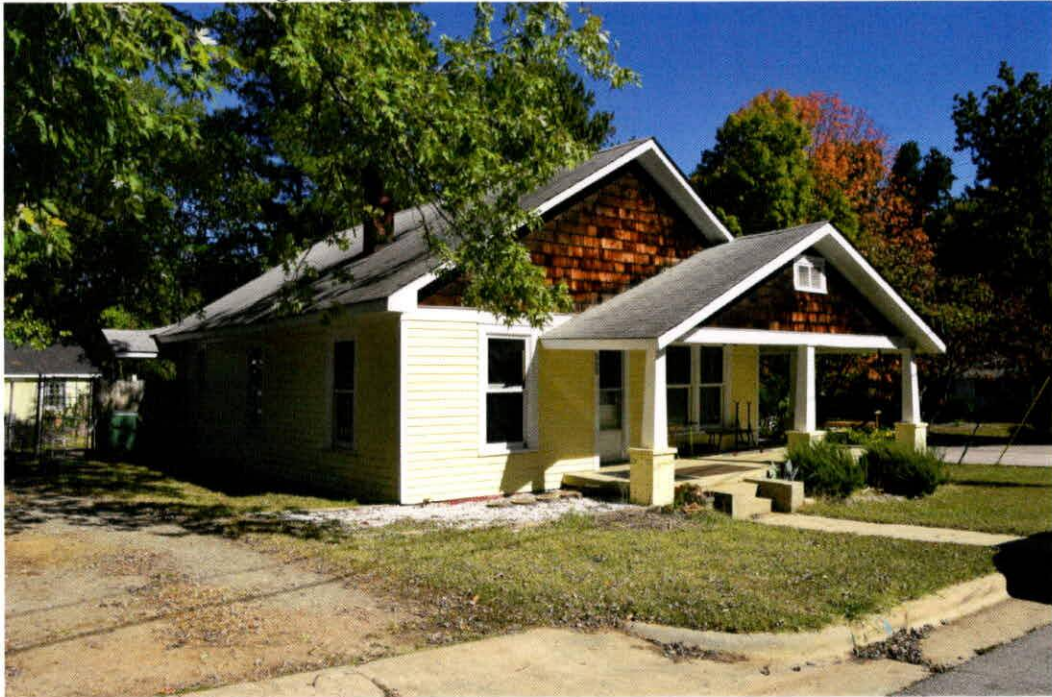
31. WA7152, House and garage, 502 Wood Street, 0764321482, 1945.

37a. House. One-story, front-gabled bungalow with a offset front-gabled front porch on tapered posts on brick piers that wraps around the east side. Small shed-roofed addition at rear. Windows and lap siding and shingles in gable ends are all replaced, but a 3/1 sash window remains in shed addition.

The house retains integrity of location and the setting is likely intact. The house has lost integrity of design, materials, and workmanship due to alterations, which also diminish integrity of feeling and association. The house is not in an area that appears eligible as an NRHP historic district.

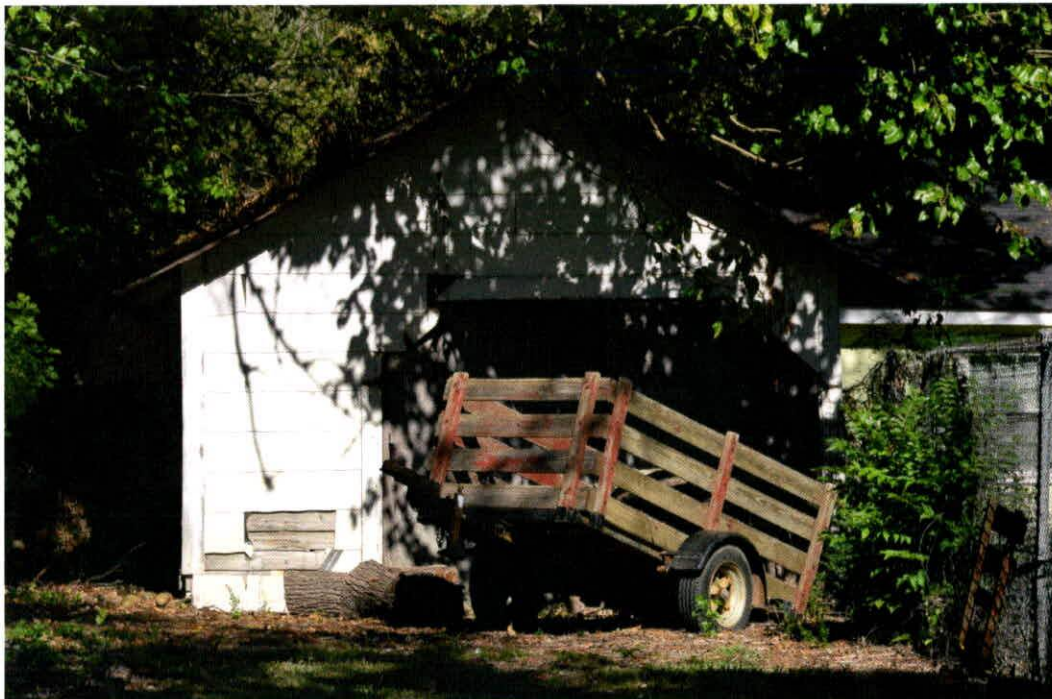
37b. Garage. Front-gabled, one-car garage with asbestos shingles over lap siding.

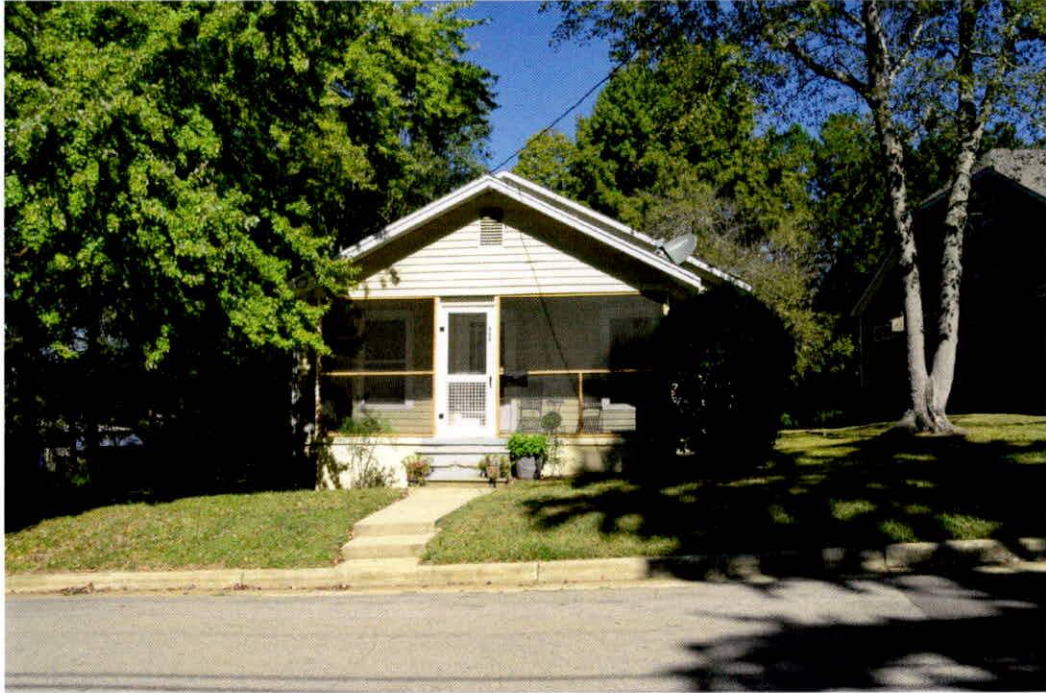
32. *WA7156, House, 316 Wood Street, 0764228259, 1922.*

Single-story, front-gabled bungalow with original partially glazed Craftsman-style door at facade, exposed rafter tails, and weatherboard siding. Screening of porch required removal of original porch posts. Four-over-one sash is visible towards the back of the east side elevation; but façade has 2/2 sash.

The house retains integrity of location and the immediate setting is likely intact. The house has lost integrity of design, materials, and workmanship due the porch alteration, which also diminishes integrity of feeling and association. The house is not in an area that appears eligible as an NRHP historic district.

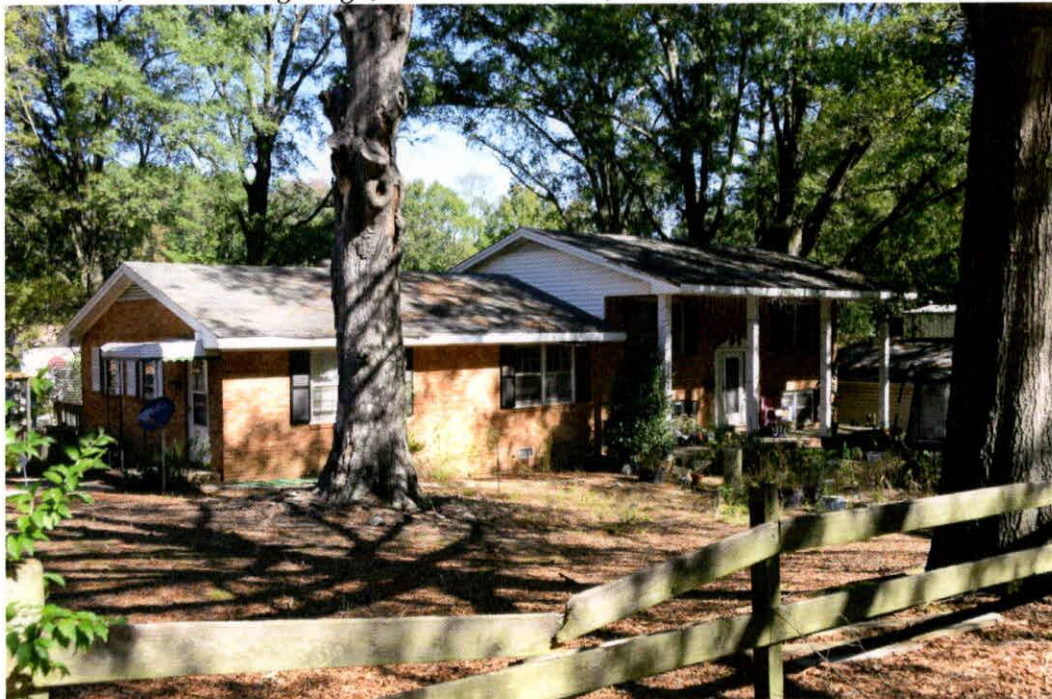
34. WA8238, House and garage, 324 Wood Street, 0764225295, 1967.

43a. House, 1967. Split-level brick-clad house with Mt. Vernon-style double-height front porch, paired 6/6 sash with faux shutters, broken pediment architrave at front door, and vinyl in gable end of two-story height section.

The house appears unchanged except for the addition of vinyl siding to the gable ends of the second story section. It retains integrity of location, setting, design, although the siding has reduced integrity of materials and workmanship a little. The house retains integrity of feeling and association. However, the house lacks architectural significance and has no known historic significance for individual listing in the NRHP. The house is not in an area that appears eligible as an NRHP historic district.

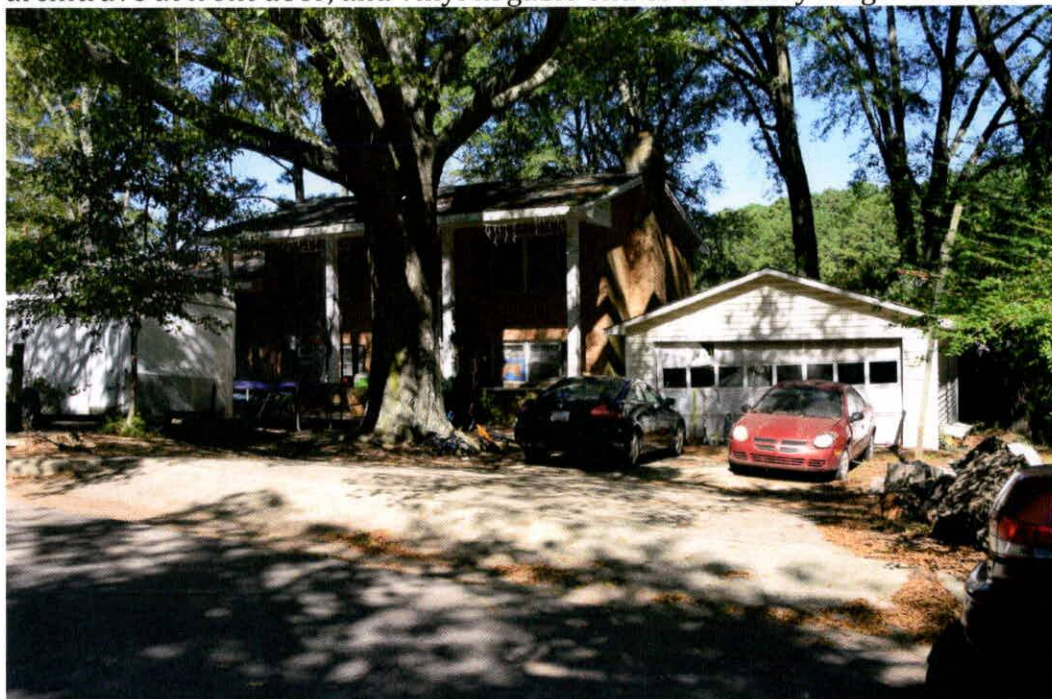
43b. Garage, 1967. Frame, front-gabled garage with vinyl siding and overhead lifting garage door with windows in upper portion of door.

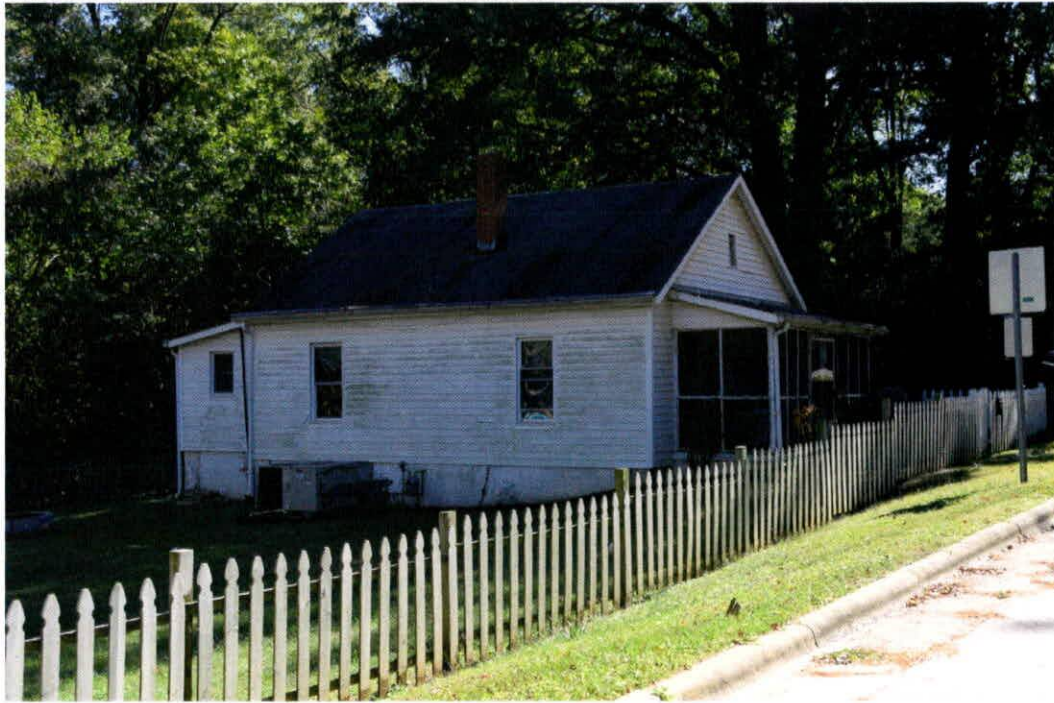
35. *WA8239, House and shed, 220 N. Dixon Street, 0764226160, 1921.*

44a. *House, 1921.* Front-gabled bungalow with replaced windows, vinyl siding, shed front porch enclosed with screens, shed rear addition or enclosed porch.

Alterations have reduced the integrity of design, materials, workmanship, feeling, and association; the integrity of setting and location are intact. The house is not in an area that appears eligible as an NRHP historic district.

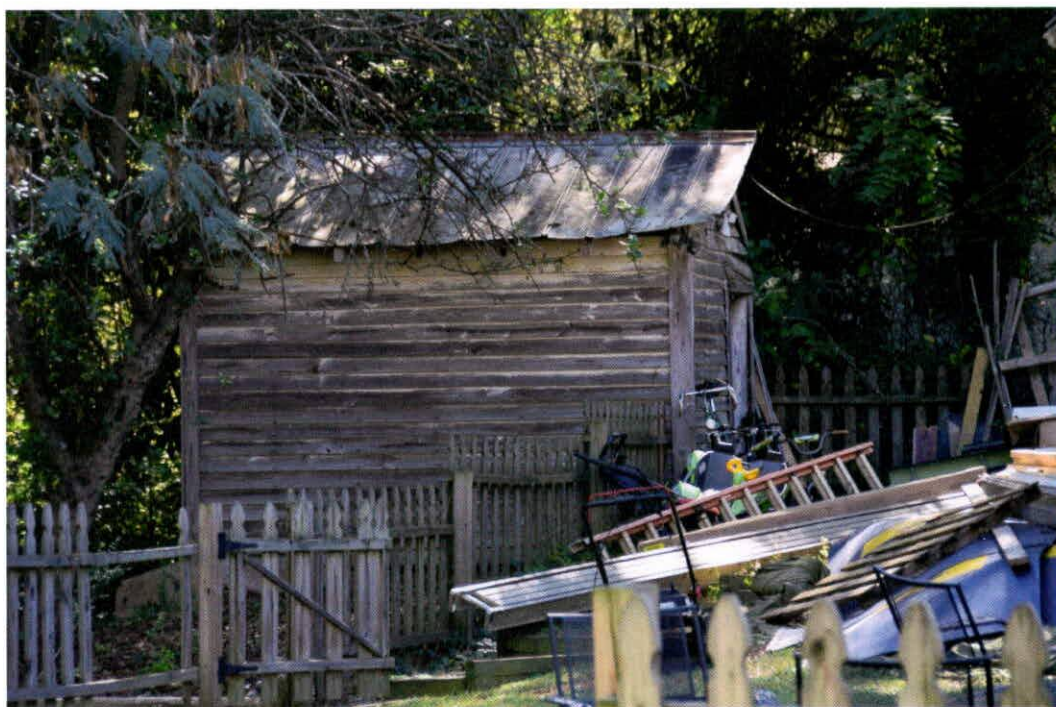
44b. Shed, 1921. Front-gabled frame shed with weatherboards in rear yard.

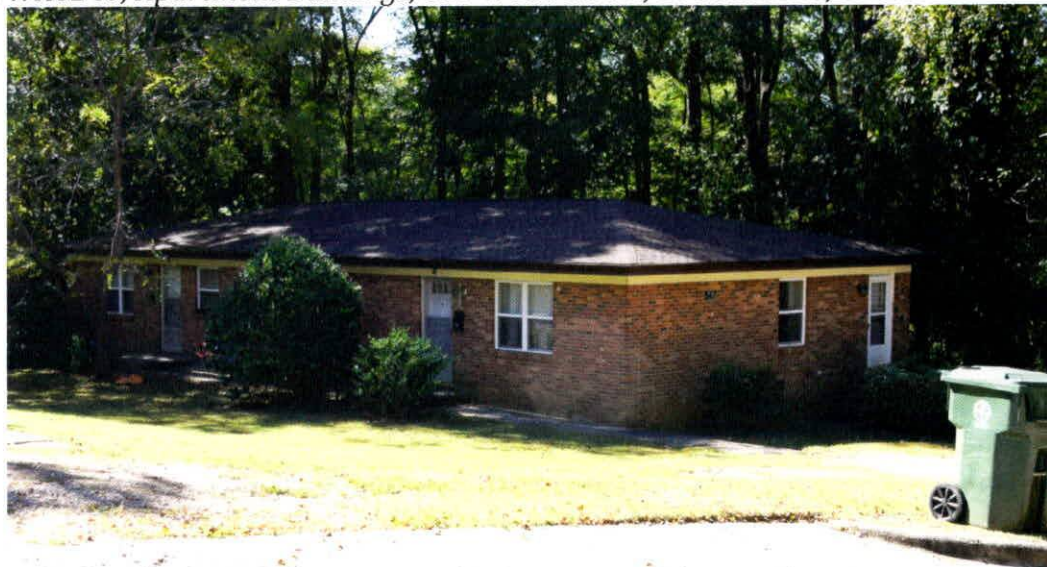
36. WA8240, Apartment Buildings, 539 Wood Street, 0764228161, 1968.

A pair of identical two-unit apartment buildings with brick exteriors, hipped roofs, boxed eaves, replacement windows, and partially glazed original doors face each other across a modest grassy courtyard.

The buildings are so minimal that the change to the windows reduces the integrity of design, materials, workmanship, feeling, and association; the integrity of setting and location are intact. The buildings are not in an area that appears eligible as an NRHP historic district.

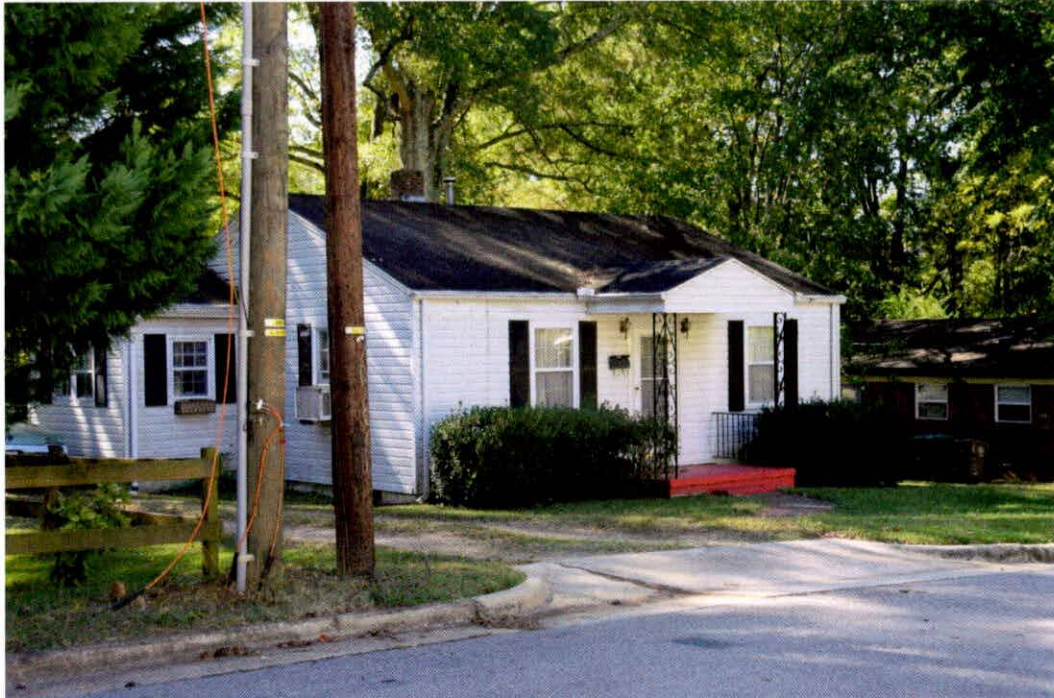
*37. WA8241, House, 531 Wood Street, 0764229151, 1948.*

Single-story, aluminum-sided Minimal Traditional side-gabled house with smaller wing at back of east side elevation, 6/6 sash, French front door behind added contemporary storm door; gabled portico on metal posts adorned with decorative scrollwork.

Aluminum siding was installed as original siding on houses in this period, but this siding appears to be a later alteration, reducing the dwelling's integrity of materials and workmanship. The intact windows, door, massing, and porch remain however, and the original architectural design is evident. The setting appears intact and the integrity of feeling and association with the post-war residential boom is basically intact. However, this house lacks architectural and appears to lack historic significance for individual listing in the NRHP. The house is not in an area that appears eligible as an NRHP historic district.

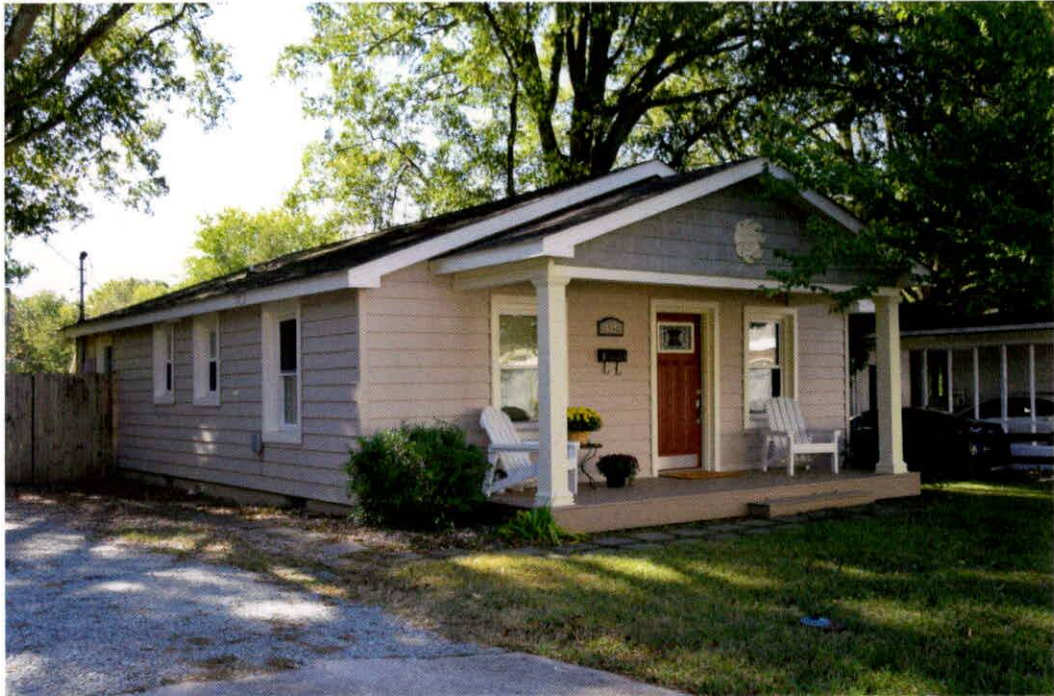
39. WA8243, House, 517 Wood Street, 0764321104, 1950.

Single-story, front-gabled Minimal Traditional house remodeled as a bungalow with nearly full-width gabled porch on squared columns replacing original portico, which was a metal awning on metal posts centered just over the front door. The house also has vinyl siding, replacement 1/1 vinyl sash, and a replaced front door.

The house has been altered to the extent that integrity of design, materials, workmanship, feeling, and association are gone. It does have integrity of location and setting. The house is not in an area that appears eligible as an NRHP historic district.

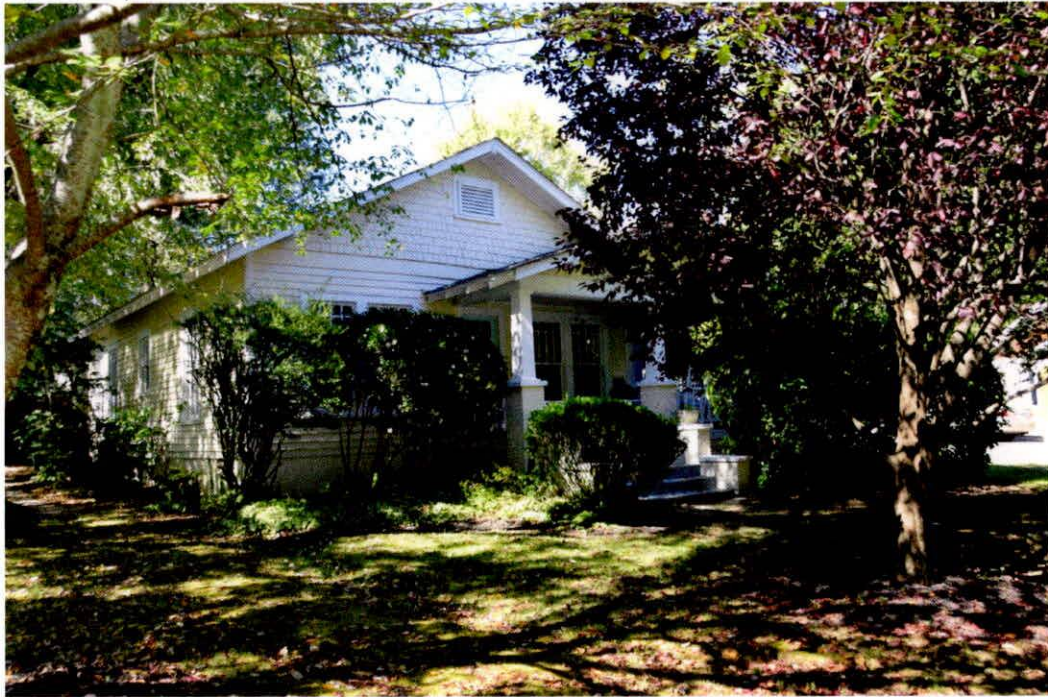
40. WA7151, 309 N. West Street, 0764322118, ca. 1925.

Front-gabled Craftsman bungalow with shingled gable ends, exposed rafter tails, windows with 8/1 Craftsman sash, battered porch posts on brick piers, and rear addition.

The house is intact and retains integrity of location, setting, design, materials, workmanship, feeling and association. It is one of two intact Craftsman bungalows in the APE. The bungalow is not, however, a distinctive example of its type and is not likely to be eligible for individual listing in the NRHP, given the number of Craftsman bungalows in Cary and Wake County that are already listed in the NRHP individually and as part of districts. This house has been identified as a preservation priority for the Town of Cary and appears to warrant continued status as a priority for the town's preservation planning.

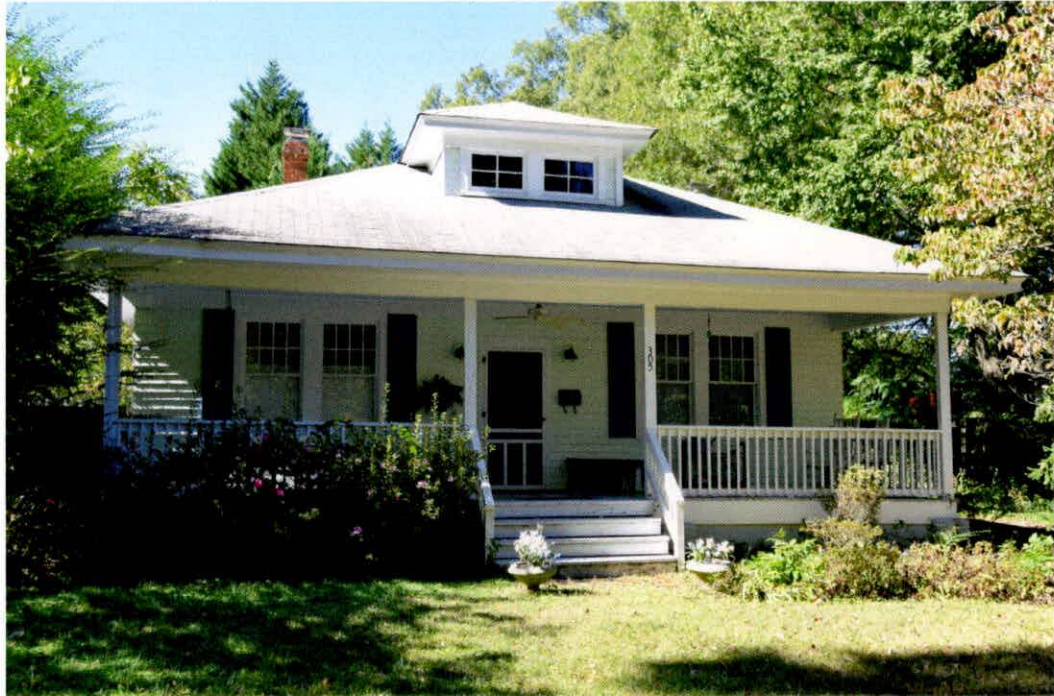
41. WA7150, House, 305 N. West Street, 0764322122, ca. 1925.

Single-story, hip-roofed bungalow with inset front porch, hipped dormer on front roof slope, 8/1 sash set in pairs, and replaced porch posts and railings.

The house has lost some integrity of materials, design, and workmanship, reducing as well the integrity of feeling and association. The integrity of location and setting are intact. The house is not in an area that appears eligible as an NRHP historic district.

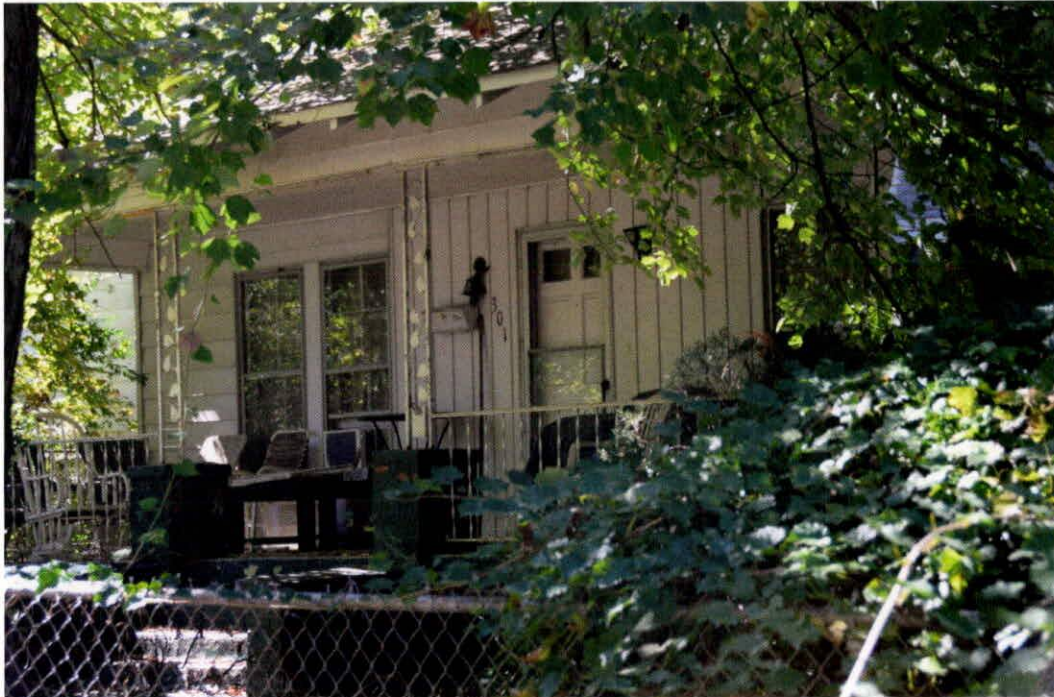
42. WA7149, House, 301 N. West Street, 0764322082, ca. 1930.

Single-story, hip-roofed house with hipped dormer, paired 2/2 windows, exposed rafter tails and replacement porch of metal awning supported by decorative metal posts on brick piers with a metal railing. The house is reclad in aluminum and plywood.

The house has lost integrity of materials, design, workmanship, feeling, and association. The integrity of location and setting are intact. The house is not in an area that appears eligible as an NRHP historic district.

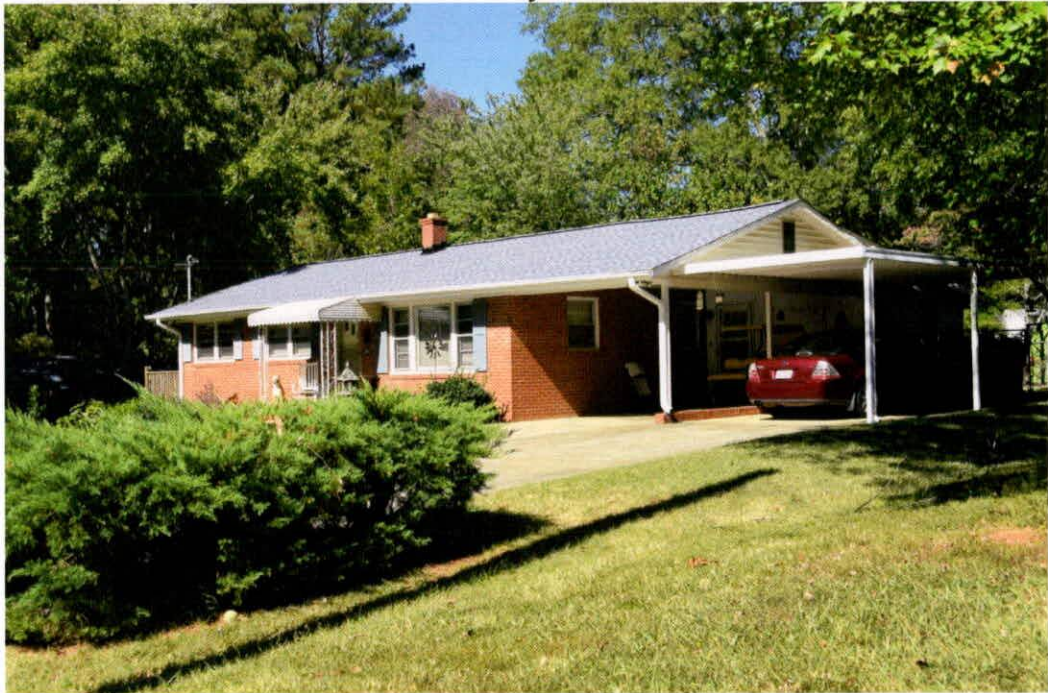
43. WA8244, House and sheds, 312 Holloway Street, 0764219978, 1959.

52a. House, 1959. Side-gabled Ranch house with brick exterior, vinyl siding in gable ends, 2/2 horizontal sash, and integrated carport.

The house appears unchanged except for the addition of vinyl siding to the gable ends of the second story section. It retains integrity of location, setting, design, although the siding has reduced integrity of materials and workmanship a little. The house retains integrity of feeling and association. However, the house lacks architectural significance and has no known historic significance for individual listing in the NRHP. The house is not in an area that appears eligible as an NRHP historic district.

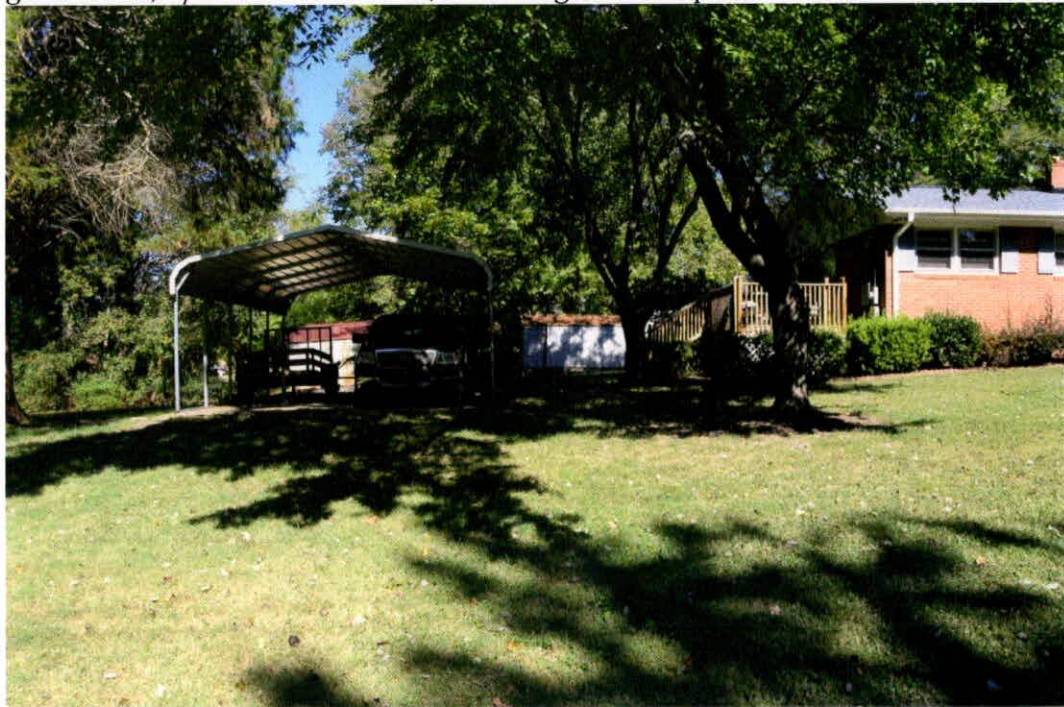
52b. Carport. Ca. 1980. Prefabricated freestanding metal carport southwest of house.

52c. Shed, ca. 1980. Prefabricated metal shed immediately north of carport.

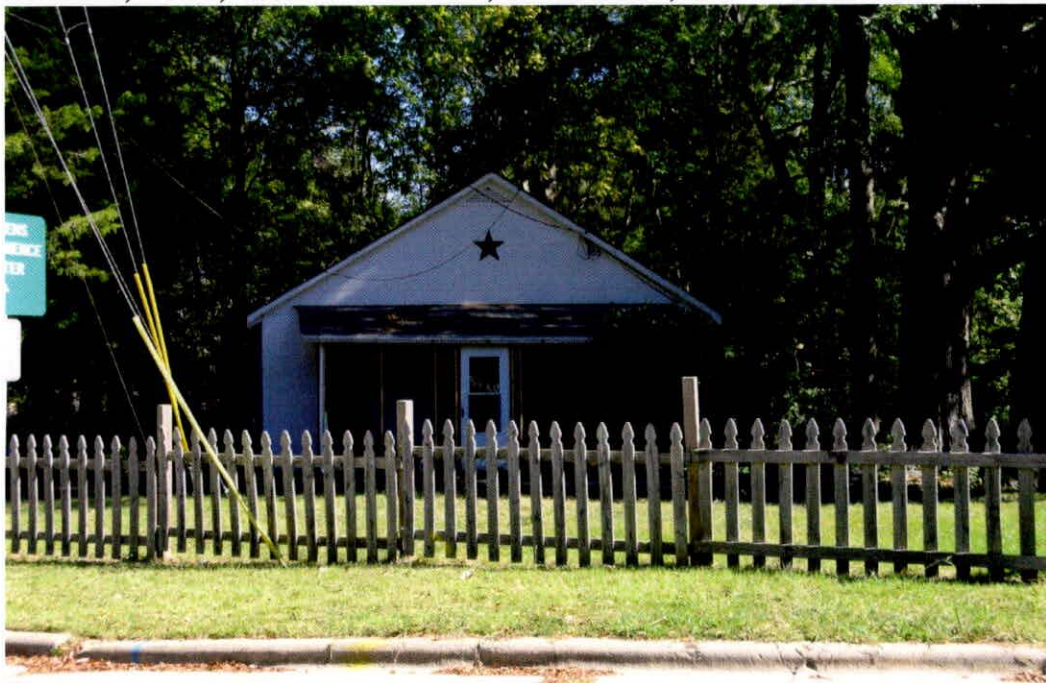
44. *WA8245, House, 216 N. Dixon Street, 0764227001, 1921.*

Single-story, front-gabled bungalow with asbestos shingle siding, replacement 1/1 sash, and screened shed porch at façade.

The house has lost integrity of materials, design, and workmanship, reducing as well the integrity of feeling and association. The integrity of location and setting are intact. The house is not in an area that appears eligible as an NRHP historic district.

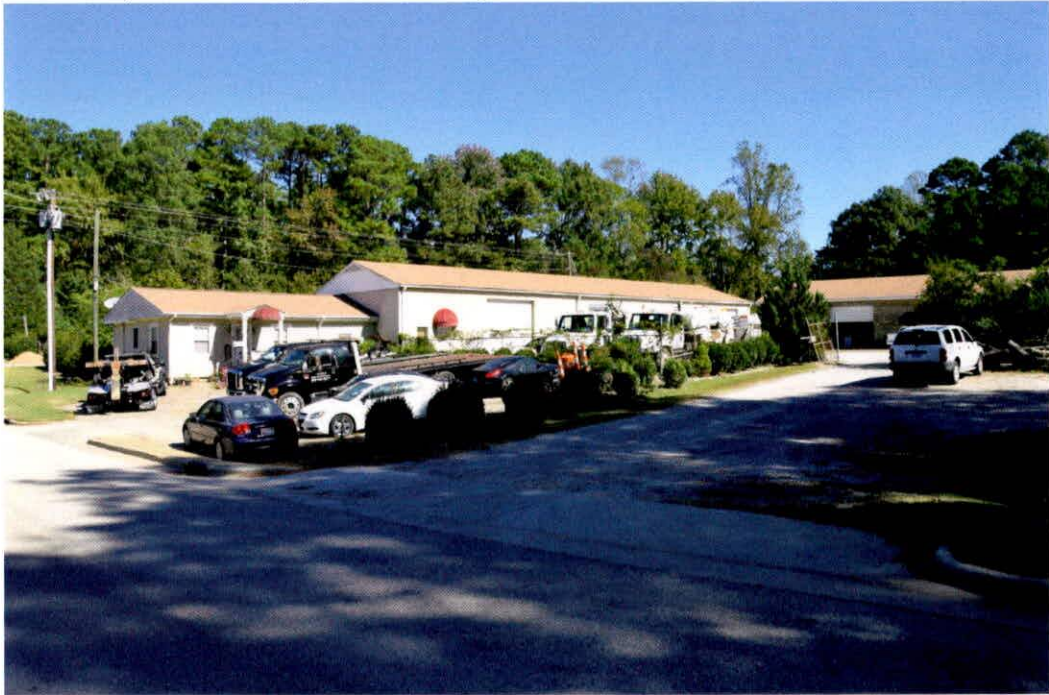
45. WA8246, Warehouses, 0764226432, 310 N. Dixon Street, 1971, 1972.

54a. Warehouse 1, 1972. Side-gabled, concrete-block warehouse with garage entrances in main block along south-facing elevation and personnel door under gabled portico in smaller gabled office block with vinyl siding and 6/6 vinyl sash at west end of building.

The warehouses retain integrity of location and setting, but they appear to have been altered with new siding, windows, and doors. They lack integrity and significance for individual listing in the NRHP and are not in an area that appears eligible as an NRHP district.

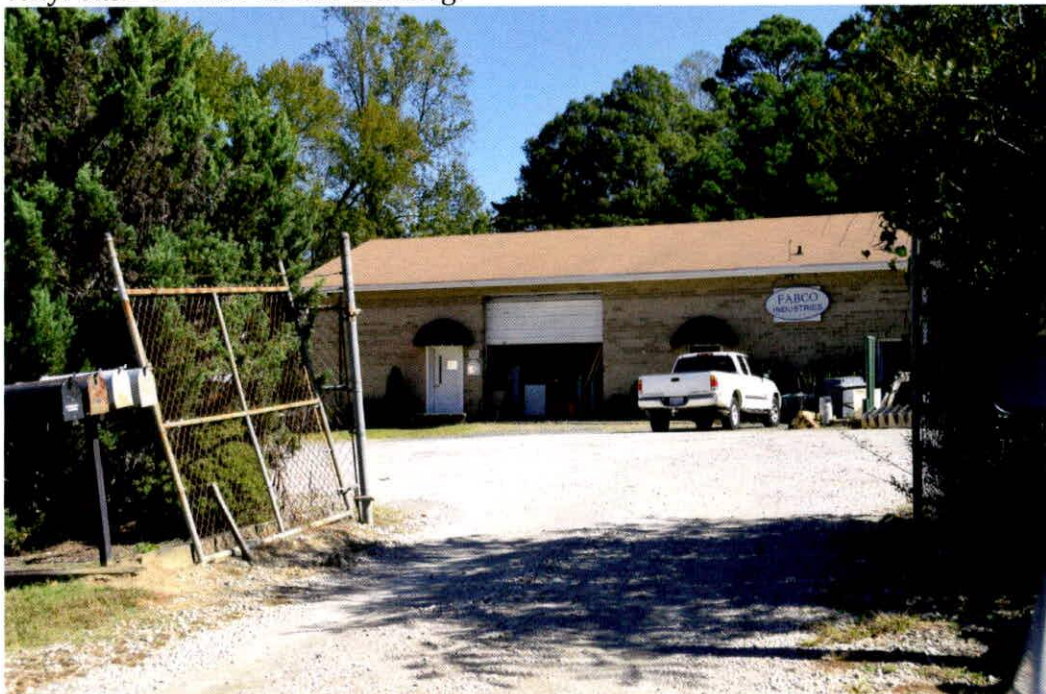
54b. Warehouse 2, 1971. Side-gabled, light-brown brick exterior with single-leaf personnel doors and overhead-lifting garage doors at west-facing façade.

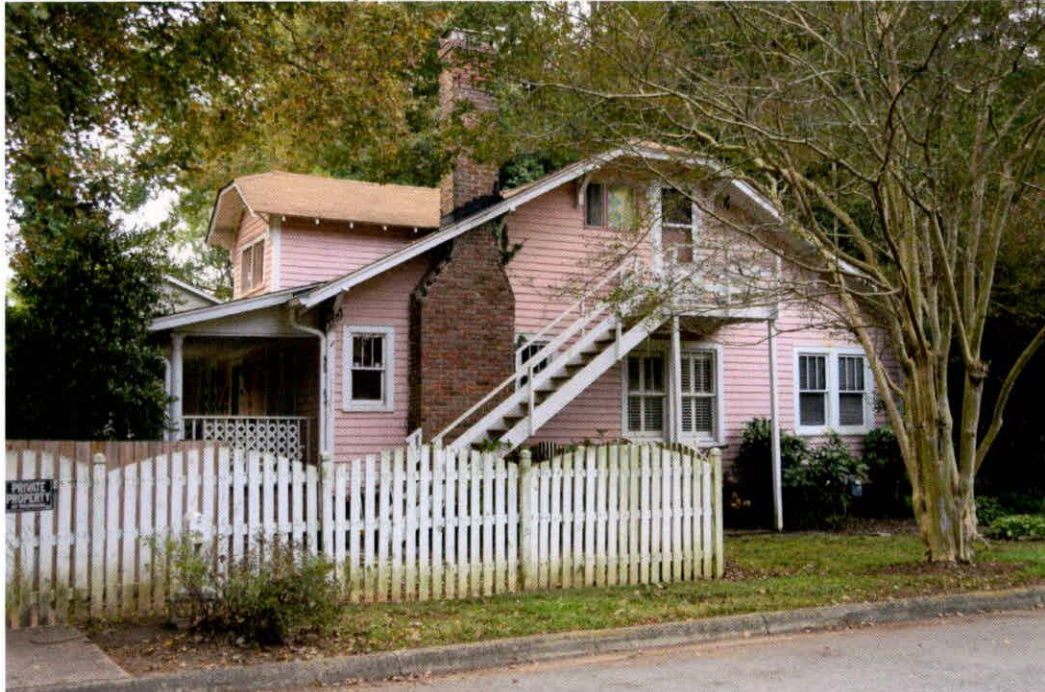
46. WA7319, House, 8721 Chapel Hill Road, 0764237415, ca. 1925

One-and-a-half story clipped-gable Craftsman bungalow with clipped-gable dormer and full-width shed porch on Tuscan columns and replacement balustrade. A section that wraps around the east side of the house has been enclosed. The house retains its weatherboard siding, triangular eave brackets, exposed rafter tails, and 3/1 Craftsman sash. An exterior brick chimney pierces the eave on the west side elevation. An added exterior stair at the west elevation rises to provide access to added door in gable; a window in this gable end has also been changed. On the rear elevation is a shed dormer.

The house appears to retain integrity of location and setting. While some changes (to fenestration at the west gable end, the porch enclosure, and the porch railing and possibly the columns) have been made to the house, its architectural type and style are intact and integrity of materials, design, and workmanship have not been completely eliminated. The changes are not enough to have completely diminished integrity of feeling and association. However, the house lacks distinction for its type—in fact, a better and more intact example of a Craftsman bungalow stands across Hickory Street, just outside the APE. It does not appear individually eligible for the NRHP and is not in an area eligible as an NRHP district.

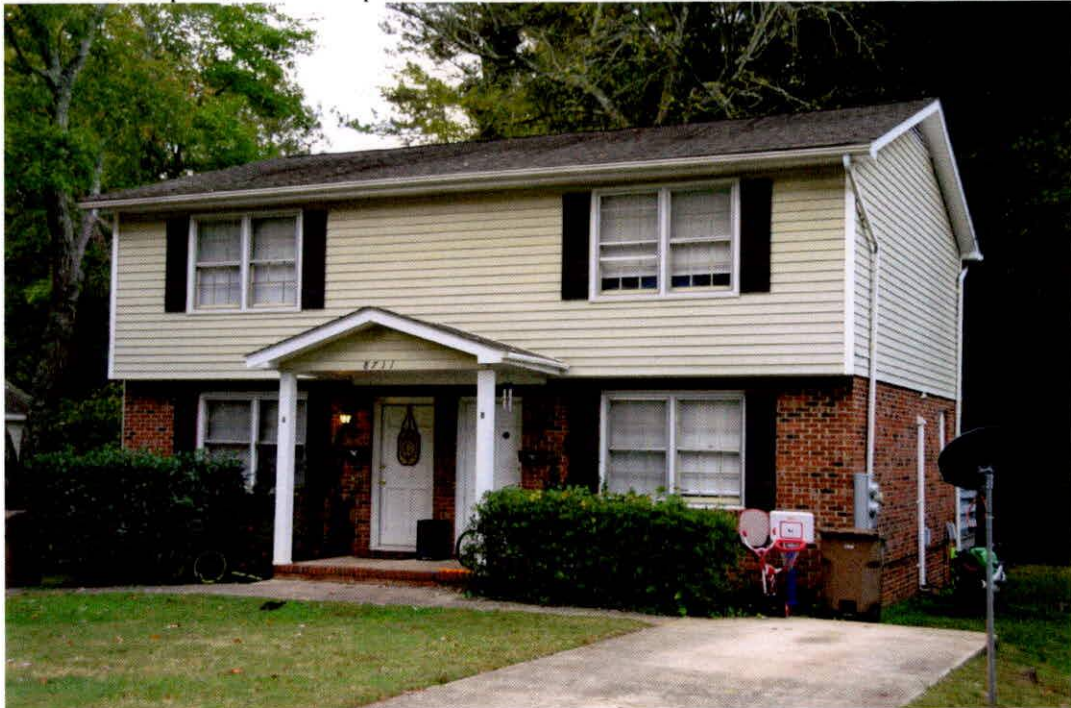
48. WA8248, Duplex, 8711 Chapel Hill Road, 0764239322, 1972

Two-story, side-gabled duplex with brick exterior at first floor and aluminum siding at second floor, 6/6 sash, faux shutters, gabled portico over side-by-side paneled front doors at center of façade's first floor. Second story overhangs very slightly over first.

The building's integrity of location and setting are intact, and integrity of materials is altered a bit by the application of aluminum siding. Other original details remain intact, however, so the integrity of design and workmanship is basically intact, as is integrity of feeling and association. However, the duplex lacks architectural and historical significance for individual listing in the NRHP. The building is in an area that does not appear eligible as an NRHP district.

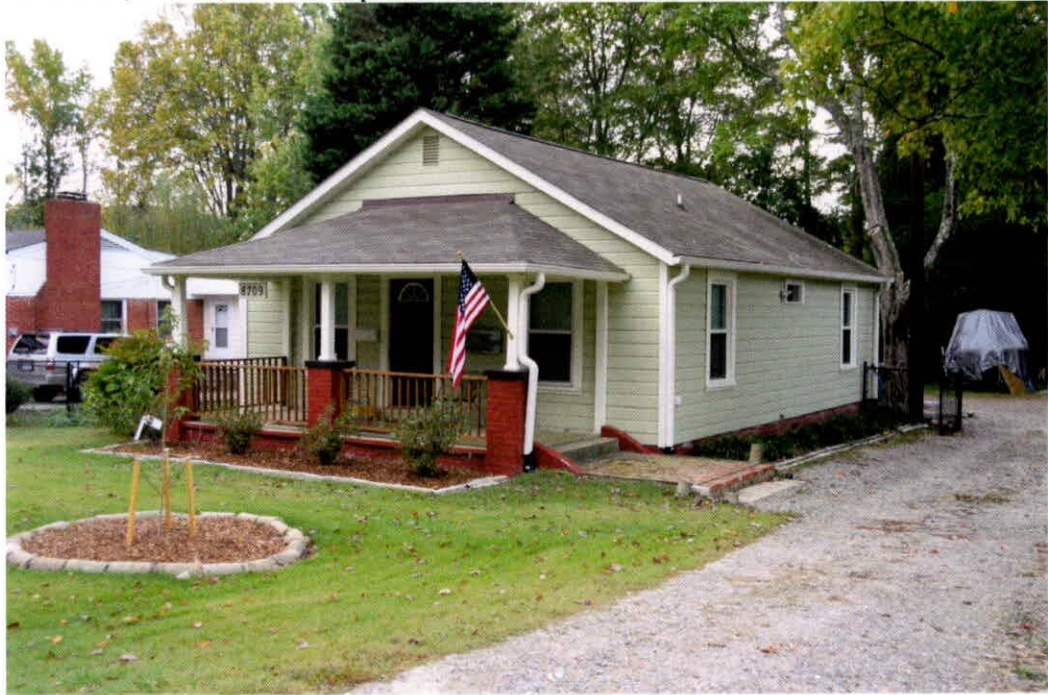
49. WA8249, House, 8709 Chapel Hill Road, 0764239298, 1940

Single-story, front-gabled bungalow with hip-roofed porch on slender squared posts on brick piers; replacement porch balustrade with opening at side rather than front; replacement German siding; replacement 1/1 sash; and replacement door.

While the location, setting, and overall form and massing are intact, the new materials introduced in a recent renovation have reduced the building's integrity of style, materials, and workmanship and, consequently, of feeling and association. The house lacks architectural distinction for individual listing in the NRHP and is not in an area that appears eligible as an NRHP district.
