**North Carolina Department of Natural and Cultural Resources  
State Historic Preservation Office**

Re: Feasibility Study for Downtown Multi Modal Transit Center, Cary, Wake County, ER 19-0950

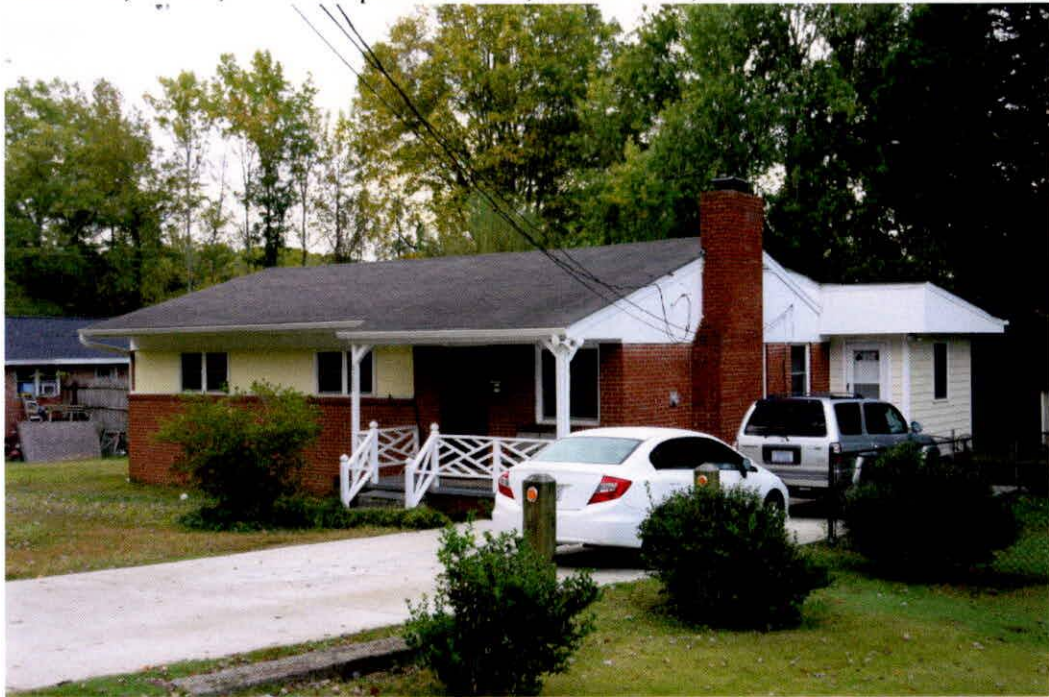
50. WA8250, House, 8705 Chapel Hill Road, 076433025, 1948

Side-gabled Ranch with brick and plywood exterior; 2/2 horizontal sash; replacement front door; rear addition; shed-roofed front porch with Chippendale balustrade and rail.

The house retains integrity of location and setting, and minimal changes have not eliminated integrity of style, materials, workmanship, feeling, and association. However, the house is not architecturally distinctive and doesn't appear to have historic significance for individual listing in the NRHP. The dwelling is not in an area that appears eligible for listing in the NRHP as a district.

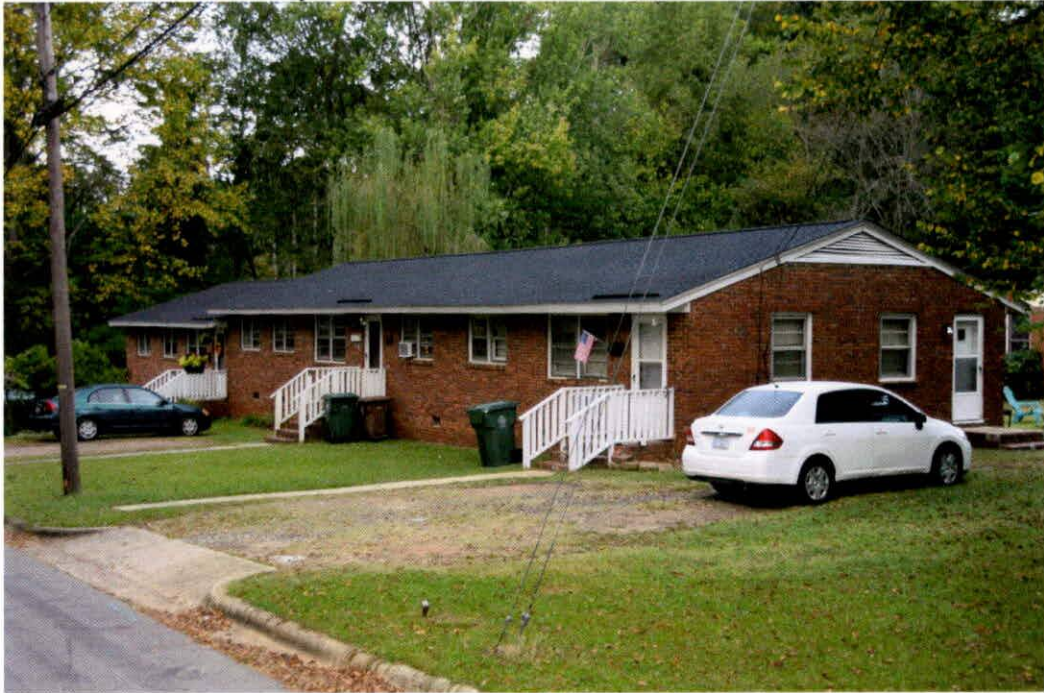
51. WA8251, House, 413 Spruce Street, 07643312222, 1963

Single-story, side-gabled triplex with brick exterior, 2/2 horizontal sash, and added railings of extruded metal at stoop.

The building has been minimally altered and retains all seven aspects of integrity. However, it lacks architectural and historic significance for listing in the NRHP. The building is not in an area that appears eligible as an NRHP district.

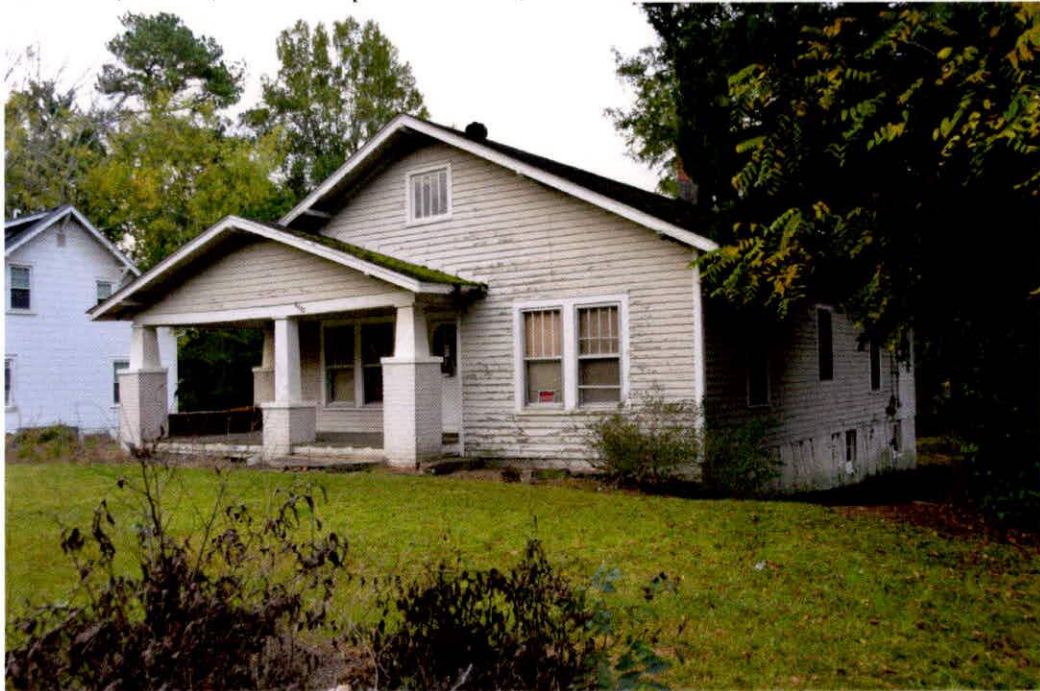
52. WA7320, House, 8637 Chapel Hill Road, 0764332127, 1920

Single-story, front-gabled bungalow with nested gabled wraparound porch with battered posts on brick piers, including added post at lower original pier at center of porch span. Weatherboard exterior, 4/1 sash in pairs at façade and singly at side elevations. Projecting gabled bay at east side elevation with 4-light piano window. Some replacement fenestration at rear elevation.

The house is relatively intact and retains all seven aspects of integrity, despite some changes to the rear elevation. However, it lacks architectural distinction and does not appear to have historic significance. The dwelling is not in an area that appears eligible as an NRHP district.

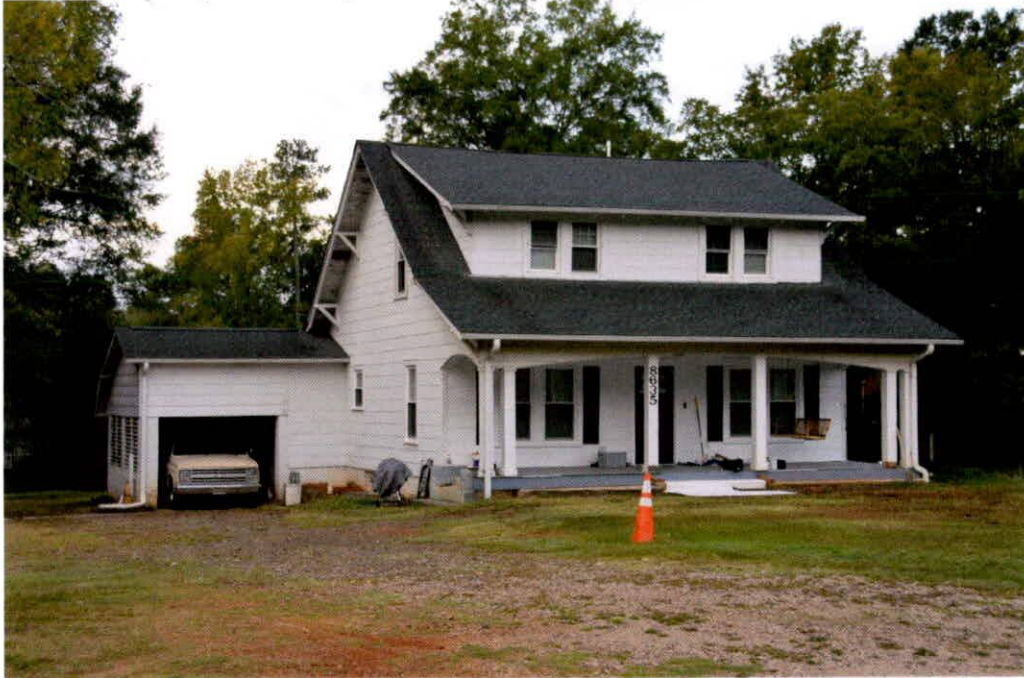
53. WA7321, House, 8635 Chapel Hill Road, 0764332193, 1938.

One-and-a-half story, side-gabled bungalow with wide, two-bay shed dormer and engaged front porch on paired and single squared posts; arched, weatherboarded frieze at porch; exposed rafter tails; bracketed gable eaves; asbestos-shingle siding; 6/1 mismatched sash; exterior storm windows; single-bay garage addition at east side replaced a carport.

Integrity of location and setting may be intact. While the overall form is intact, the siding, addition, and likely window replacement reduce the integrity of design, materials, and workmanship. The integrity of feeling and association are also diminished. The house is not in an area that appears eligible as an NRHP district.

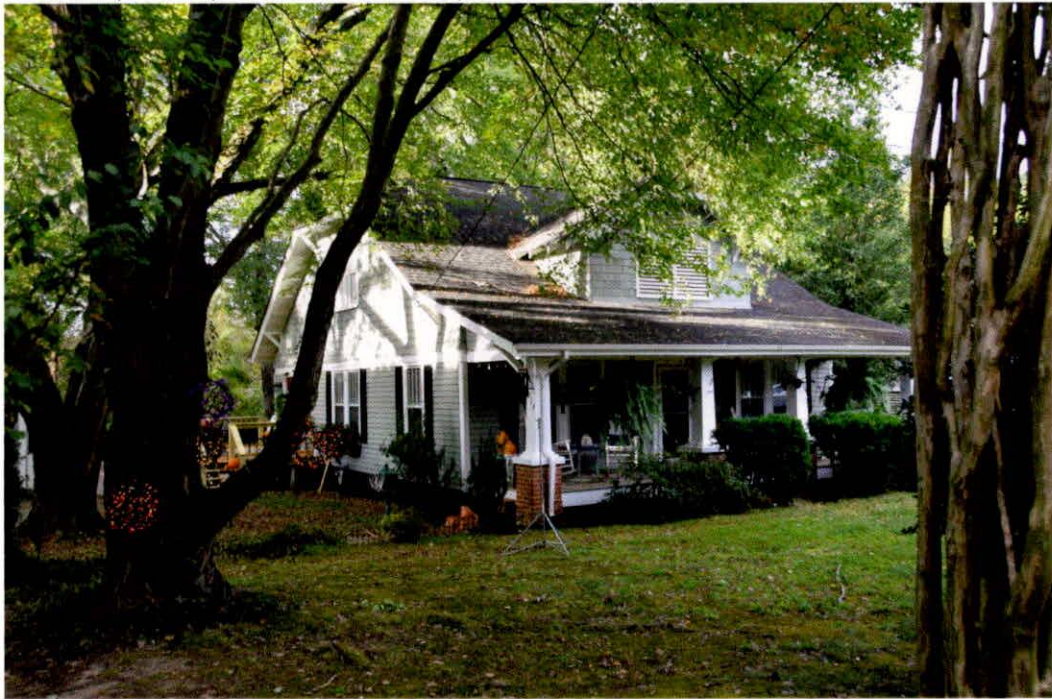
54. WA7322, House, 237 Adams Street, 0764333088, 1925

One-and-a-half-story, clipped-gable Craftsman bungalow with clipped-gable front dormer; weatherboard sheathing with shingles in gable ends and dormer; engaged, full-façade porch on tapered square posts with brick piers, triangular eave brackets, and exposed rafter tails. The windows are 4/1 original wood sashes, although a single 1/1 sash is observed at the north end of the west side elevation.

The house is intact and retains integrity of location, setting, design, materials, workmanship, feeling and association. It is one of two intact Craftsman bungalows in the APE. The bungalow is not, however, a distinctive example of its type and is not likely to be eligible for individual listing in the NRHP, given the number of Craftsman bungalows in Cary and Wake County that are already listed in the NRHP individually and as part of districts. This house has been identified as a preservation priority for the Town of Cary and appears to warrant continued status as a priority for the town's preservation planning.

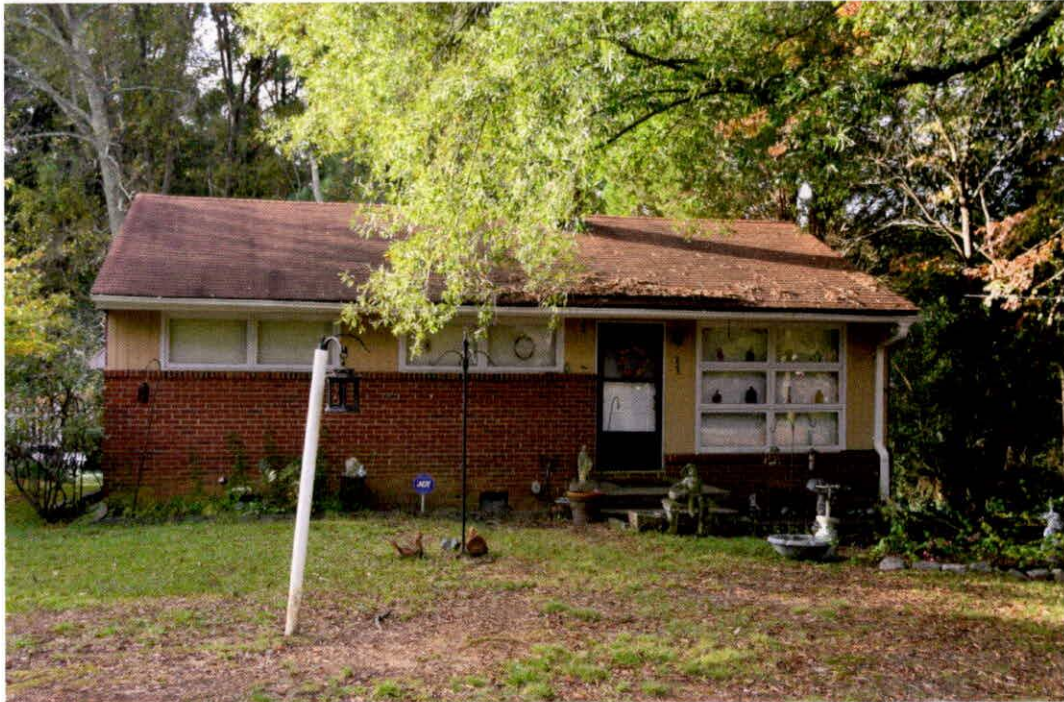
55. WA7316, House, 223 Adams Street, 0764327904, 1956

Side-gabled Ranch with brick and plywood exterior and weatherboards at the gable ends; awning windows set in two pairs to the left of the front entry and stacked in pairs to the right.

The house appears to be unaltered and therefore retains integrity of location, setting, design, materials, workmanship, feeling, and association. It is a typical but not distinctive example of its type, however, and does not appear to have historic or architectural significance sufficient for listing in the NRHP. It is not in an area that appears eligible as an NRHP district.

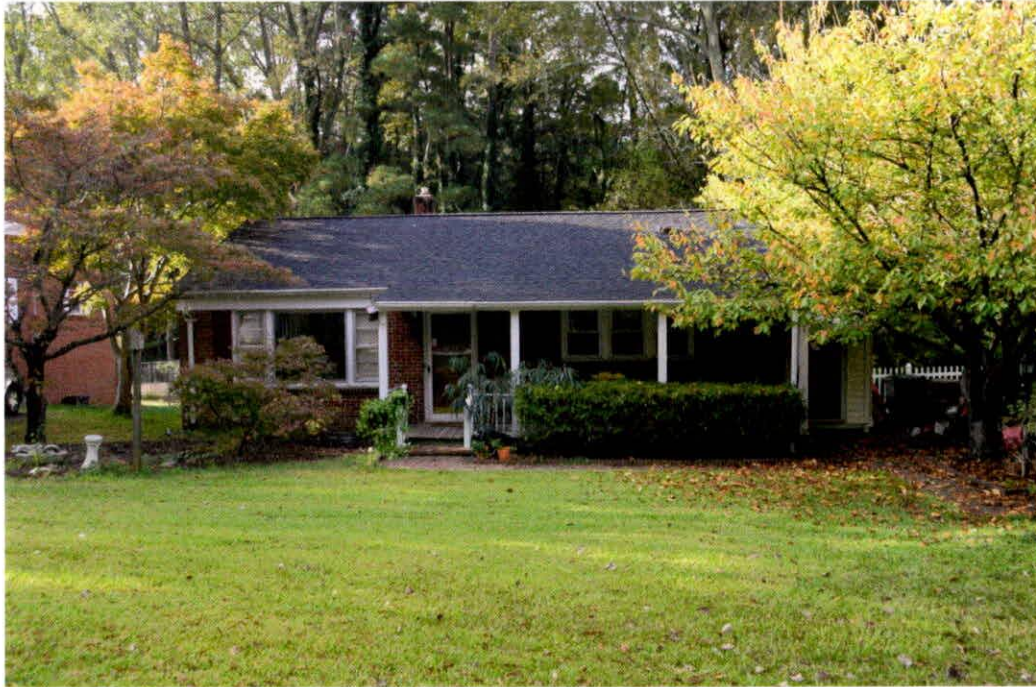
56. WA8252, House, 221 Adams Street, 0764327963, 1956

Side-gabled Ranch with brick exterior; original picture window with 2/2 horizontal sidelights; replacement 6/6 vinyl sash; porch under shed roof extension on squared posts across two-thirds of width of façade.

The dwelling retains integrity of location and setting. Integrity of materials, design, and workmanship are diminished by the change in windows, and the integrity of feeling and association is slightly diminished as well. The dwelling is not in an area that appears eligible as an NRHP district.

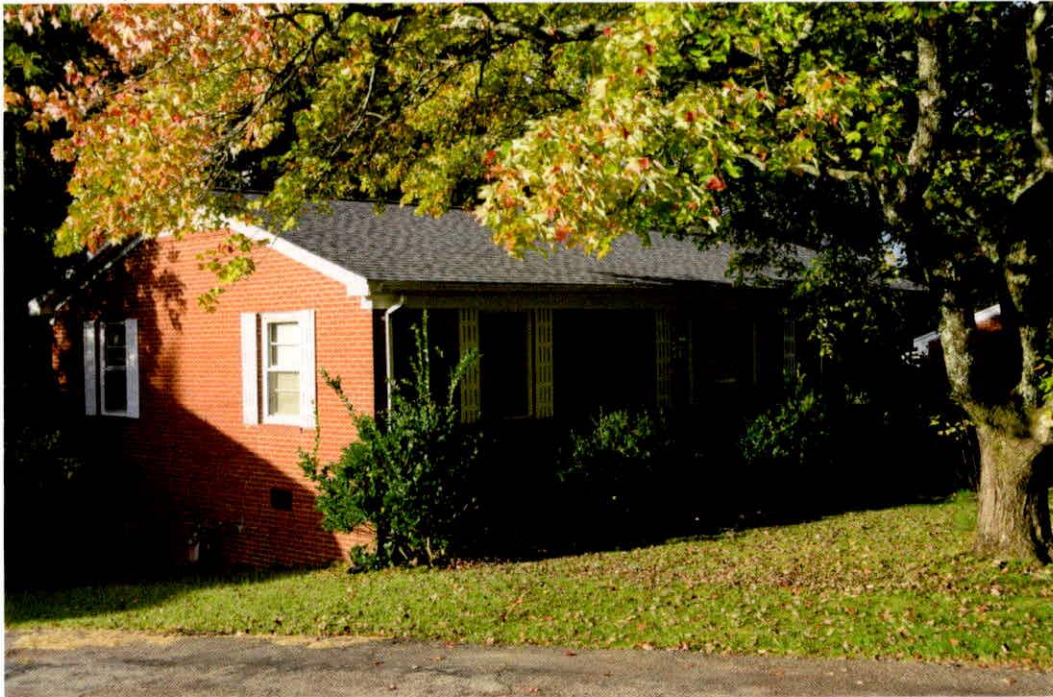
57. WA8253, House, 217 Adams Street, 0764328822, 1954

Side-gabled Ranch with brick exterior; 2/2 horizontal sash, including picture window with 2/2 sidelights; faux shutters; inset corner entry porch on metal columns with scrollwork.

The house appears to be unaltered and therefore retains integrity of location, setting, design, materials, workmanship, feeling, and association. It is a typical but not a distinctive example of its type, however, and does not appear to have historic or architectural significance sufficient for listing in the NRHP. It is not in an area that appears eligible as an NRHP district.

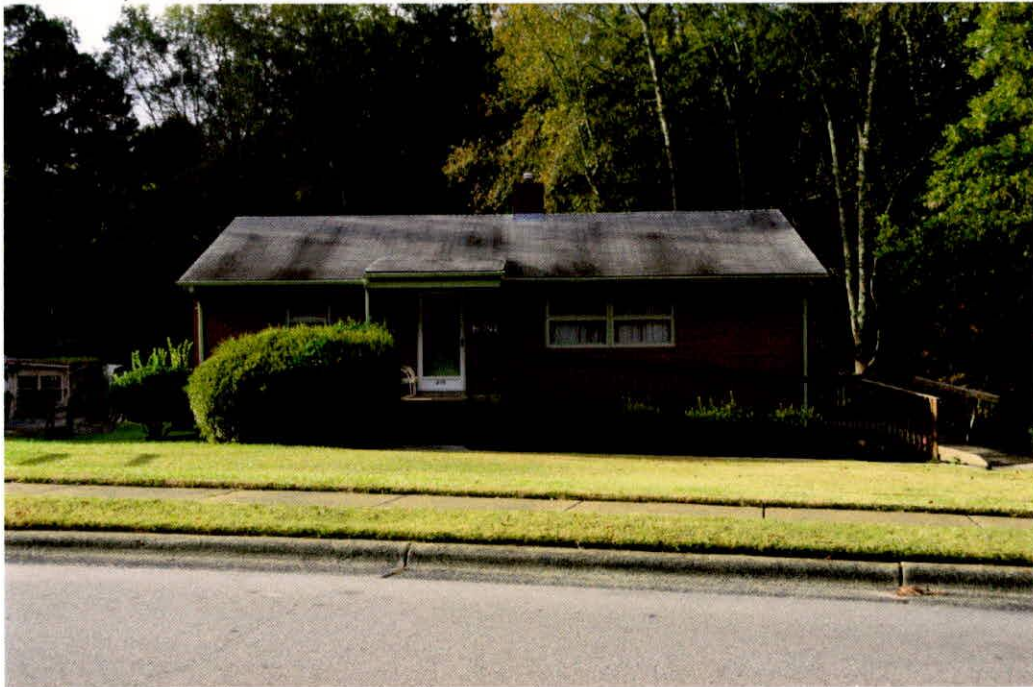
58. WA8254, House, 215 Adams Street, 0764328890, 1955

Side-gabled Ranch with brick exterior, 6/6 sash, quad of aluminum awning windows at living room, small extended shed roof on metal columns with scrollwork, added aluminum siding in gable end.

The house appears to be unaltered and therefore retains integrity of location, setting, design, materials, workmanship, feeling, and association. It is a typical but not a distinctive example of its type, however, and does not appear to have historic or architectural significance sufficient for listing in the NRHP. It is not in an area that appears eligible as an NRHP district.

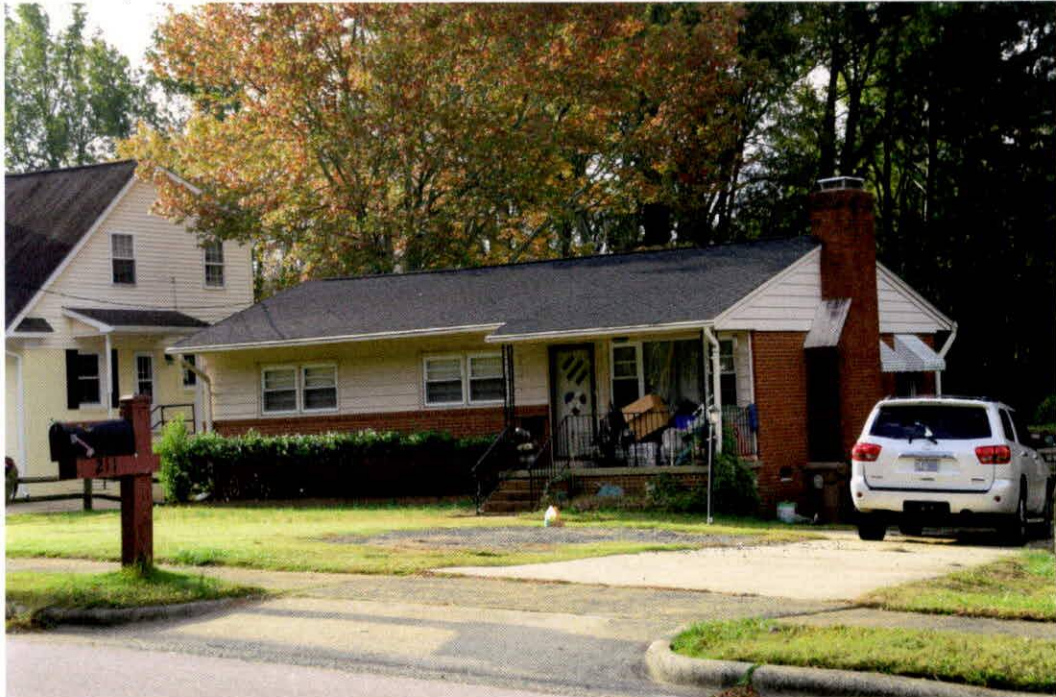
59. WA8255, House, 211 Adams Street, 0764329767, 1955

Side-gabled Ranch with brick and aluminum-sided exterior; 2/2 sash hung in pairs and with picture window and 2/2 sidelights at living room; porch under extended shed roof on metal columns at right end of façade; exterior brick chimney.

The house retains integrity of location and setting. It appears to be altered with the application of aluminum siding, reducing integrity of design, materials and workmanship and, to a lesser extent, feeling and association. It is not in an area that appears eligible as an NRHP district.

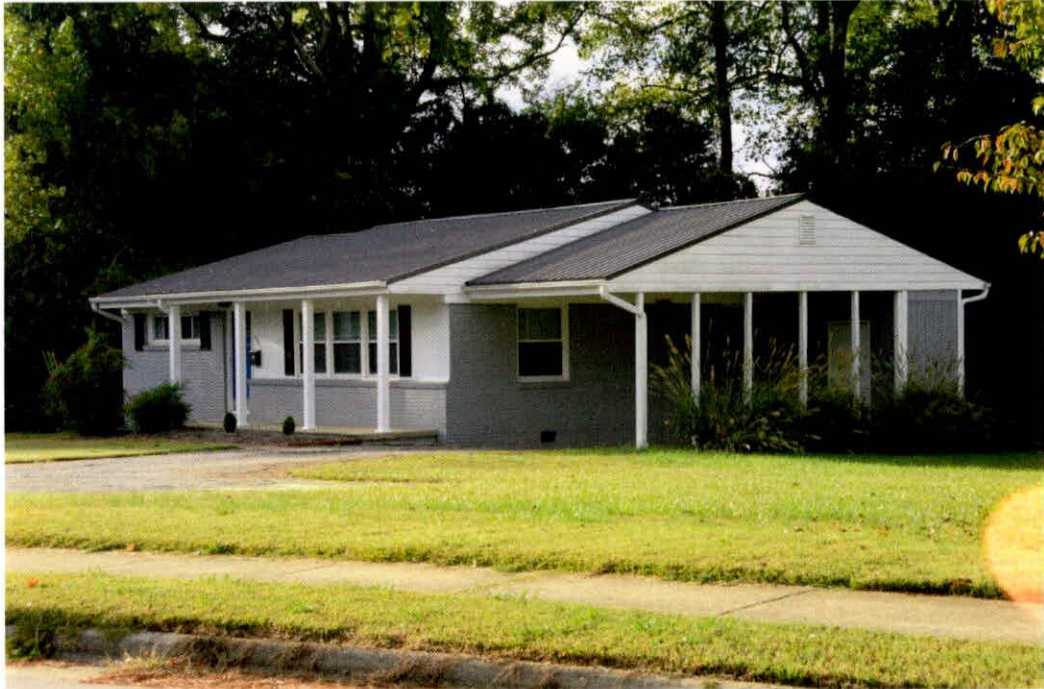
62. WA8258, House, 201 Adams Street, 0764421796, 1956

Side-gabled brick ranch with accent plywood siding and vinyl siding in gable ends; replacement 1/1 sash; carport at right end of façade.

The dwelling retains integrity of location and setting, but the integrity of design, materials, and workmanship are reduced by alterations, also reducing integrity of feeling and association.

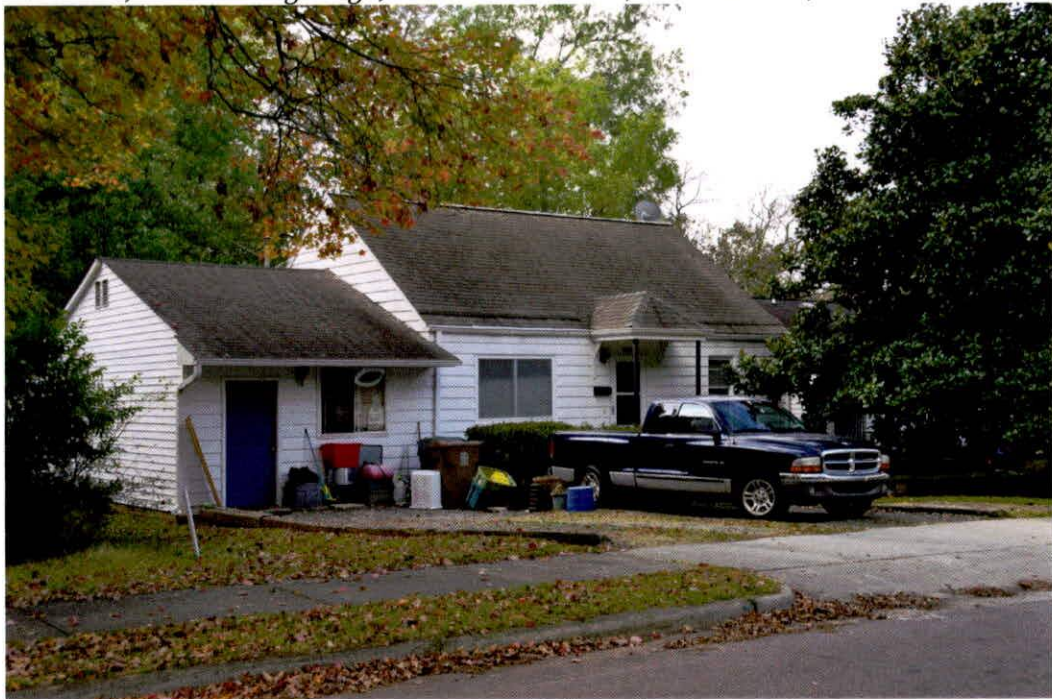
63. WA8259, House and garage, 119 Adams Street, 0764424700, 1949

63a. House, 1949. Side-gabled Cape Cod dwelling with replaced windows, hipped porch on metal posts, aluminum siding, and added side wing or enclosed garage.

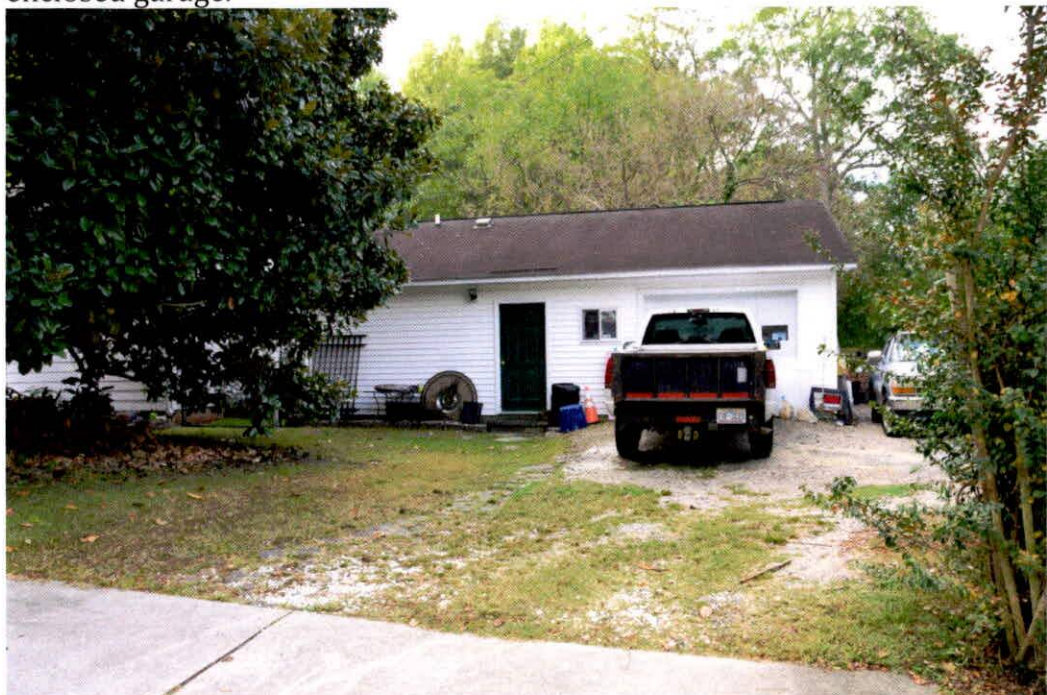
63b. Garage, 1949. Side-gabled garage with single-leaf personnel door and small slider window; vinyl siding.

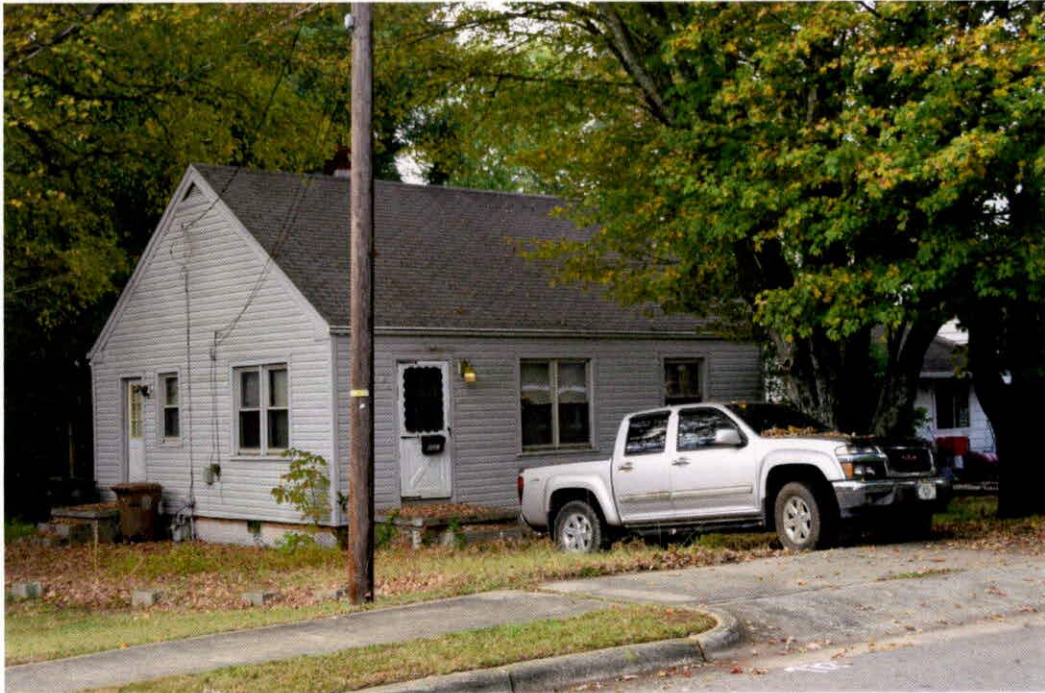
64. WA8260, House, 117 Adams Street, 764424760, 1949

Single-story, frame, Cape Cod dwelling with replacement vinyl 1/1 sash set in pairs and singly, vinyl siding, and original partially glazed paneled front door.

The house retains integrity of location and setting but has lost integrity of design, materials, and workmanship due to alterations and new materials. The integrity of feeling and association has also been diminished. The house is not in an area that appears eligible for the NRHP as a district.

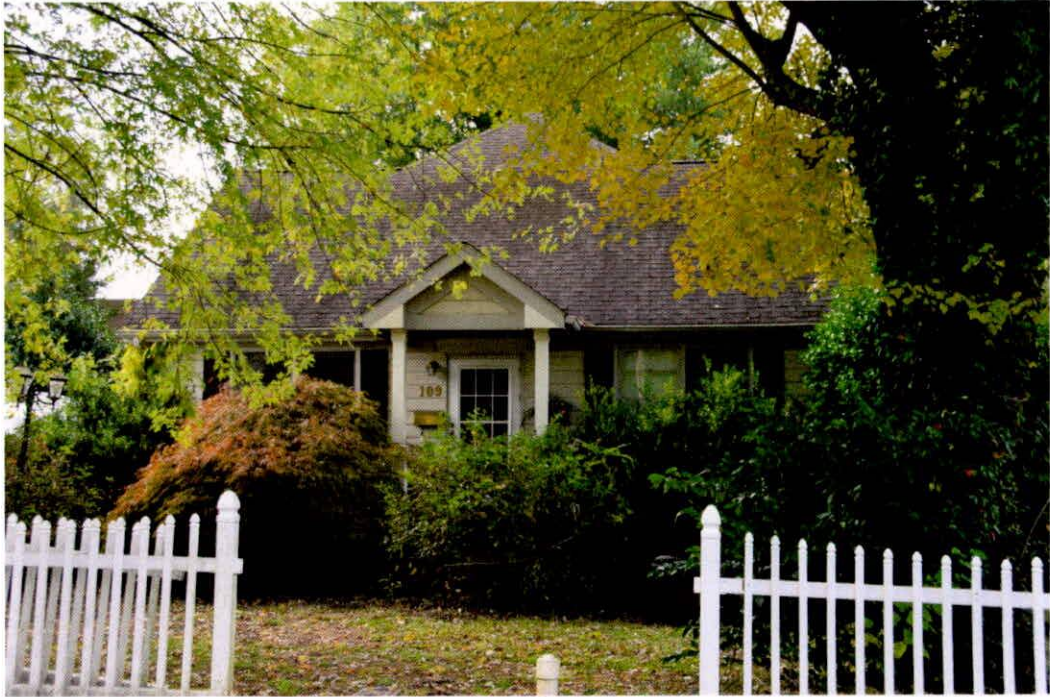
67. WA8263, House, 109 Adams Street, 0764426740, 1949

One-and-a-half story Cape Cod with gabled portico; vinyl siding; paired replacement windows; replacement front door and storm door; gabled dormers at side slopes of added gabled addition at rear.

The house retains integrity of location and setting, but the replacement windows, door, and added siding reduce the integrity of design, materials, and workmanship, also diminishing integrity of feeling and association. The house is not in an area that appears eligible for the NRHP as a district.

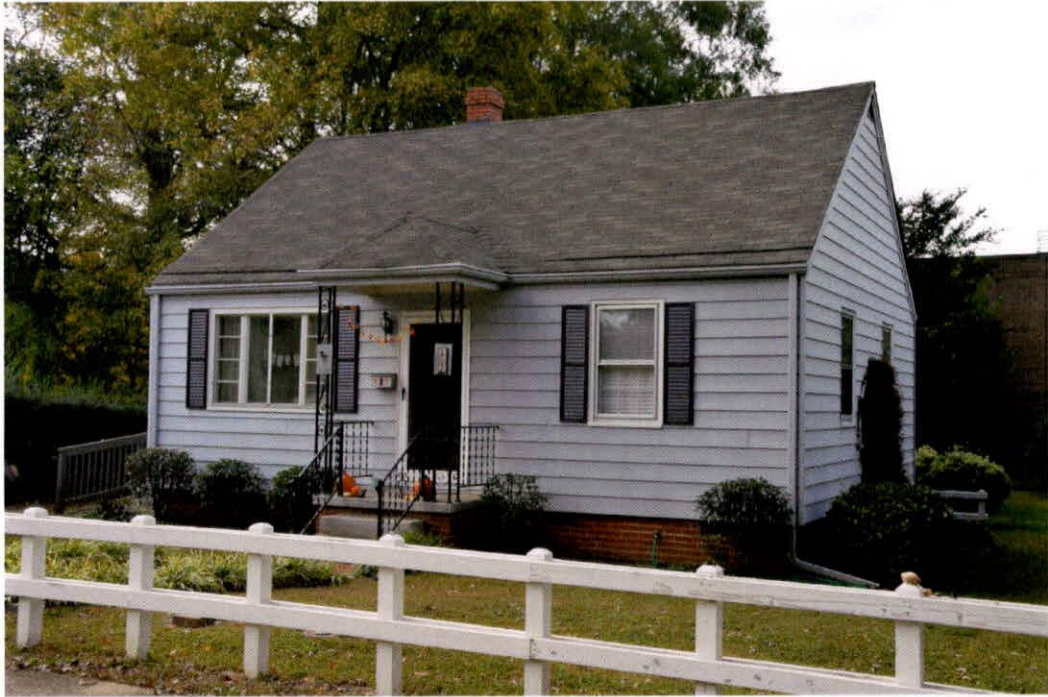
68. WA8264, House, 107 Adams Street, 0764427700, 1949

Single-story Cape Cod with flat-roofed portico on metal posts with scrollwork; metal balustrade at concrete stoop; 6/6 sash and multi-lite fixed sash sidelights at picture window; aluminum siding.

The house retains integrity of location and setting, and the overall form is intact, preserving much of the integrity of design. The replacement siding reduces the integrity of materials and workmanship, also diminishing integrity of feeling and association. The house is not in an area that appears eligible for the NRHP as a district.

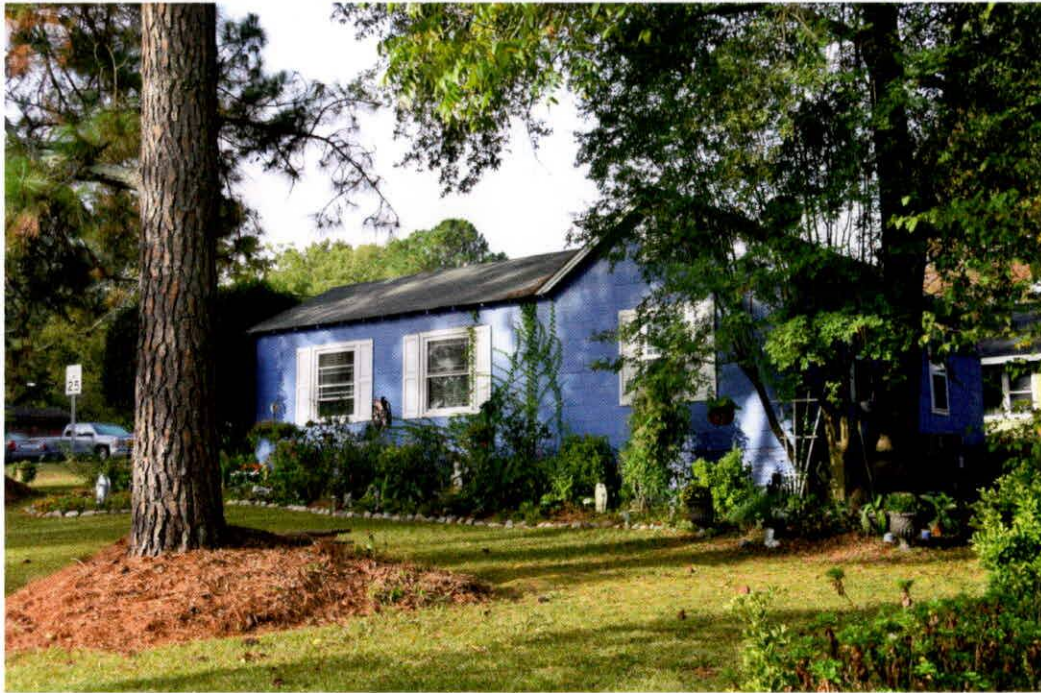
69. WA8265, House, 102 Adams Street, 0764428825, 1950

One-story gable-front-and-wing house with asbestos-shingle siding, replacement windows, interior brick stack, and shed porch at front ell.

The house retains integrity of location and setting, but, in such a simple dwelling, replacement windows reduce the integrity of design, materials, and workmanship, also diminishing integrity of feeling and association. The asbestos-shingle siding may be original or an alteration. The house is not in an area that appears eligible for the NRHP as a district.

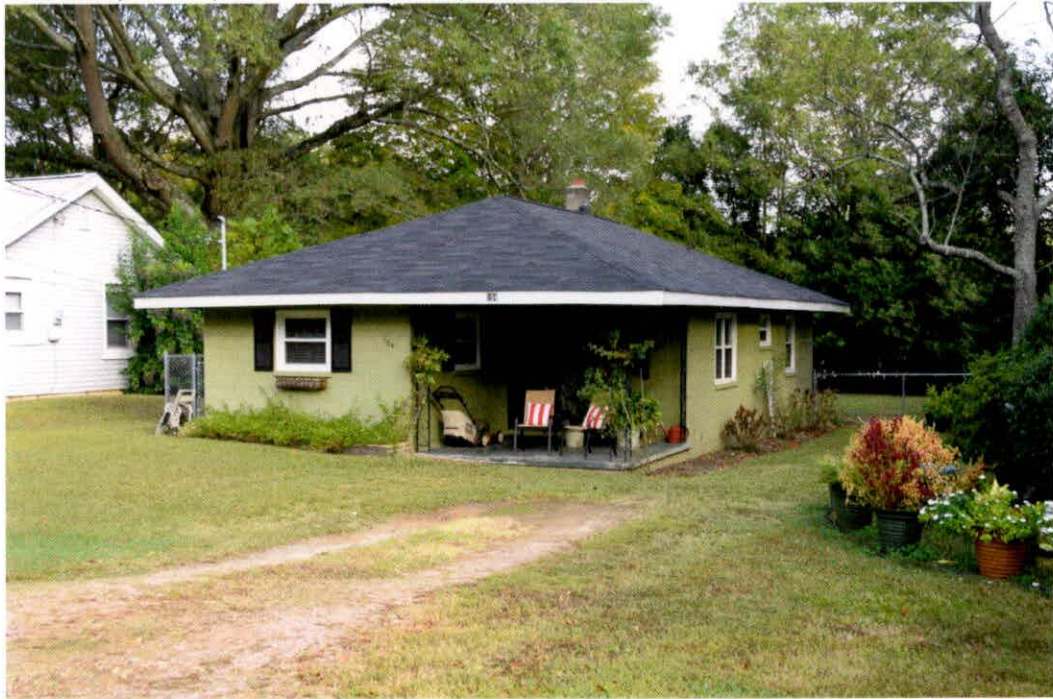
70. WA8266, House, 104 Adams Street, 0764427857, 1950

Single-story, hip-roofed concrete-block house with inset corner porch with concrete floor, replacement 1/1 sash, and deep boxed eaves.

The house retains integrity of location and setting, but, in such a simple dwelling, replacement windows reduce the integrity of design, materials, and workmanship, also diminishing integrity of feeling and association. The house is not in an area that appears eligible for the NRHP as a district.

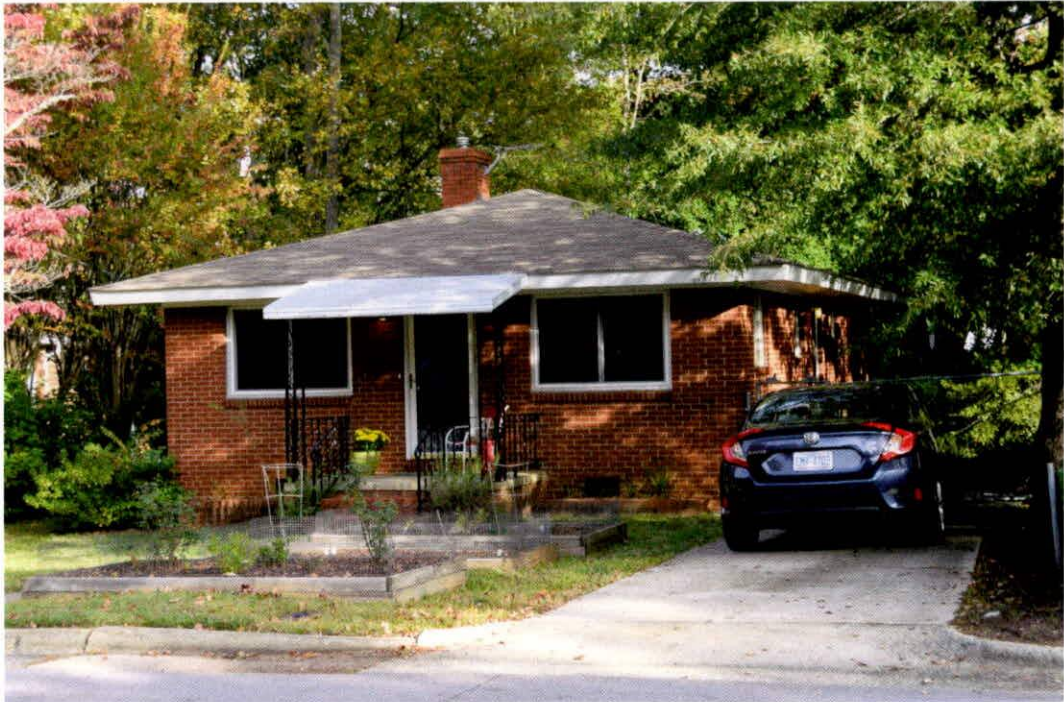
72. WA8268, House, 114 Adams Street, 0764425819, 1956

Single-story, hip-roofed dwelling with replacement sash, brick exterior, deep boxed eaves, metal awning on metal posts with decorative scrollwork shelters centered front door, interior brick stack.

The house retains integrity of location and setting, but replacement windows have reduced the integrity of design, materials, and workmanship, also reducing integrity of feeling and association. The house is not in an area that appears eligible for the NRHP as a district.

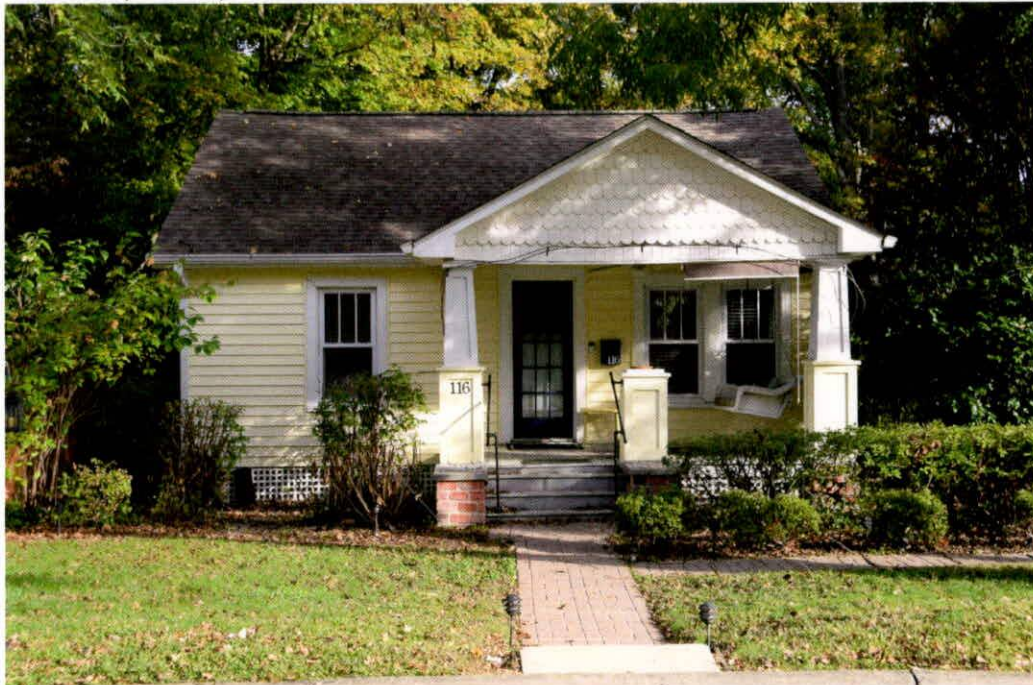
73. WA8269, House, 116 Adams Street, 0764424859, 1950

Single-story, side-gabled dwelling renovated in bungalow style with gabled front porch on battered posts on squared piers, scalloped shingles in porch gable end, replacement 3/1 sash, weatherboard siding.

The house retains integrity of location and setting, but renovations have integrity of design, materials, and workmanship, also reducing integrity of feeling and association. The house is not in an area that appears eligible for the NRHP as a district.

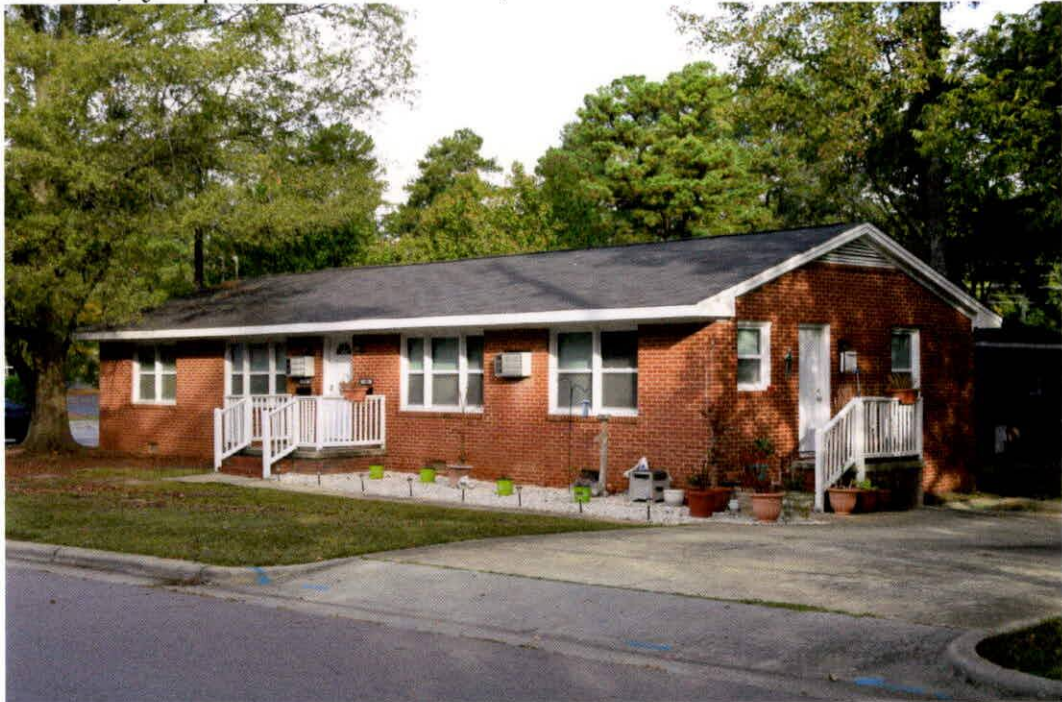
74. WA8270, Quadplex, 120 Adams Street, 0764433960, 1963

One-story, side-gabled, L-plan quadplex with running-bond brick exterior, replacement 1/1 sash and replacement doors, and extruded metal railings at concrete-topped brick stoops.

The apartment building retains integrity of location and setting, but the replacement materials and added stoop railings are sufficient to reduce integrity of design, materials, and workmanship in such a simple building. The integrity of feeling and association is also reduced. The building is not in an area that appears eligible for the NRHP as a district.

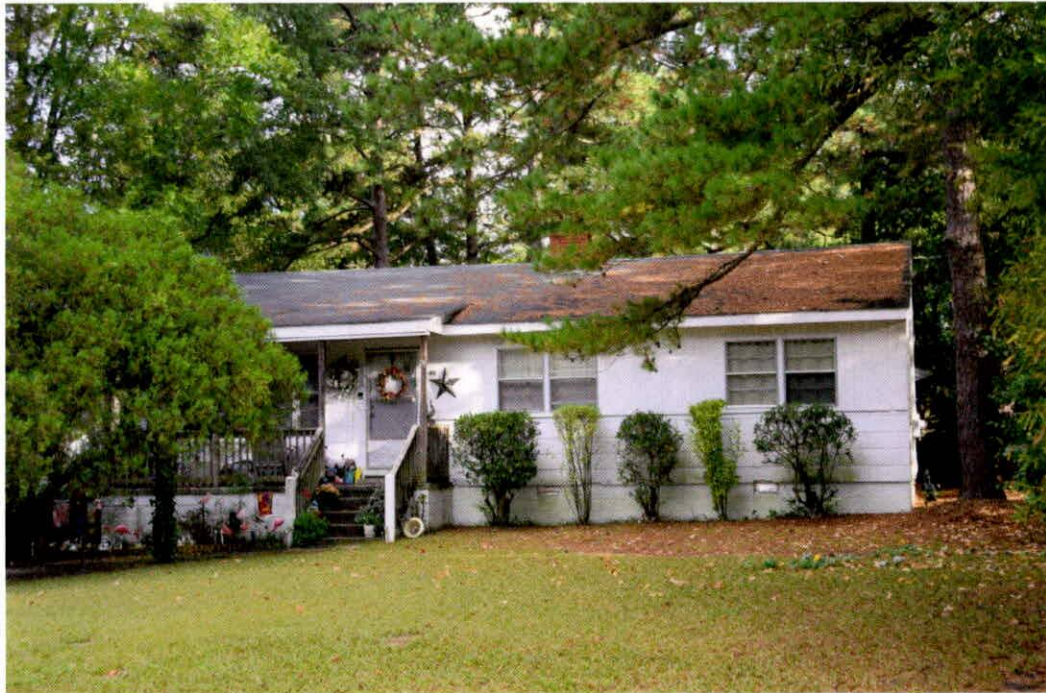
75. WA8271, House, 214 Adams Street, 0764339078, 1955

Side-gabled Ranch house with aluminum and plywood siding; 2/2 horizontal sash, including picture window with 2/2 horizontal sidelights at living room, as well as in pairs at façade and singly at side elevations; shed porch across portion of façade with replacement posts and railing. This is a less heavily altered version of the Ranch that stands to the west at 8615 Chapel Hill Road (WA8272).

The house retains integrity of location and setting, but the integrity of design, materials, and workmanship has been reduced by the replacement porch elements and the addition of aluminum siding at walls and window trim. The integrity of feeling and association is also diminished. The house is not in an area that appears eligible for the NRHP as a district.

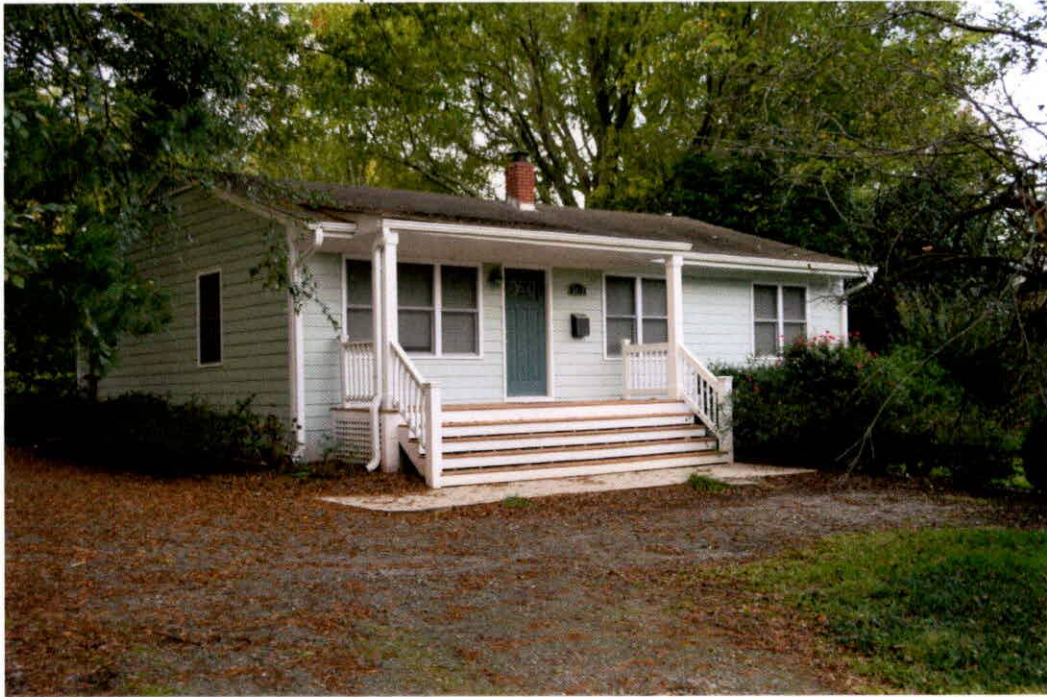
76. WA8272, House, 8615 Chapel Hill Road, 0764338191, 1955

Side-gabled Ranch house with cement-fiber lap siding; replacement 1/1 sash; shed porch across portion of façade with replacement posts, railing, and steps; replacement front door. This is a more heavily altered version of the Ranch that stands to the east at 214 Adams Street (WA8271).

The house retains integrity of location and setting but replacement materials and features has eliminated integrity of design, materials, workmanship, feeling, and association. The house is not in an area that appears eligible for the NRHP as a district.

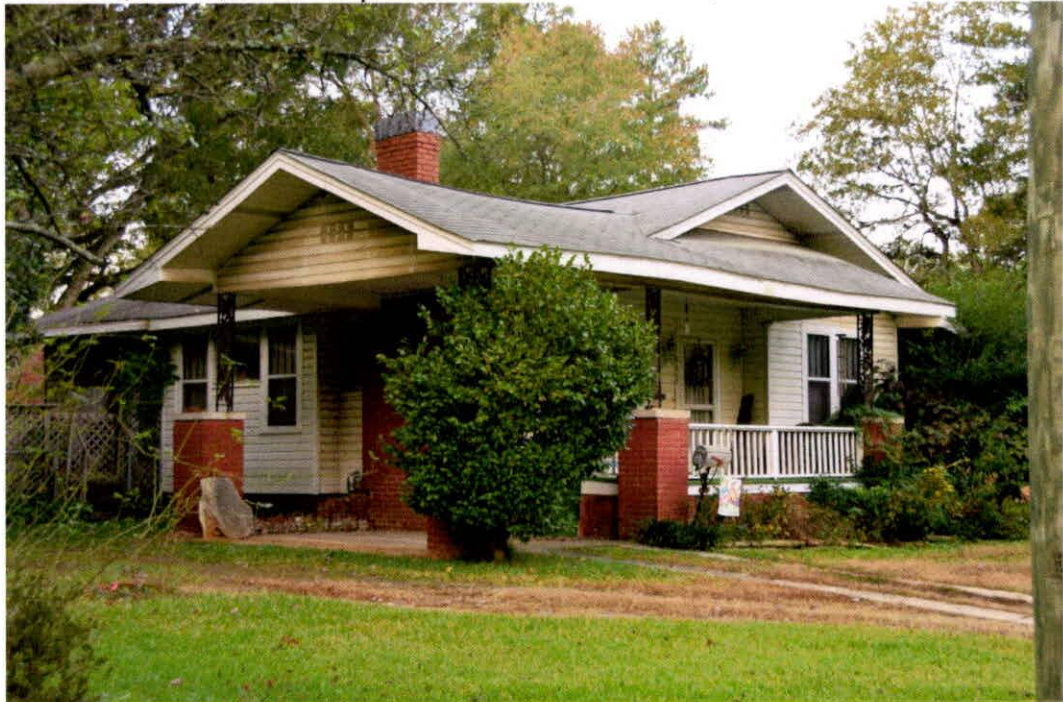
77. WA8273, House, 8617 Chapel Hill Road, 0764338103, 1955

Single-story front-gabled bungalow with side-gabled porch that extends to the east to form a porte-cochere; iron scrollwork posts on brick piers; 4/1 sash; French door; aluminum siding. This appears to be a very late example of a bungalow with Craftsman features. The mix of 4/1 sash and the possibly original iron posts on brick piers is unusual and possibly indicative of the use of an outdated style at midcentury.

The house retains integrity of location and setting but the integrity of materials and workmanship has been reduced by the application of aluminum siding. The integrity of design is more intact, although, if not original, the installation of metal porch posts reduces integrity of design. The integrity of feeling and association is also reduced by changes to the dwelling. The house is not in an area that appears eligible for the NRHP as a district.

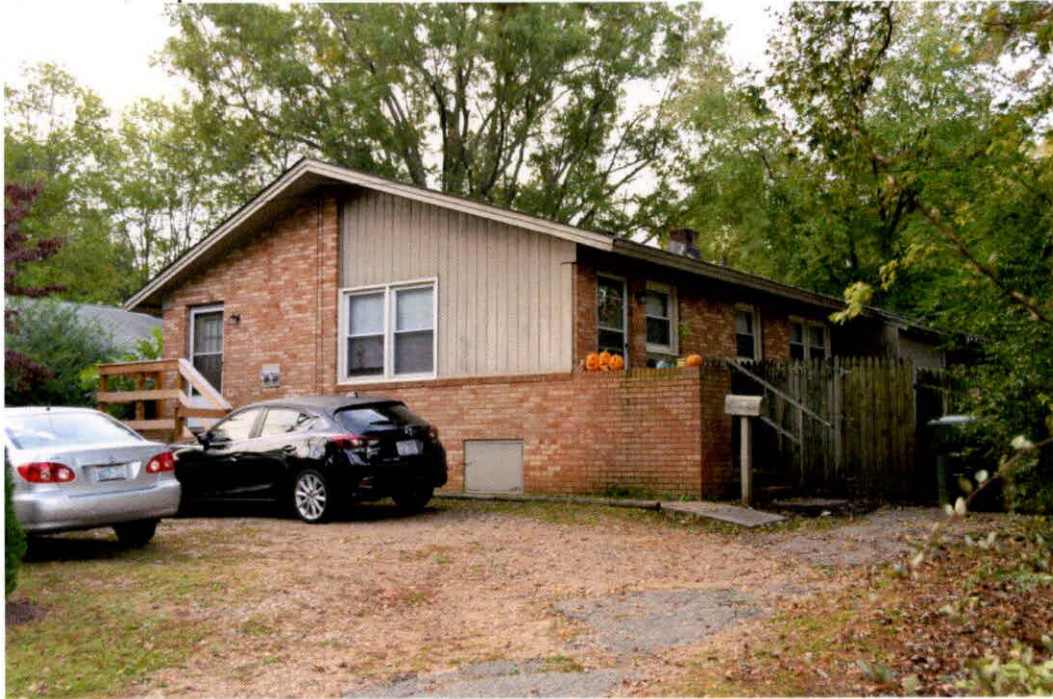
78. WA8274, Duplex, 224 Adams Street, 0764337135, 1961

Single-story gabled duplex with brick exterior accented with sections of vertical plywood siding, replacement 1/1 aluminum sash set singly and in pairs, deep eaves.

The house retains integrity of location and setting but the integrity of materials, workmanship, and design are compromised by the window replacement, diminishing as well the integrity of feeling and association. The house is not in an area that appears eligible for the NRHP as a district.
