**North Carolina Department of Natural and Cultural Resources  
State Historic Preservation Office**

Re: Feasibility Study for Downtown Multi Modal Transit Center, Cary, Wake County, ER 19-0950

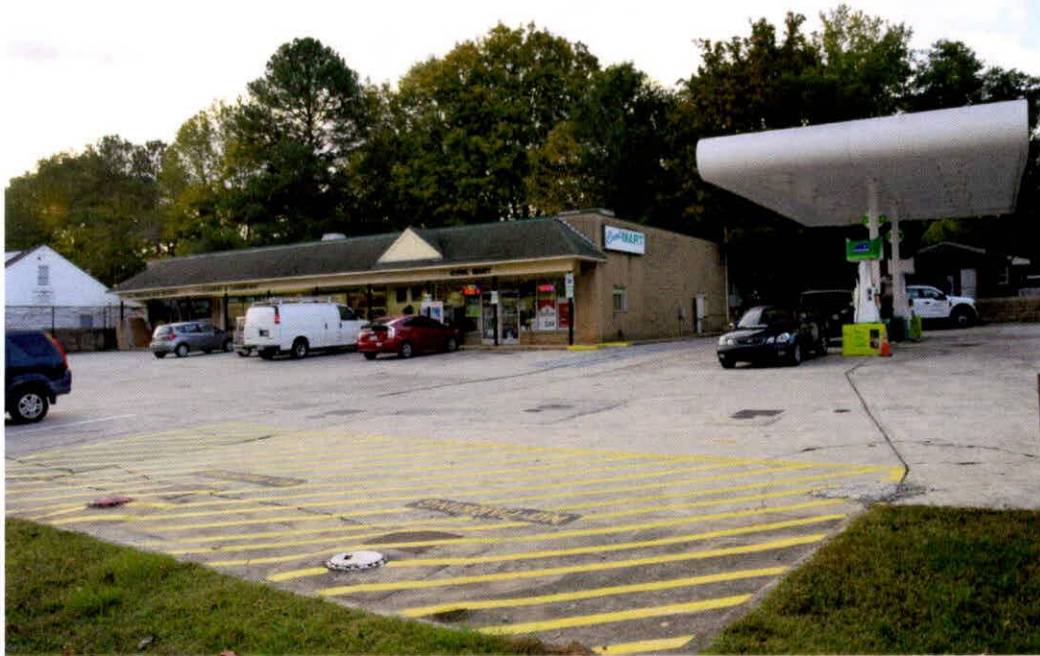
79. WA8275, Commercial Strip, 8559 Chapel Hill Boulevard, 0764434003, 1972

Single-story, flat-roofed, concrete-block commercial strip with three retail spaces behind extruded aluminum storefronts with some brown brick veneer; concrete at side walls has Brutalist-inspired vertical “corduroy” finish. A hipped roof has been added to what was likely a flat canopy on metal columns sheltering the sidewalk in front of the building. A parking lot is in front of the building and twenty-first-century-era gas pumps under a twenty-first-century-era canopy are to the west.

The building has integrity of location but integrity of setting is likely compromised by the new gas pumps. The integrity of design has been compromised by the installation of the hipped roof. Integrity of materials and workmanship is somewhat intact, but alterations and the newer gas pumps and canopy reduce the integrity of feeling and association. The commercial strip is not in an area that appears eligible for the NRHP as a district.

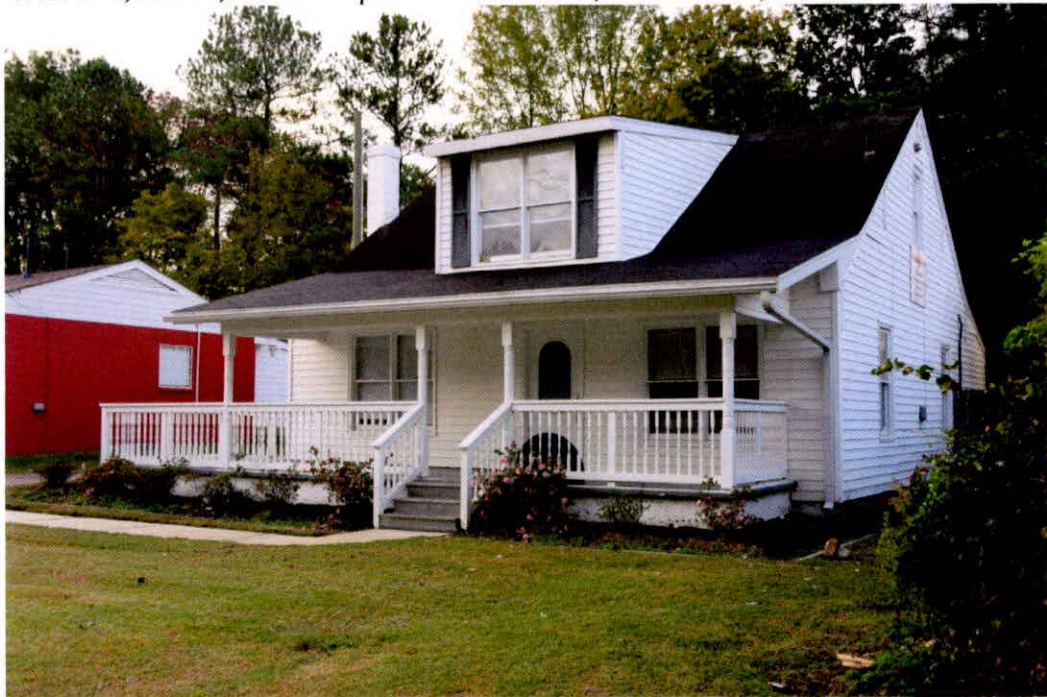
80. WA8276, House, 8551 Chapel Hill Boulevard, 076435013, 1940

One-and-a-half-story house with replacement vinyl windows, replacement door, vinyl siding, shed-roofed front porch on replacement turned posts with turned balustrade, shed dormer at front roof slope.

The house has integrity of location, but integrity of setting may be compromised, judging by the mix of domestic and commercial architecture in this area. The dwelling itself has lost integrity of materials, design, and workmanship with the extensive alterations to the dwelling. The integrity of feeling and association has also been diminished. The house is not in an area that appears eligible for the NRHP as a district.

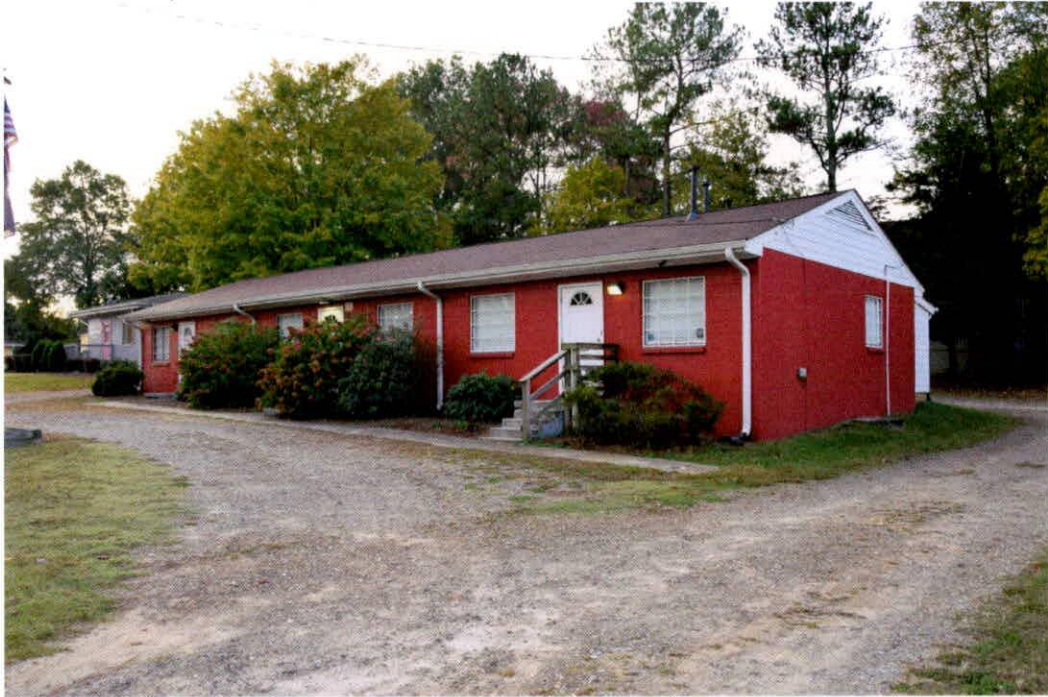
81. WA8277, American Legion Clubhouse, 8523 Chapel Hill Boulevard,  
0764435092, 1959

Single-story, side-gabled concrete-block building with fixed sash, replacement doors, concrete stoops with added wood railings.

The building has integrity of location and possibly setting, however the alterations to the very simple building has diminished its integrity of design, materials, and workmanship. Additionally, integrity of feeling and association is reduced. The building is not in an area that appears eligible for the NRHP as a district.

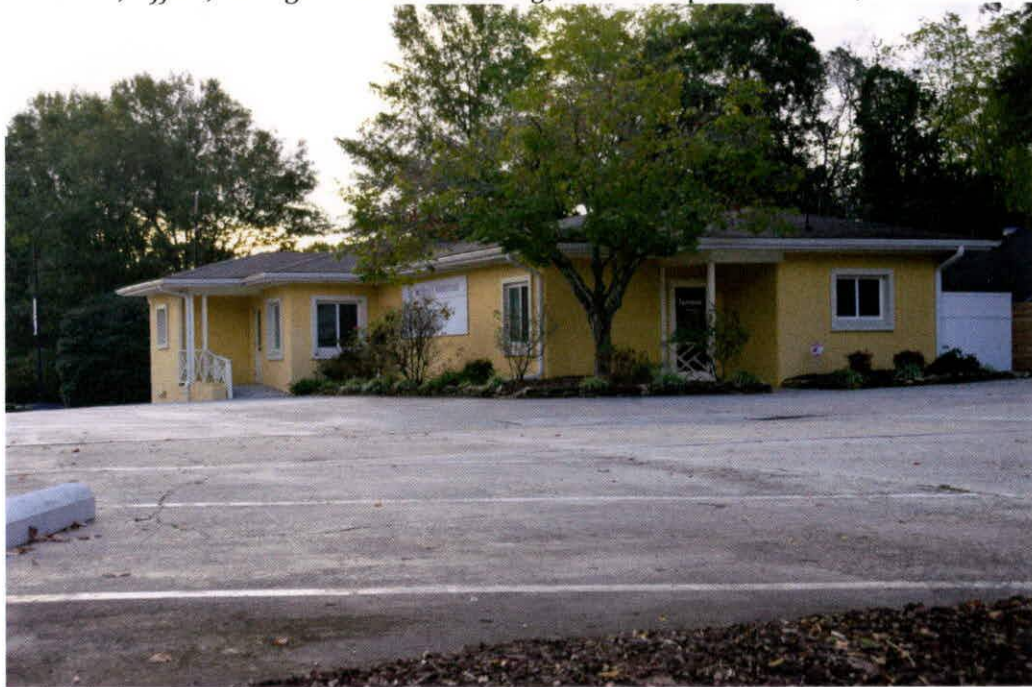
82. WA8278, Office, Garage & Retail Building, 8513 Chapel Hill Road, 0764437051.

82a. Office, 1960, 2016. Single-story, hip-roofed dwelling with deep boxed eaves, stucco exterior, replacement slider sash, replacement single-light glazed doors, Chippendale railings at stoops.

The buildings in this complex appear to have integrity of location, but integrity of setting is likely altered. The two buildings may have originally been dwellings and are now used for office/retail purposes, so the areas in front of the buildings are paved for parking. The office and retail buildings integrity of design, materials, and workmanship have been severely diminished by alterations to windows, doors, and exterior wall surfaces; this has also reduced integrity of feeling and association. The buildings are not in an area that appears eligible for the NRHP as a district.

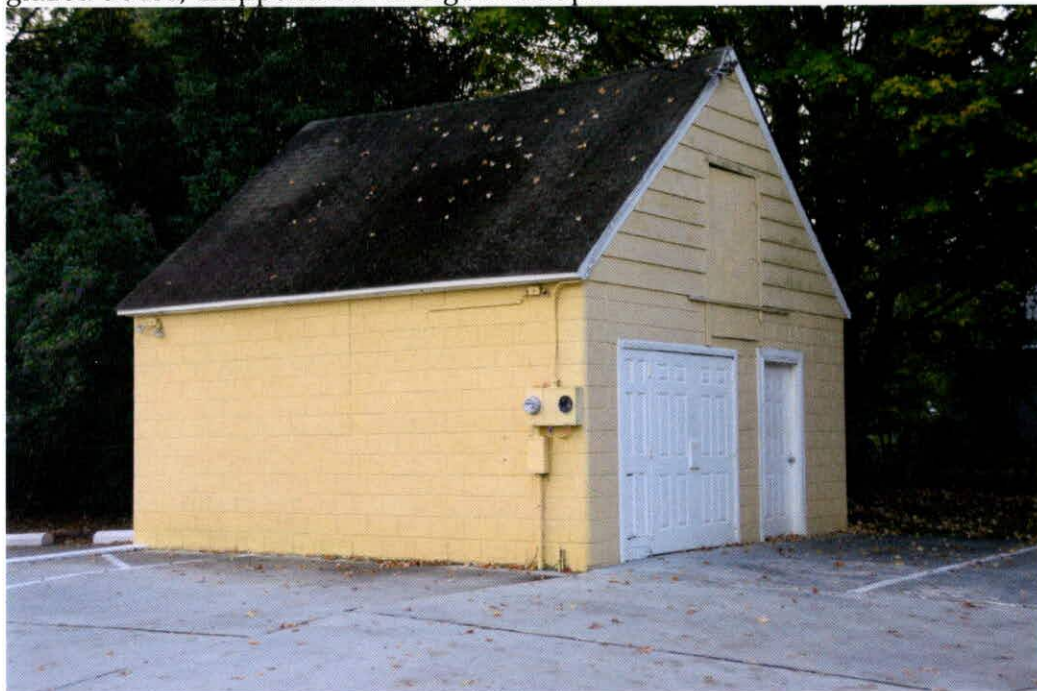
82b. Garage, 1960. Concrete-block front-gabled garage with fiber-cement siding in gable end, overhead lifting door and personnel door at façade, which faces west.

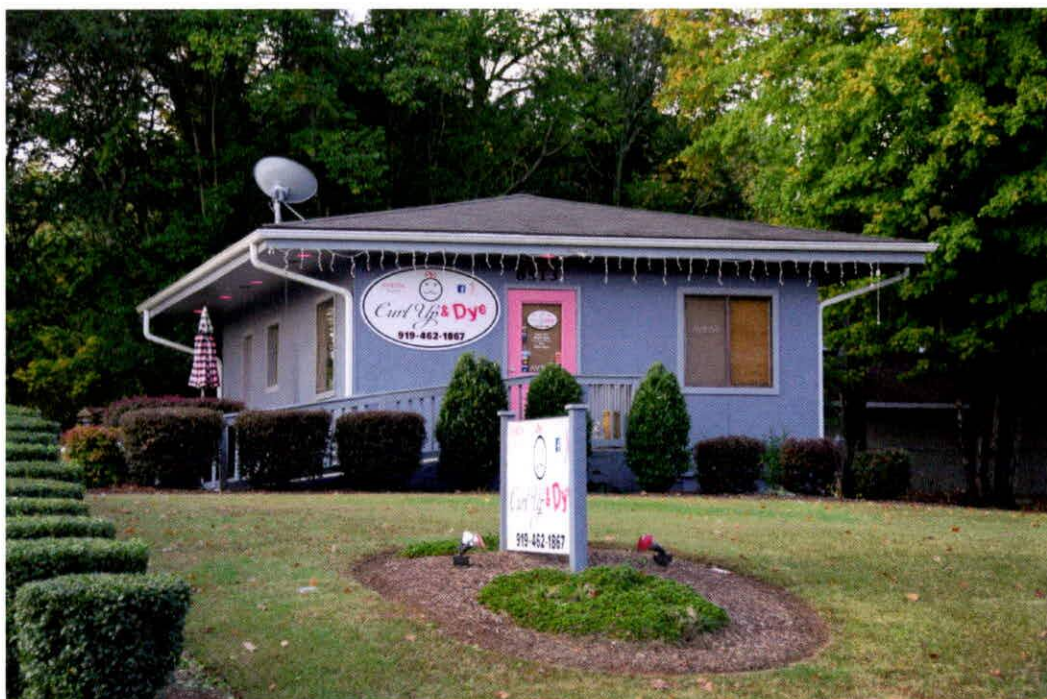
82c. Retail Building, 1982. Single-story hip-roofed building with replacement slider sash, single-light glazed wood door, ramp with wood rail and balustrade to front door, stucco exterior, deep boxed eaves.

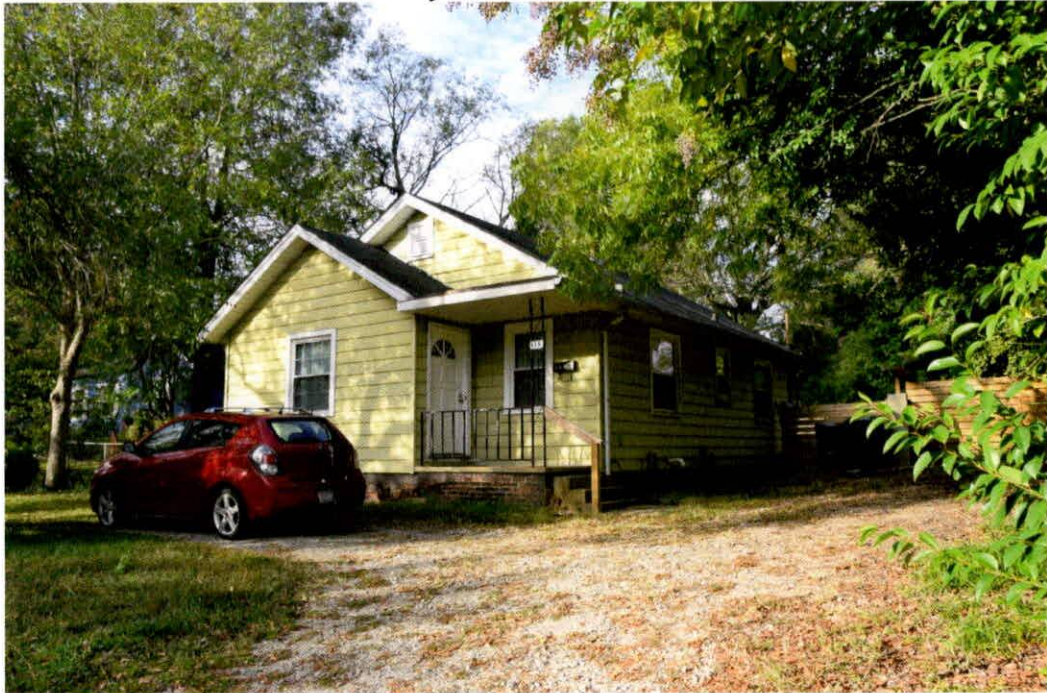
83. WA8279, House, 419 N. Academy Street, 0764428932, 1955

Front-gabled single-story dwelling with offset, smaller gabled bay at façade; flat-roofed entry porch on metal column with scrollwork, metal balustrade, and concrete floor in front ell; replacement 1/1 sash with press-in grids; replacement front door; vinyl siding.

The house retains integrity of location and setting, but changes to the materials and features has reduces integrity of materials, design, and workmanship, in turn reducing the integrity of feeling and association. The house is not in an area that appears eligible for the NRHP as a district.

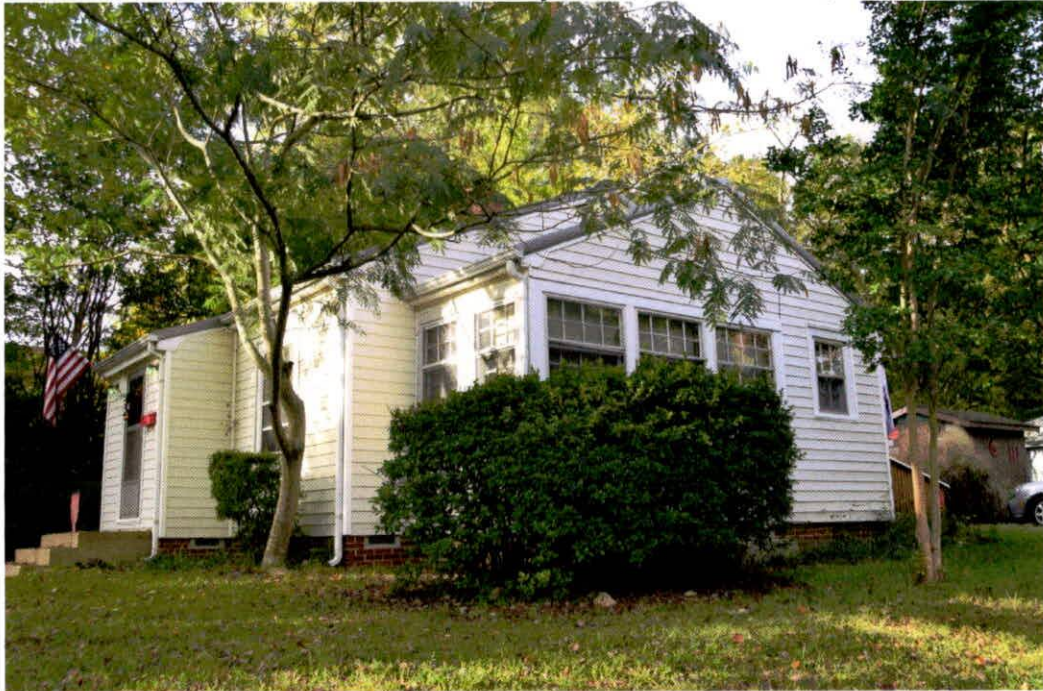
84. WA8280, House and shed, 411 N. Academy Street, 0764428702, 1949

84a. House, 1949. Side-gabled, single-story house with smaller side gable, vinyl siding, 6/6 and 8/8 sash in pairs and singly, shed-roofed entrance bay at the center of the façade.

The house retains integrity of location and setting, but the integrity of design, materials, and workmanship are reduced by the addition of vinyl siding.

Integrity of feeling and association are also adversely affected. The house is not in an area that appears eligible for the NRHP as a district.

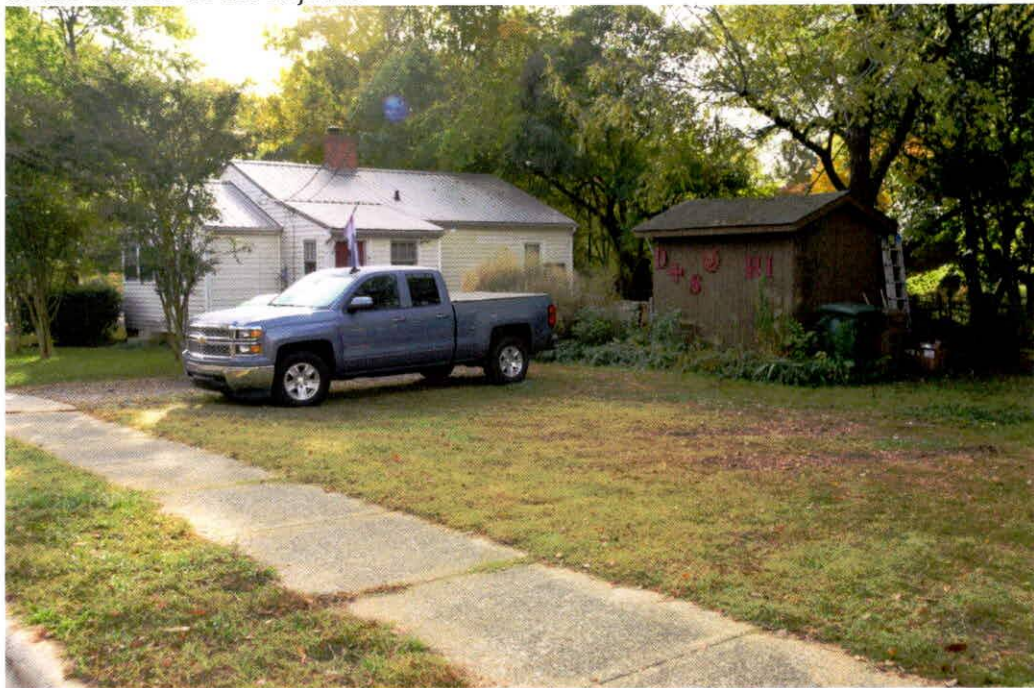
84b. Shed, 1990. Gabled shed with vertical plywood siding.

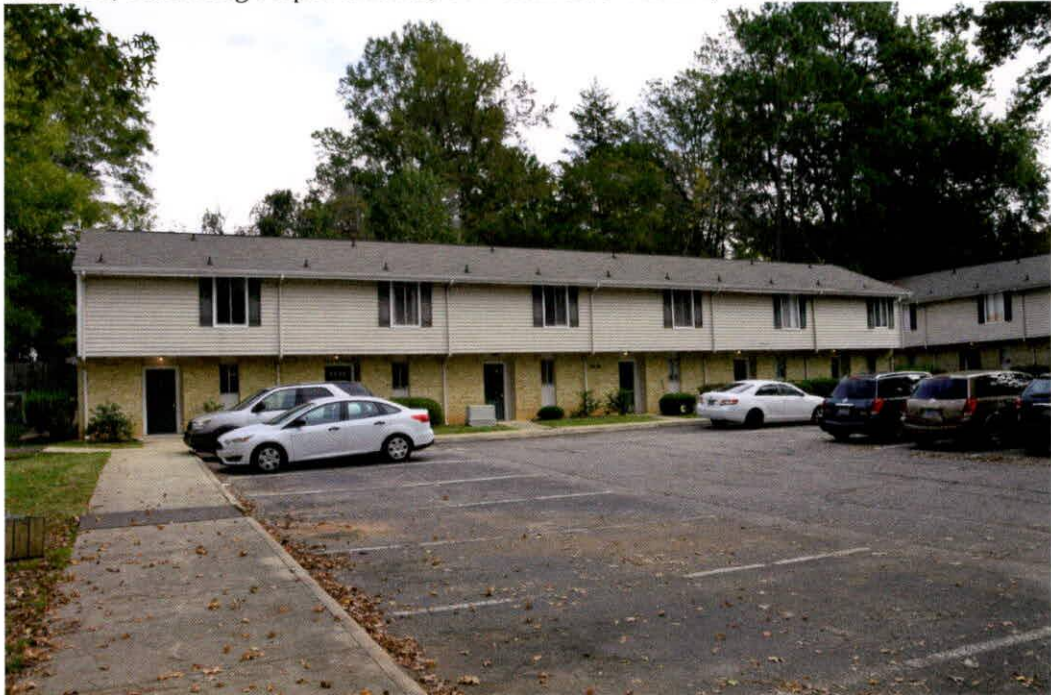
85. *WA8281, Pine Ridge Apartments, 409 Galveston Court, 0764323860, 1973*

Complex of eleven apartment buildings arranged around two courtyards. Two-story, side-gabled buildings with blonde brick at first stories, vinyl siding at slightly overhanging second story; vertical aluminum paired windows; overhanging eaves.

The buildings retain integrity of location and setting. The alterations reduce integrity of design, materials, workmanship, feeling and association. The house is not in an area that appears eligible for the NRHP as a district.

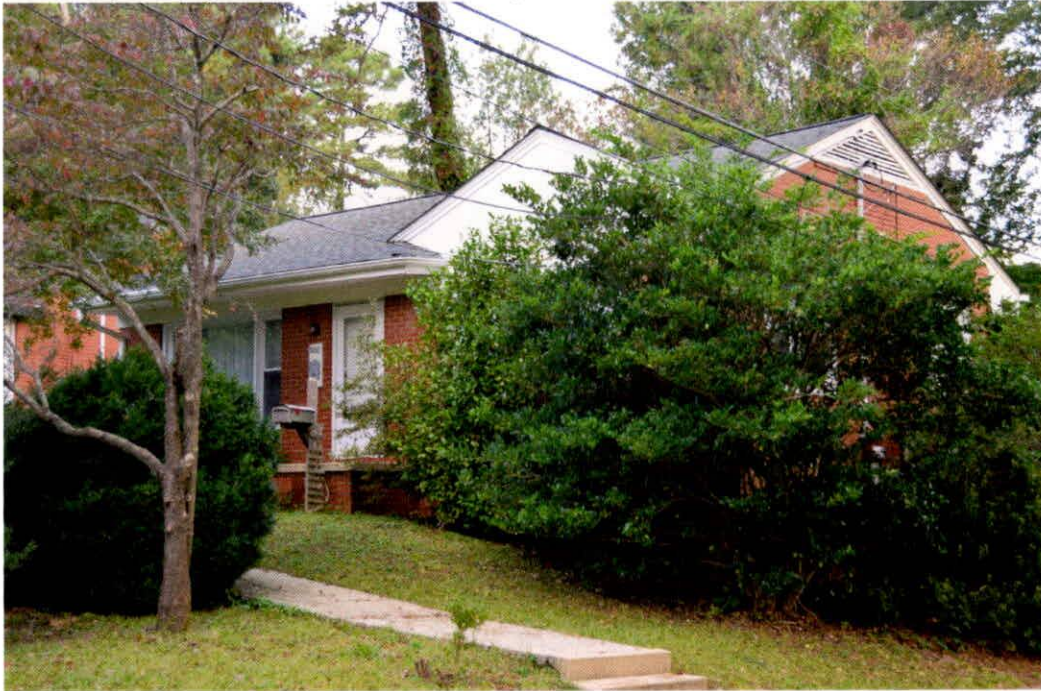
86. WA8282, House, 300 Middleton Avenue, 0764330043, 1956

Side-gabled, single-story dwelling with brick exterior, replacement 1/1 vinyl sash, gabled bay at façade, open stoop with concrete floor.

The building retains integrity of location and setting. The window replacement has reduced the integrity of design, materials, and workmanship on such a simple dwelling, which also reduces integrity of feeling and association. The house is not in an area that appears eligible for the NRHP as a district.

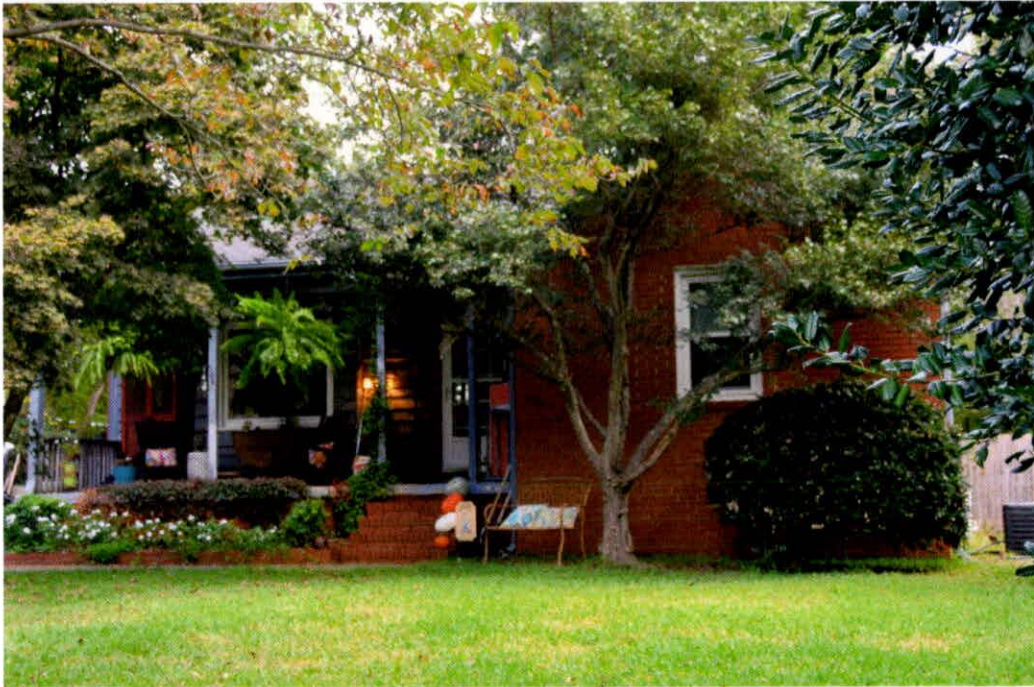
87. WA8283, House, 302 Middleton Avenue, 0764330005, 1956

Single-story gable-front-and-wing dwelling with brick exterior, 1/1 replacement vinyl windows, rustic lap siding at façade under shed-roofed porch in the front ell.

The house retains integrity of location and setting. The window replacement has reduced the integrity of design, materials, and workmanship on such a simple dwelling, which also reduces integrity of feeling and association. The house is not in an area that appears eligible for the NRHP as a district.

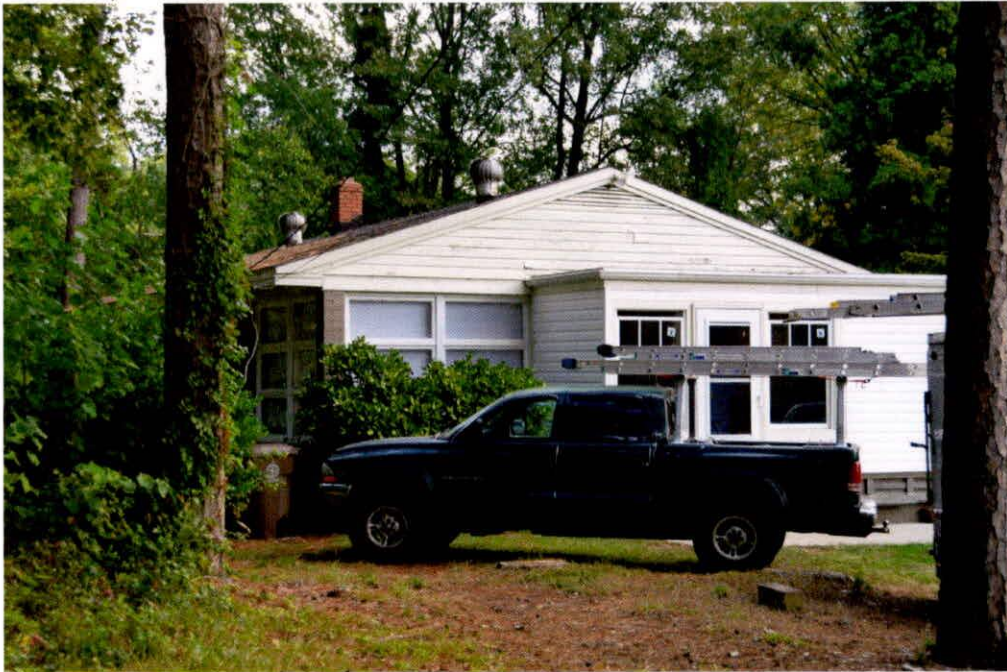
88. WA8284, House, 304 Middleton Avenue, 0764239048, 1956, 2019

Front-gabled single-story house with weatherboard siding in gable end; brick exterior; stacked awning windows; and vinyl-sided flat-roofed addition, including a garage, at one corner of the façade.

The building retains integrity of location, but the addition to the front of the house reduces the integrity of setting, design, materials, workmanship, feeling, and association. The house is not in an area that appears eligible for the NRHP as a district.

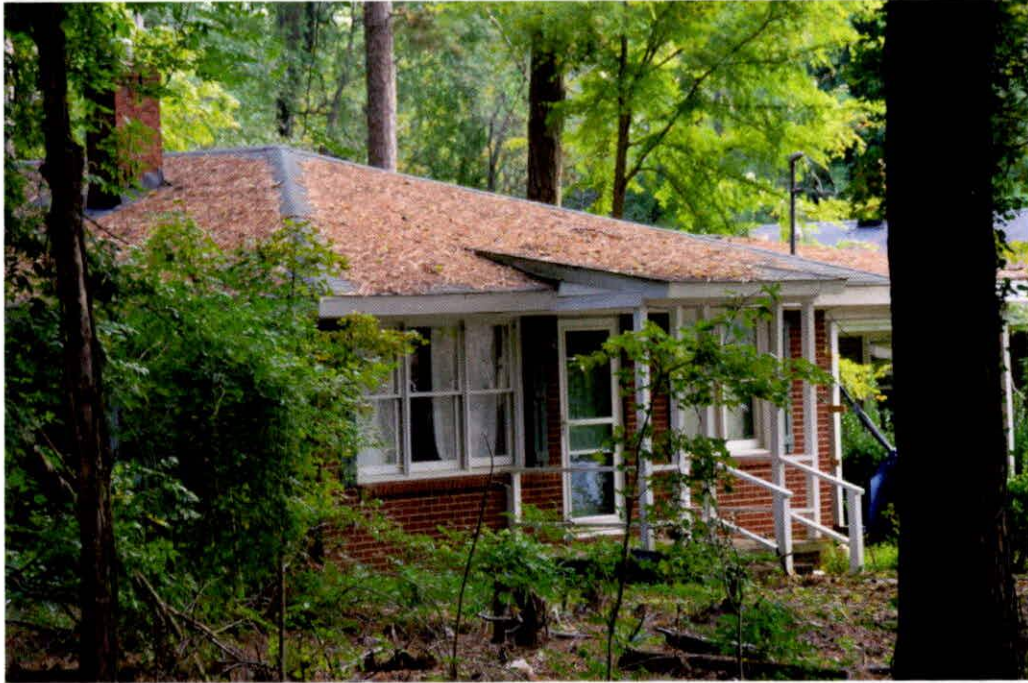
89. WA8285, House, 306 Middleton Avenue, 0764238180, 1956

Side-gabled Ranch house with brick exterior, boxed eaves, replacement 1/1 vinyl sash, faux shutters, replacement doors, and shed-roofed entry porch, integrated carport at one end of the façade, and rear addition.

The building retains integrity of location, but the change to the fenestration and the rear addition reduces the integrity of setting, design, materials, workmanship, feeling, and association in such a simple dwelling. The house is not in an area that appears eligible for the NRHP as a district.

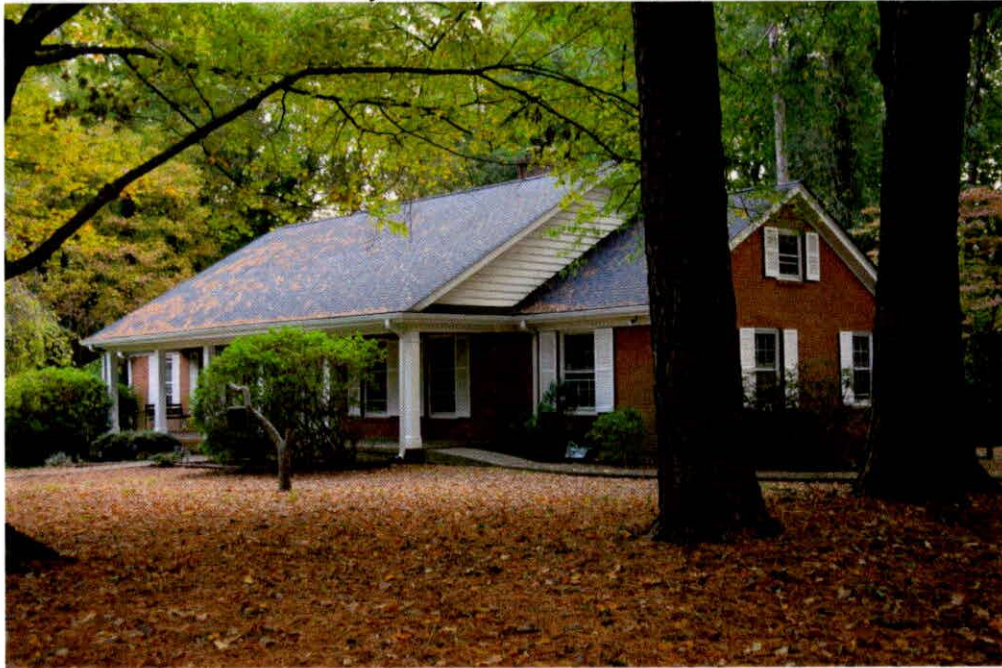
90. WA8286, House, 402 Hickory Street, 0764236262, 1959

One-and-a-half-story side-gabled dwelling with inset front porch, smaller side wings, 6/6 sash, louvered shutters, brick veneer, and squared porch posts.

The house appears unchanged and so appears to retain integrity of location, setting, design, materials, workmanship, feeling, and association. However, the house is not a distinctive example of its type and does not appear to have architectural significance. It has no known historic significance. The house is not in an area that appears eligible for the NRHP as a district.

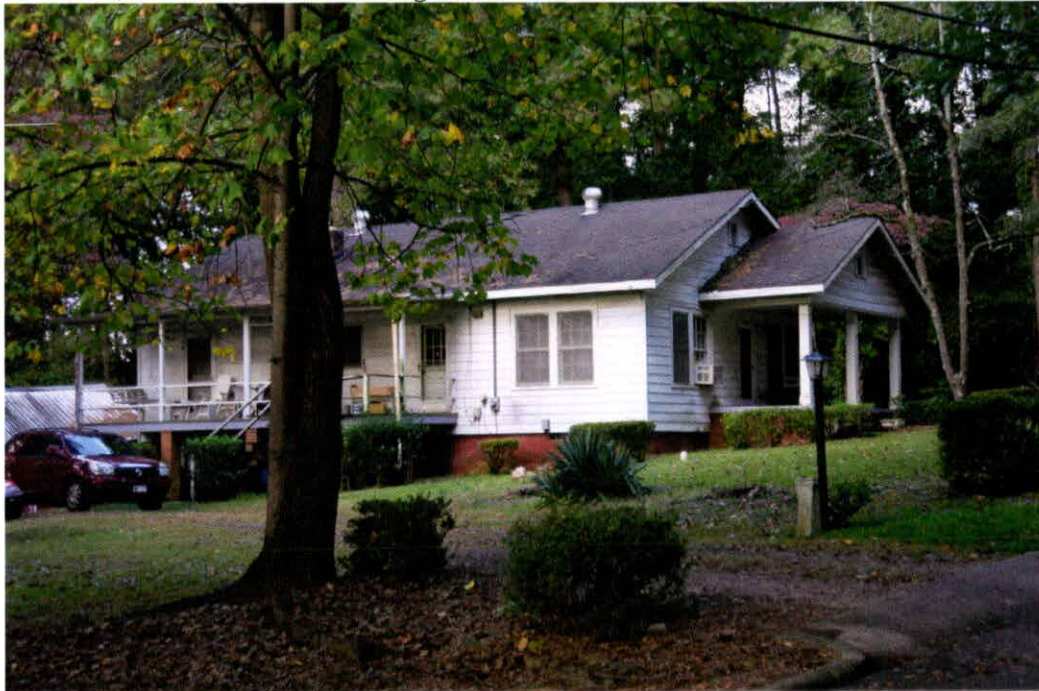
91. WA8287, House and outbuildings, 317 Middleton Avenue, 0764226968, 1929

91a. House, ca. 1929. Front-gabled bungalow on partial basement with 6/6 sash set singly and in pairs; aluminum siding; offset gabled front porch on squared posts; louvered rectangular vents in gable ends; added shed porch on brick piers at east side elevation.

The house has been altered with addition of aluminum siding, reducing integrity of materials and workmanship. Despite the added side porch, the overall form of the house is intact, as are original windows, so there is some remaining integrity of materials, workmanship, and design. The integrity of design, materials, and workmanship of the outbuildings remains intact. The integrity of location and immediate setting are intact, particularly due to the extant collection of outbuildings behind the house. Integrity of feeling and association are also intact. The alterations to the house affect integrity of the complex less than they affect the integrity of the house as an individual structure.

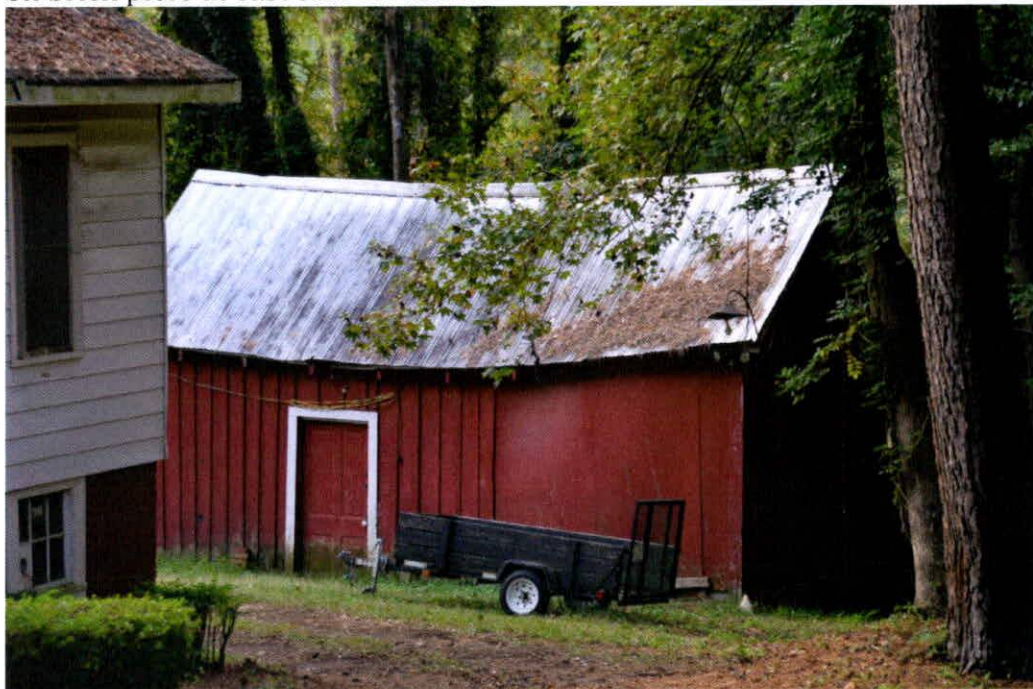
91b. Barn, ca. 1930. Large gabled barn with board-and-batten and plywood siding; standing-seam metal roofing; and single-leaf personnel door along north eave wall, board-and-batten doors on east gable end, and shed room along south eave wall. This building stands southwest of the dwelling.

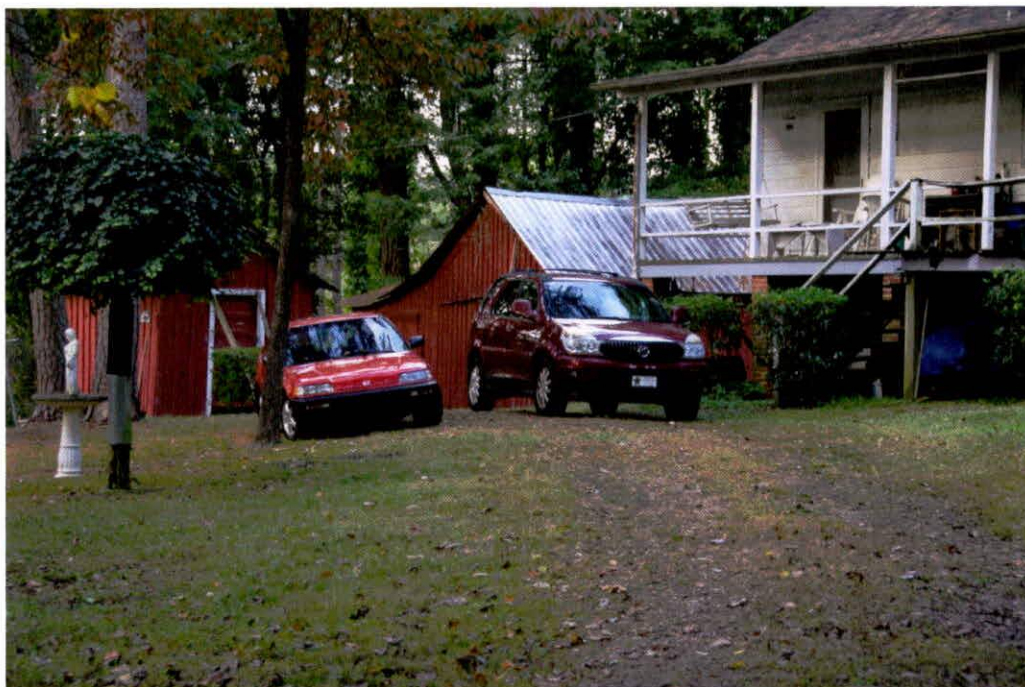
91c. Shed, ca. 1930. Front-gabled board-and-batten shed with horizontal paneled single-leaf door in the front gable end. Stands immediately east of the barn.

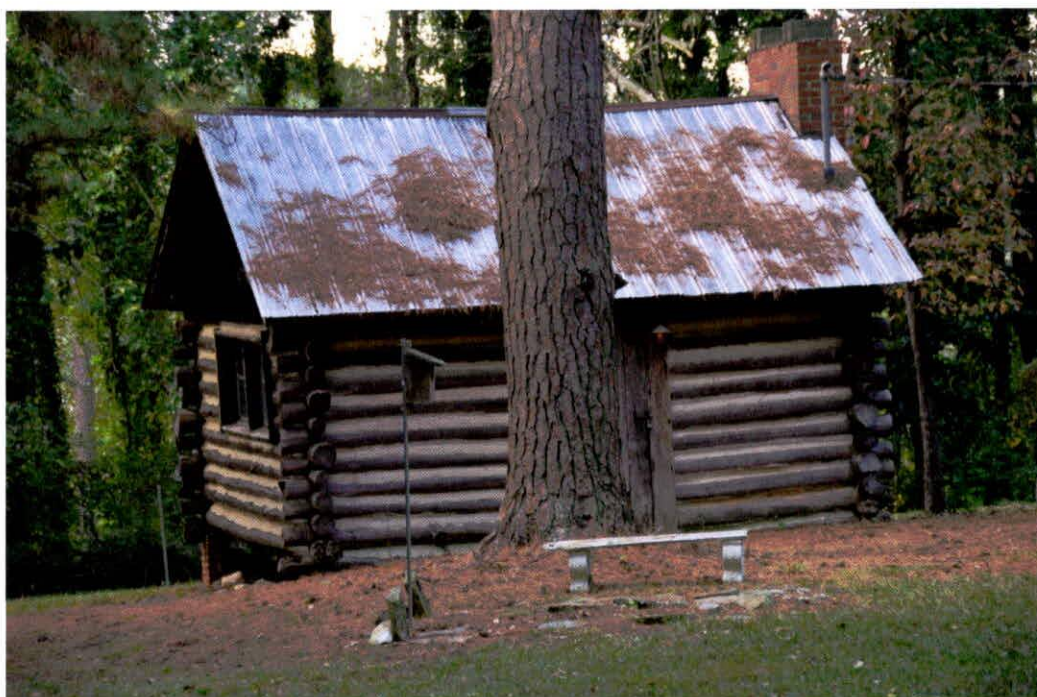
91d. Log cabin, ca. 1930. Gable-roofed, saddle-notched log cabin with double-hung sash in one gable end; brick exterior chimney at other gable end; and plank doors at eave walls. The cabin stands southeast of the dwelling and east of the other two outbuildings.

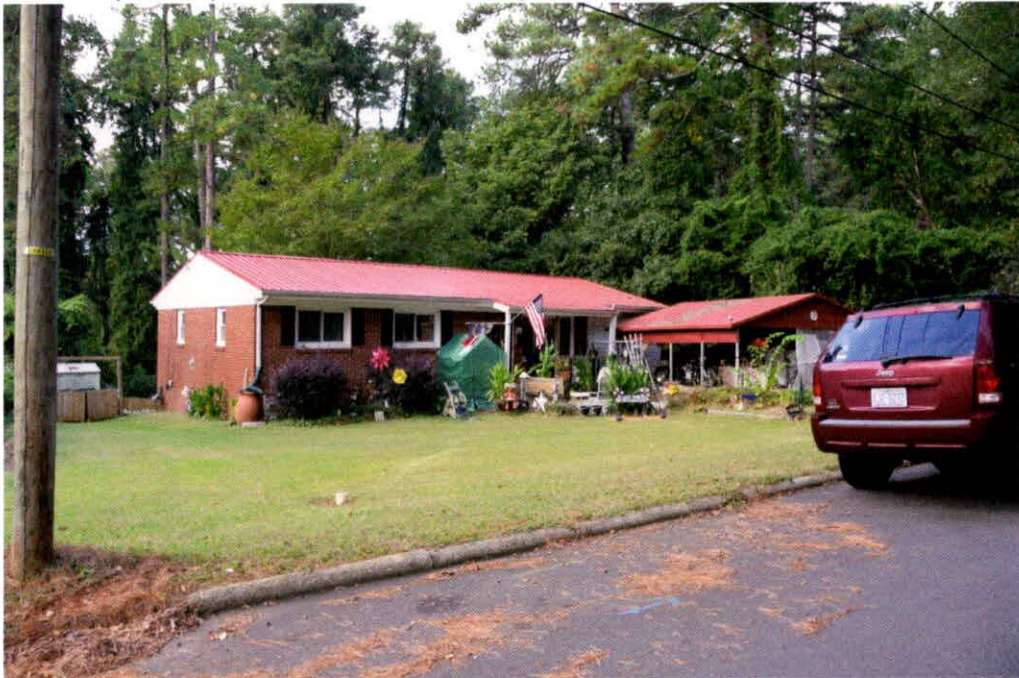
92. WA8288, House, 309 Middleton Avenue, 0764227972, 1961

92a. House, 1961. Side-gabled Ranch with brick exterior, shed-roof porch roof extension at front entry, replacement 1/1 vinyl sash, metal roofing, carport at one end of façade enclosed with vinyl siding.

92b. Carport. Ca. 2000. Freestanding prefabricated metal carport installed over the driveway.

Integrity of location and setting is intact, but the integrity of design, materials, and workmanship are reduced due to replacement windows, replacement roofing, and carport enclosure. The integrity of feeling and association are therefor also reduced. The house is not in an area that appears eligible as an NRHP historic district.

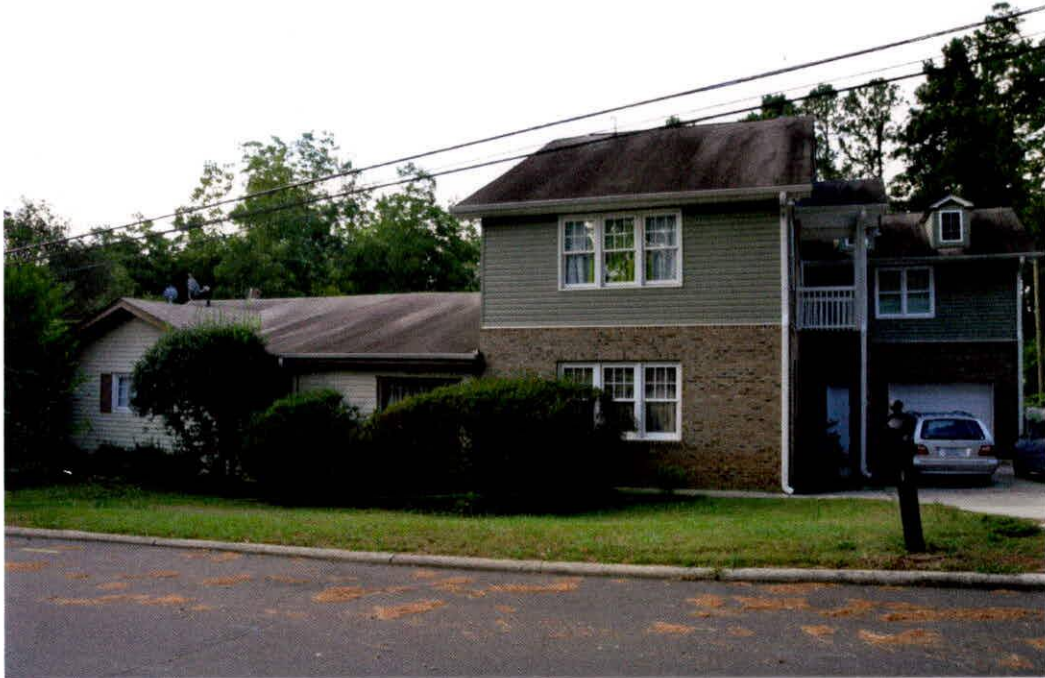
93. WA8289, House, 307 Middleton Avenue, 0764228868, 1944

Side-gabled Ranch house with front-facing gabled bay, vinyl siding, replacement sash, and large, two-story addition to one end of Ranch house.

The building retains integrity of location, but the addition to the front of the house reduces the integrity of setting, design, materials, workmanship, feeling, and association. The house is not in an area that appears eligible as an NRHP historic district.

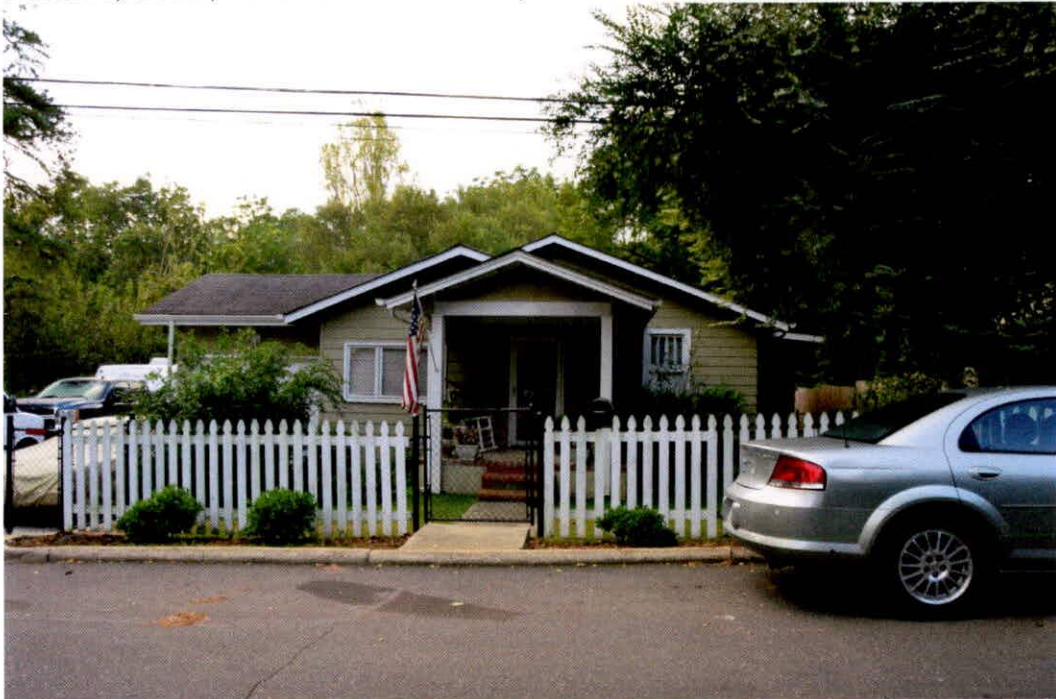
94. WA8290, House, 303 Middleton Avenue, 0764229844, 1927

Front-gabled bungalow with nested gabled porch and side additions, including a secondary front-gabled section and a garage, vinyl siding, replacement sash combined with original 4/1 sash.

While the house has integrity of location, the additions have altered the integrity of setting and design by altering the massing of the house. The replacement sash and addition of siding have reduced the integrity of design, materials, and workmanship. All of this, in turn, has eliminated the integrity of feeling and association. The house is not in an area that appears eligible as an NRHP historic district.
