SUBJECT: *Historic Structures Survey Report – Improve Four Sections on SR 1152 (Holly Springs Road) at SR 3977 (Cary Parkway), SR 1385 (Lilly Atkins Road), SR 1379 (Penny Road), and SR 1010 (Ten Ten Road), Wake County, North Carolina.*  
*TIP No. U-6217, WBS No. 48677.1.1, PA Tracking No. 24-05-0002.*  
*ER 25-0951.*

**SUBJECT:** Historic Structures Survey Report – Improve Four Sections on SR 1152  
(Holly Springs Road) at SR 3977 (Cary Parkway), SR 1385 (Lilly Atkins Road),  
SR 1379 (Penny Road), and SR 1010 (Ten Ten Road), Tip No. U-6217,  
WBS No. 48677.1.1, PA Tracking No. 24-05-0002, Wake County, ER 25-0951

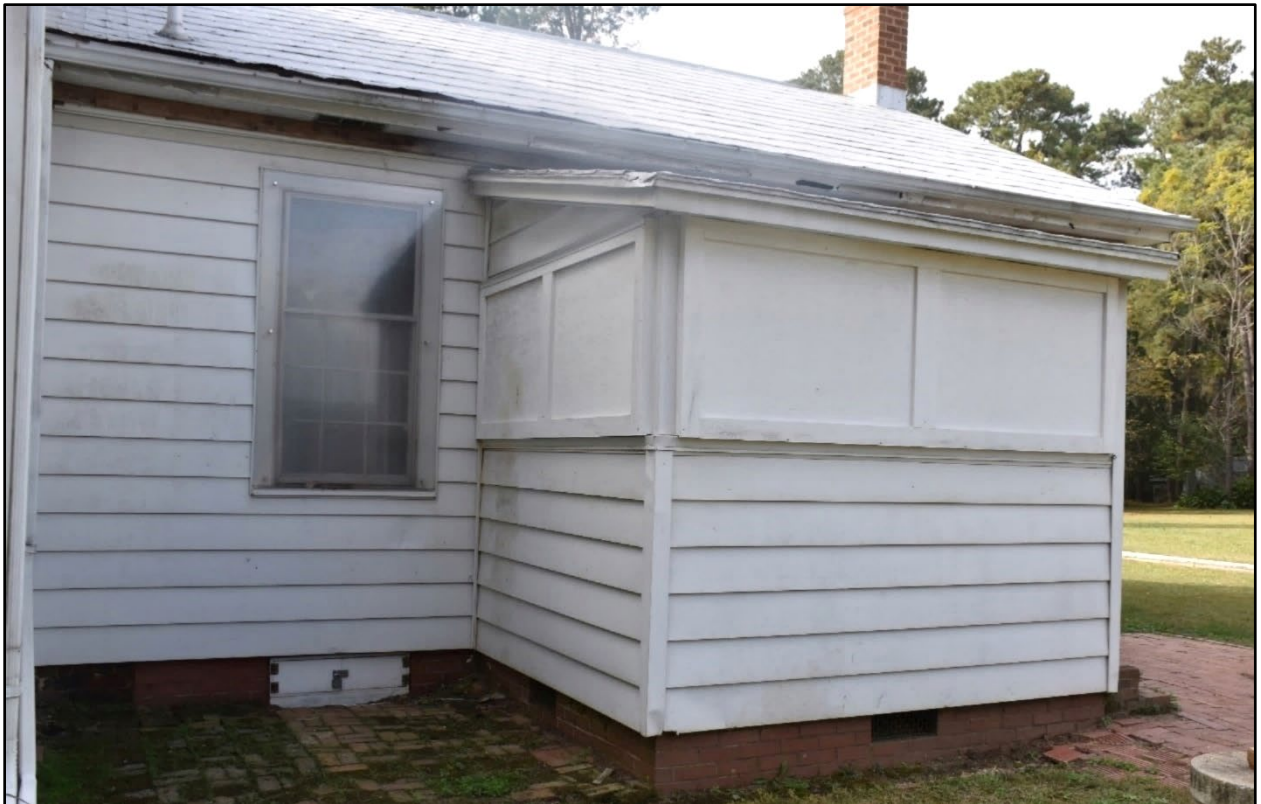
*Figure 99- Detail of the post-1961 rear addition on the east elevation.*

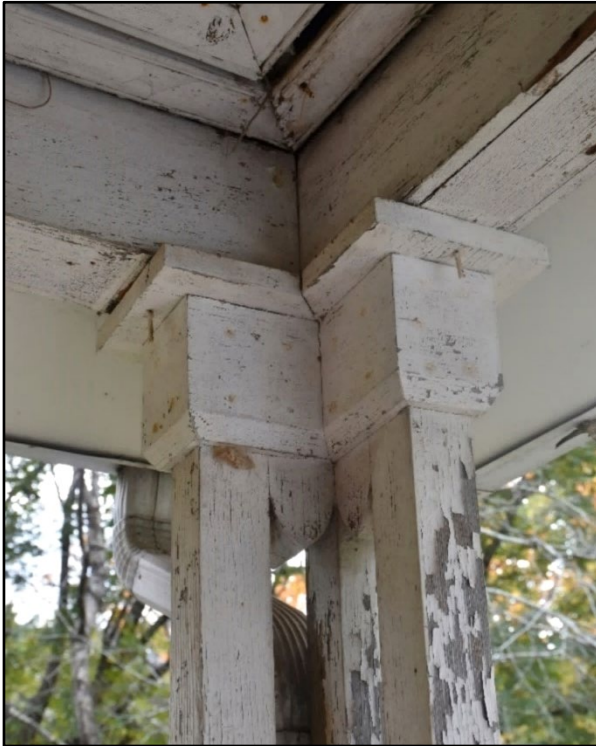
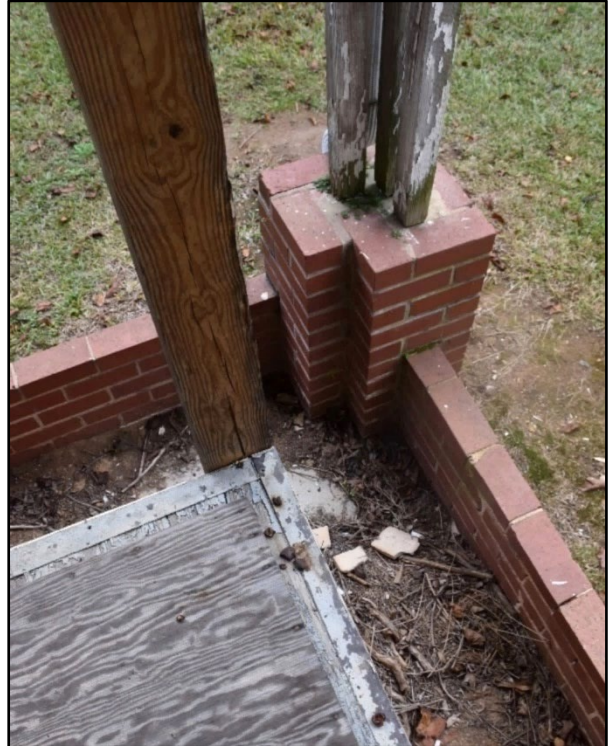
*Figure 104 (left)- Design of the wood capitals on the front porch columns.*

*Figure 105 (right)- View from porch of added brick supports and planters around the porch perimeter.*

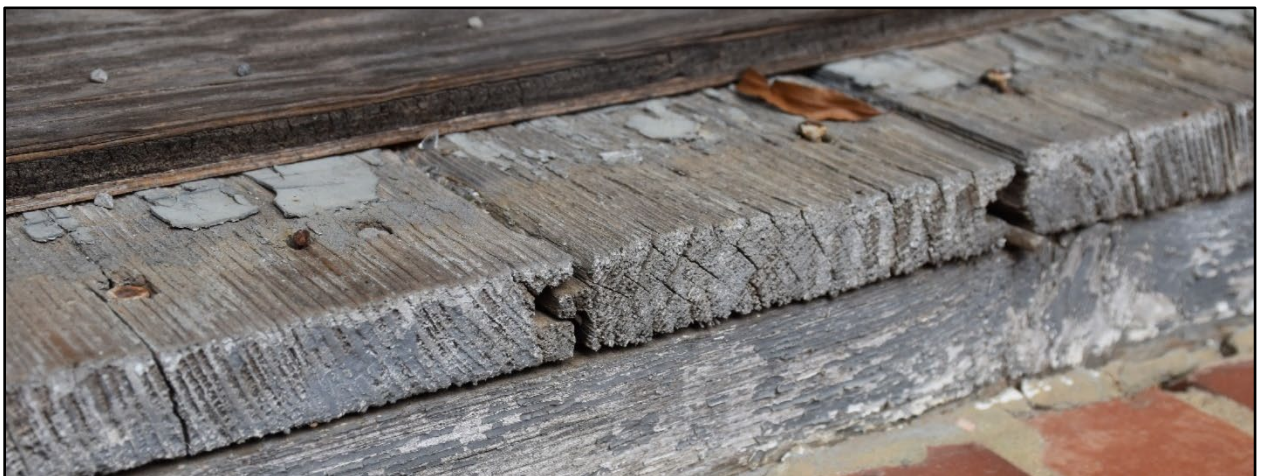
*Figure 106- Historic tongue-and-groove decking on the front porch, with modern plywood above.*

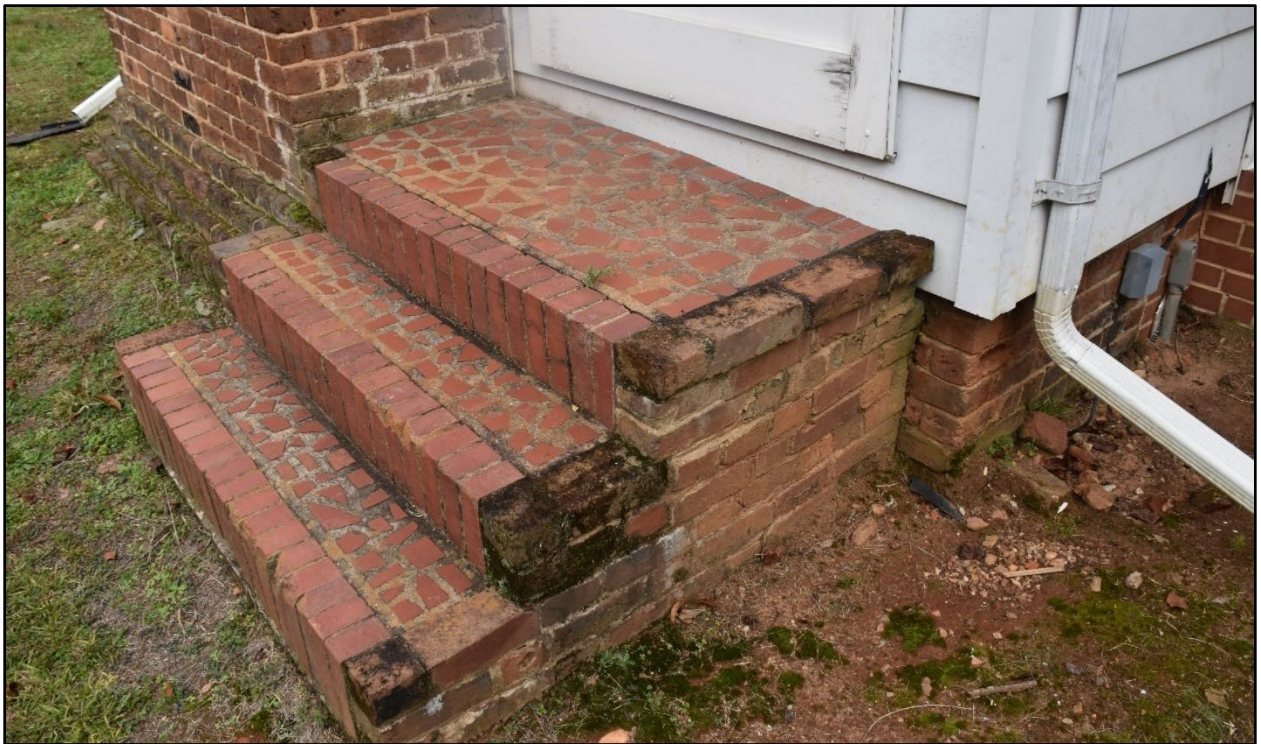
*Figure 108- Mid-to-late twentieth century addition of a tile-shard treading surface on brick side entry steps.*

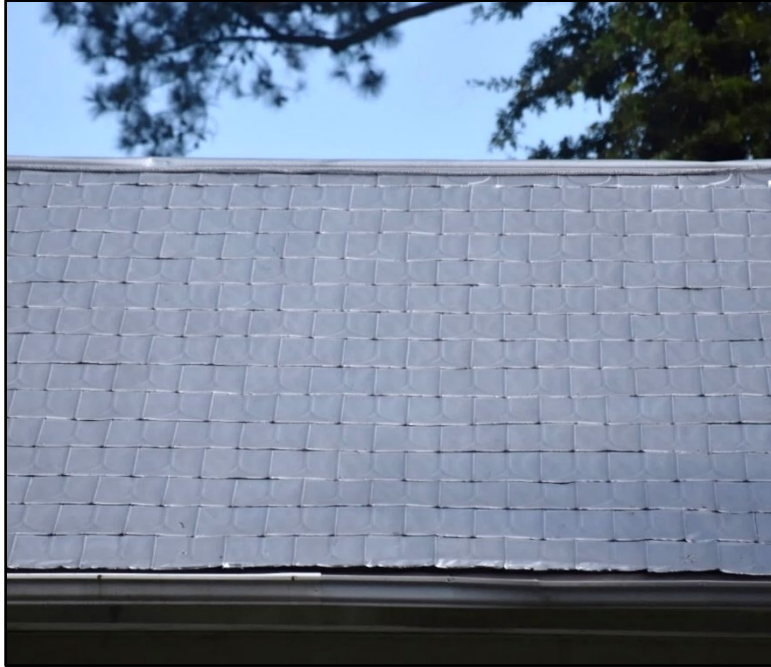
*Figure 113 (left)- Detail of the historic metal shingles on the two-story section of the farmhouse.*

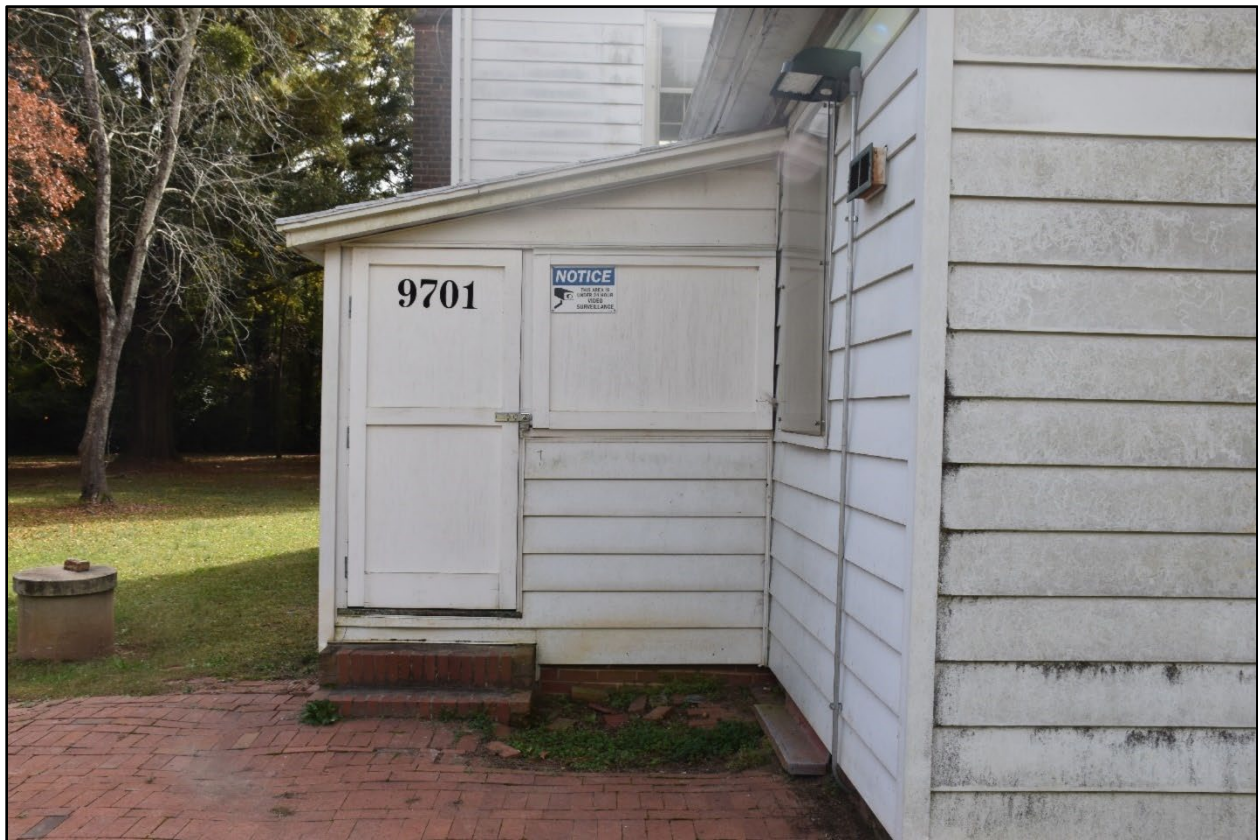
*Figure 115- Looking south at the post-1961 shed-roofed addition on the rear of the house (see Figure 126 for view from the other direction).*

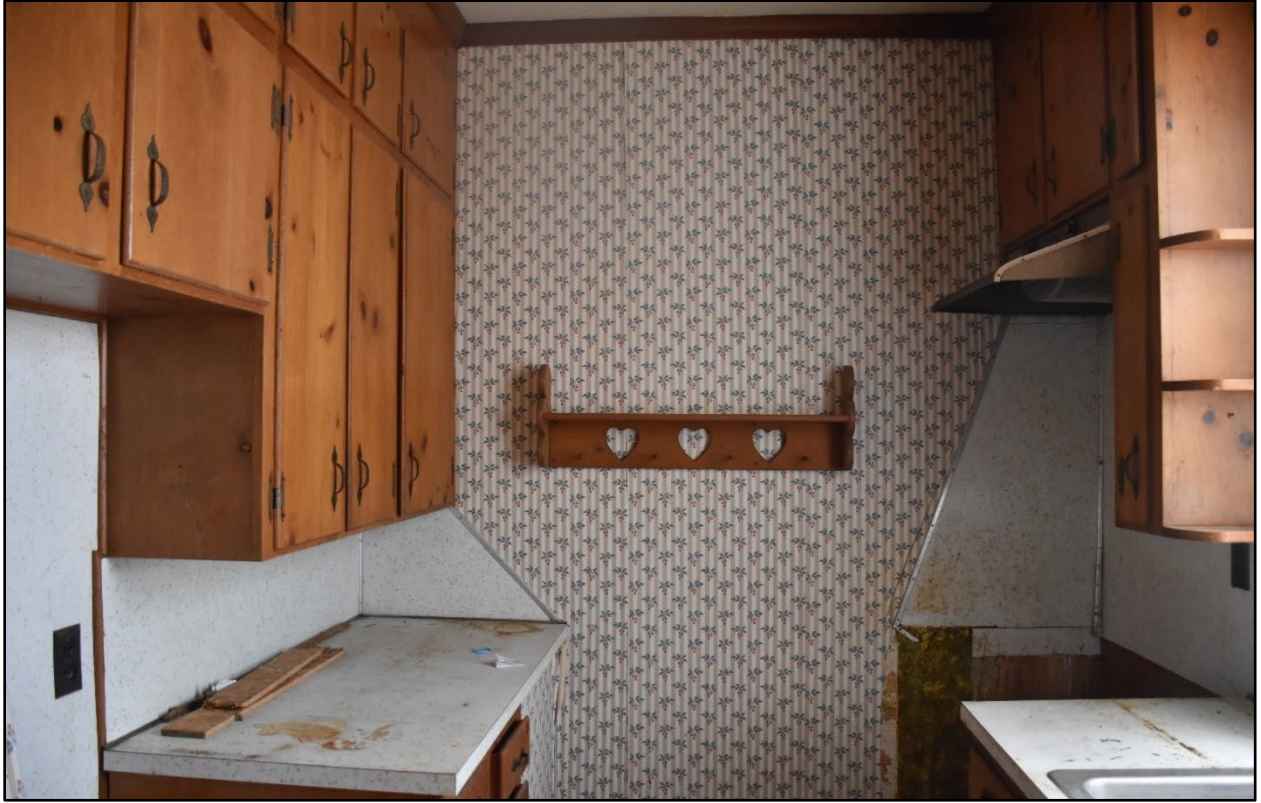
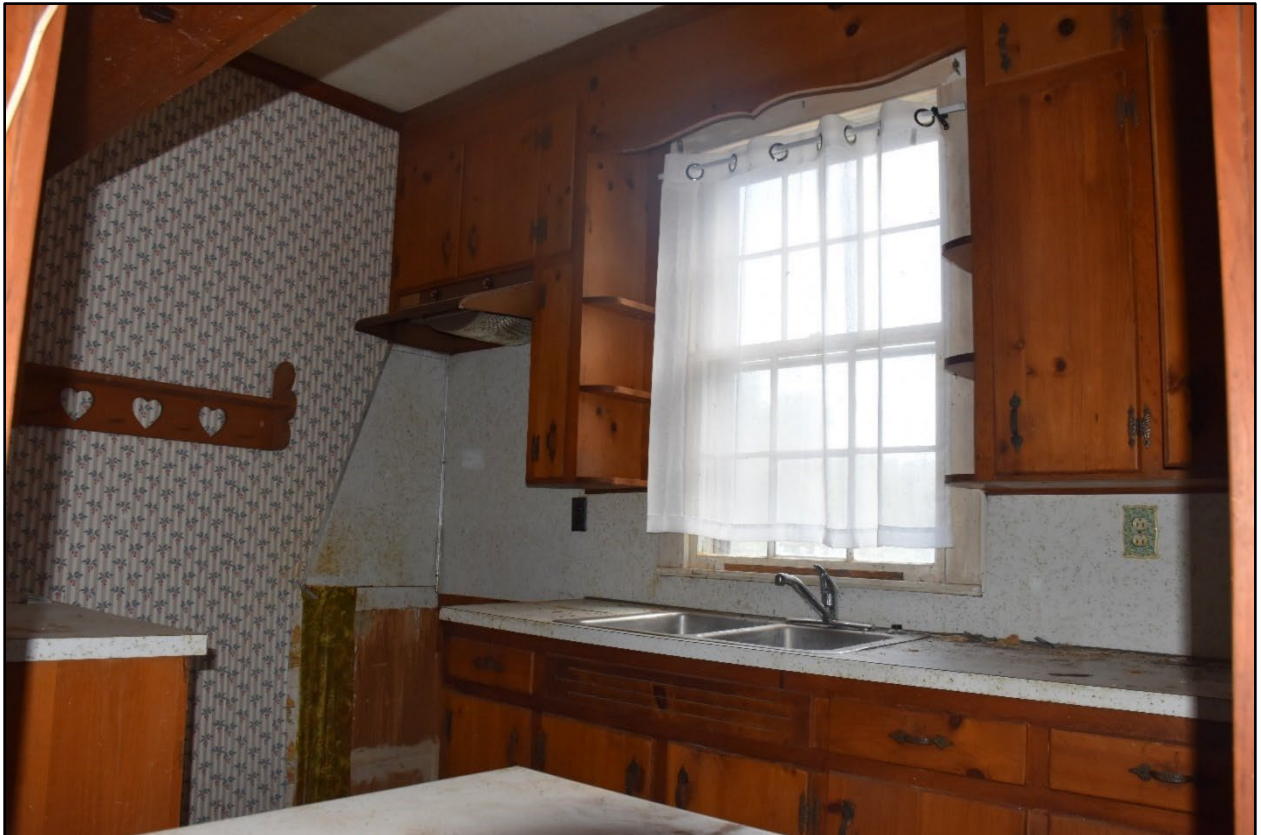
*Figures 119 and 120- The non-historic kitchen in the rear ell of the house, looking north (above) and northeast (below).*

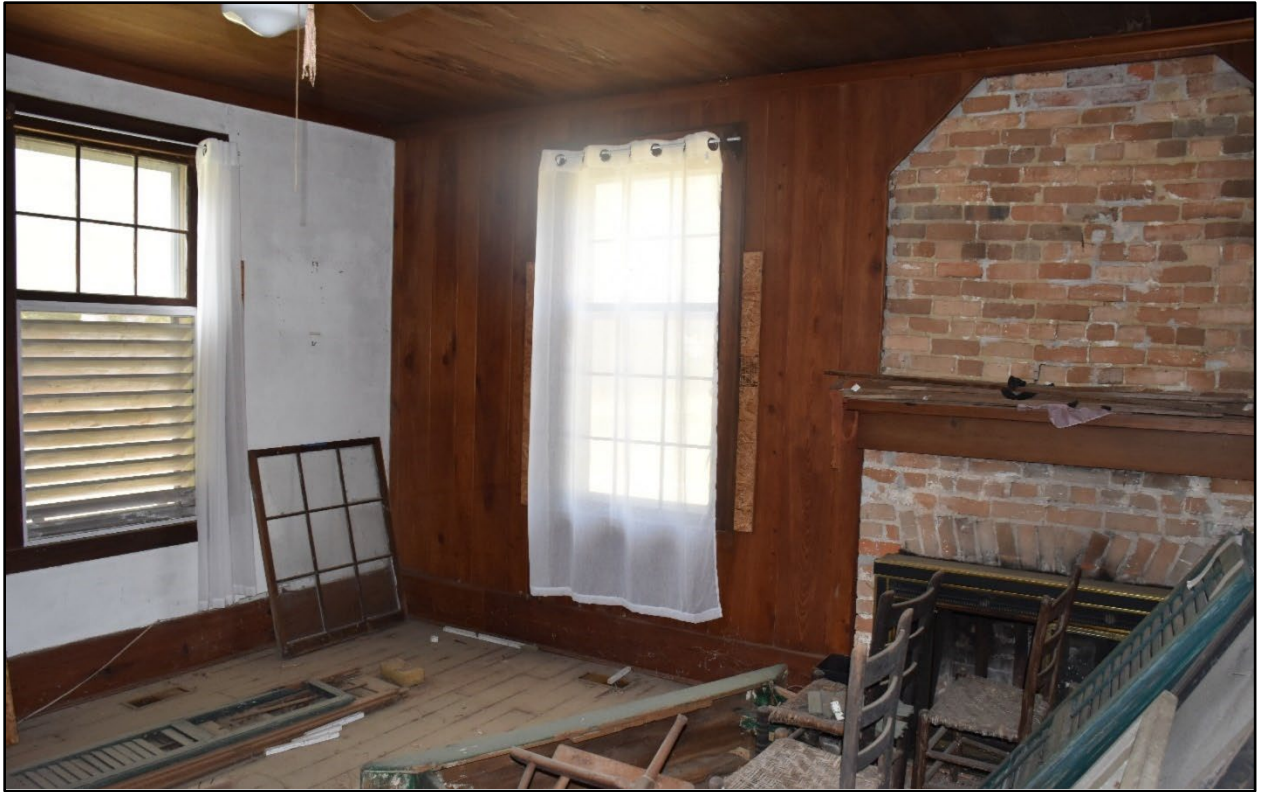
*Figure 121- The rear ell of the house, facing northwest, with non-historic wood paneling on the back wall.*

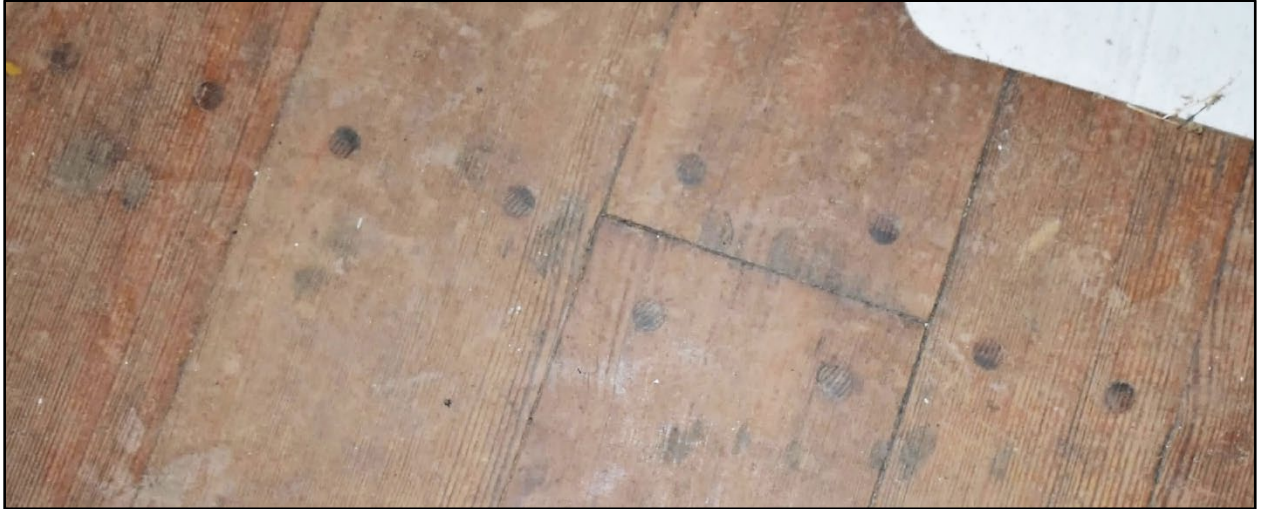
*Figure 123- Historic wood floors in the rear ell, with wood plugs covering nail holes.*

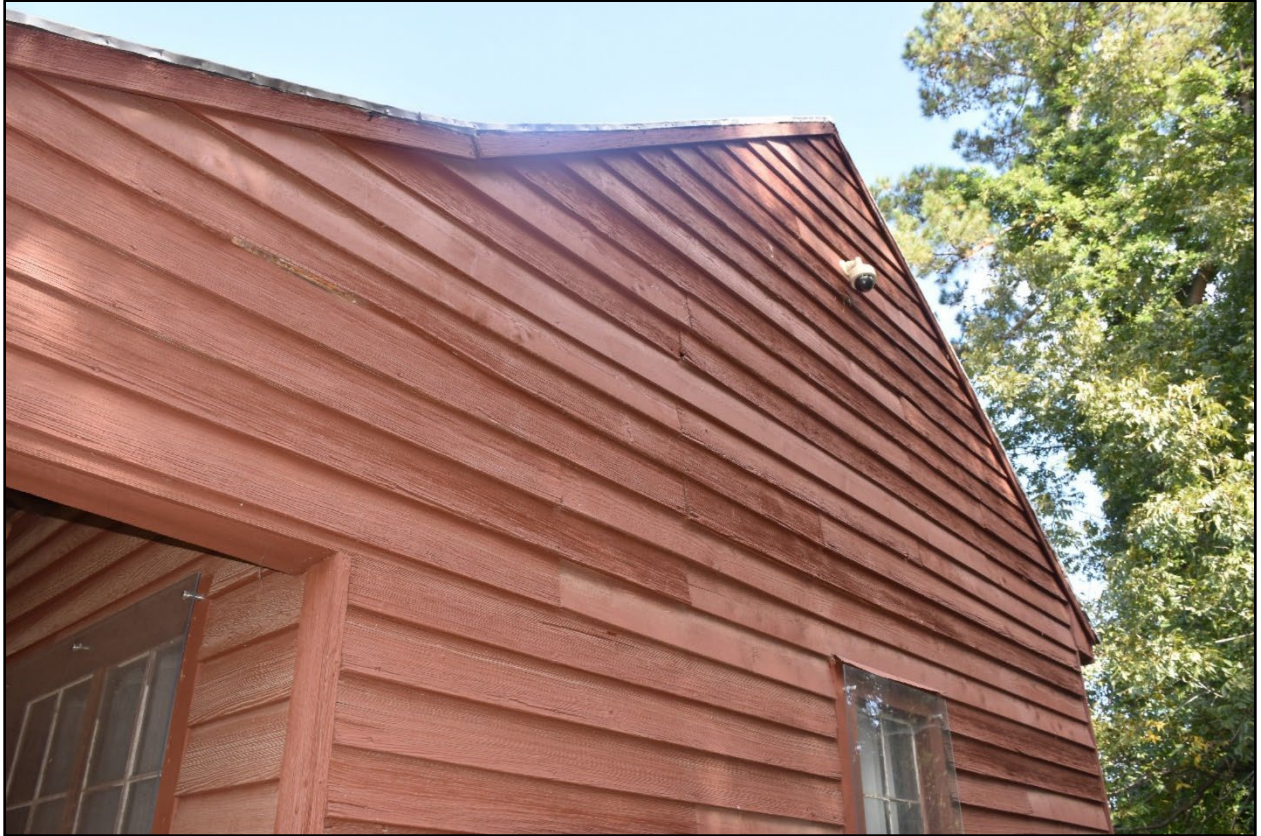
*Figure 173- The wood siding of the kitchen/schoolhouse along the south elevation.*

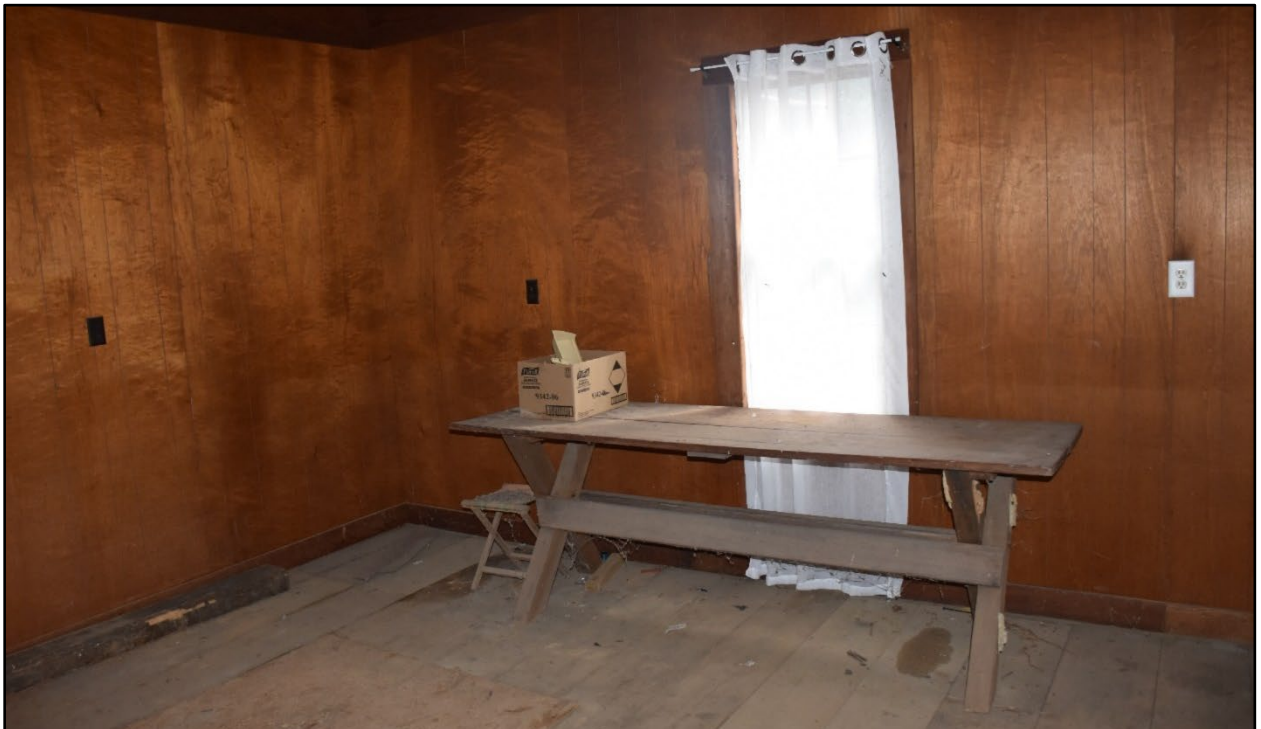
*Figure 179- The south wall of the kitchen/schoolhouse, with historic wood floors and non-historic wood wall paneling.*

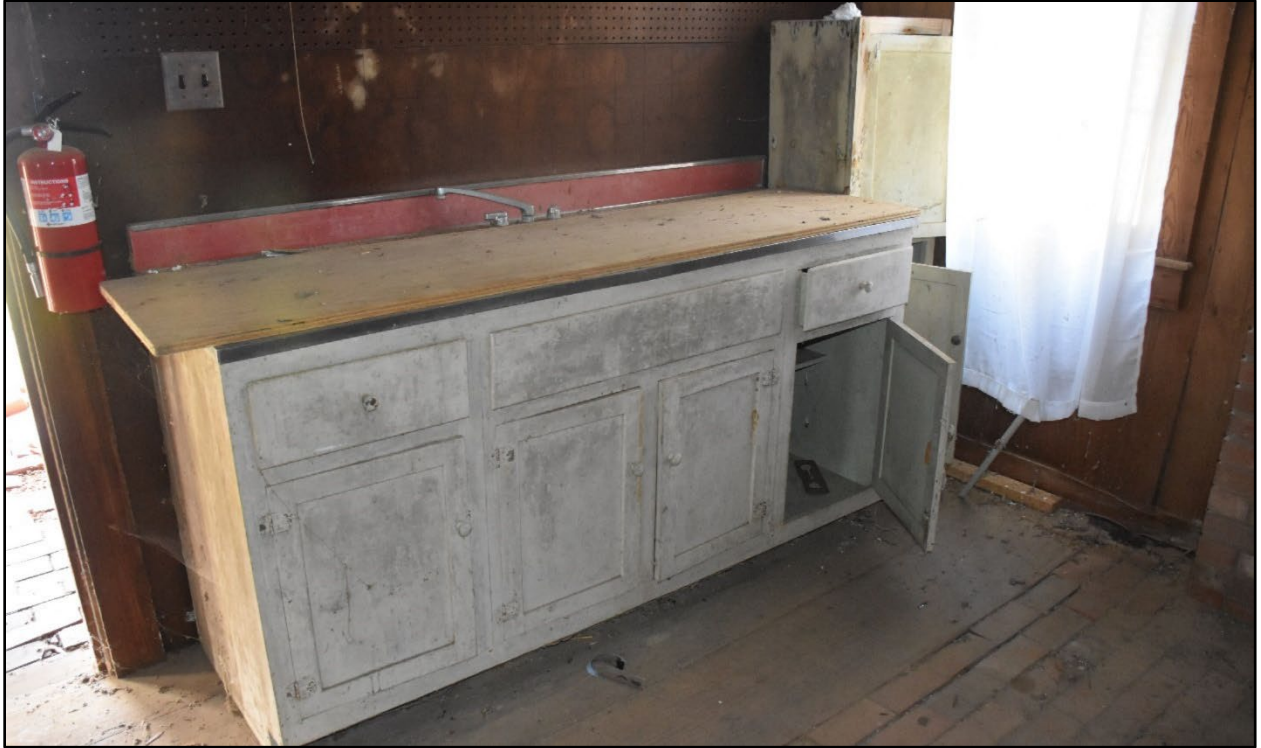
*Figure 180- The lower west wall of the kitchen/schoolhouse, with non-historic cabinetry.*

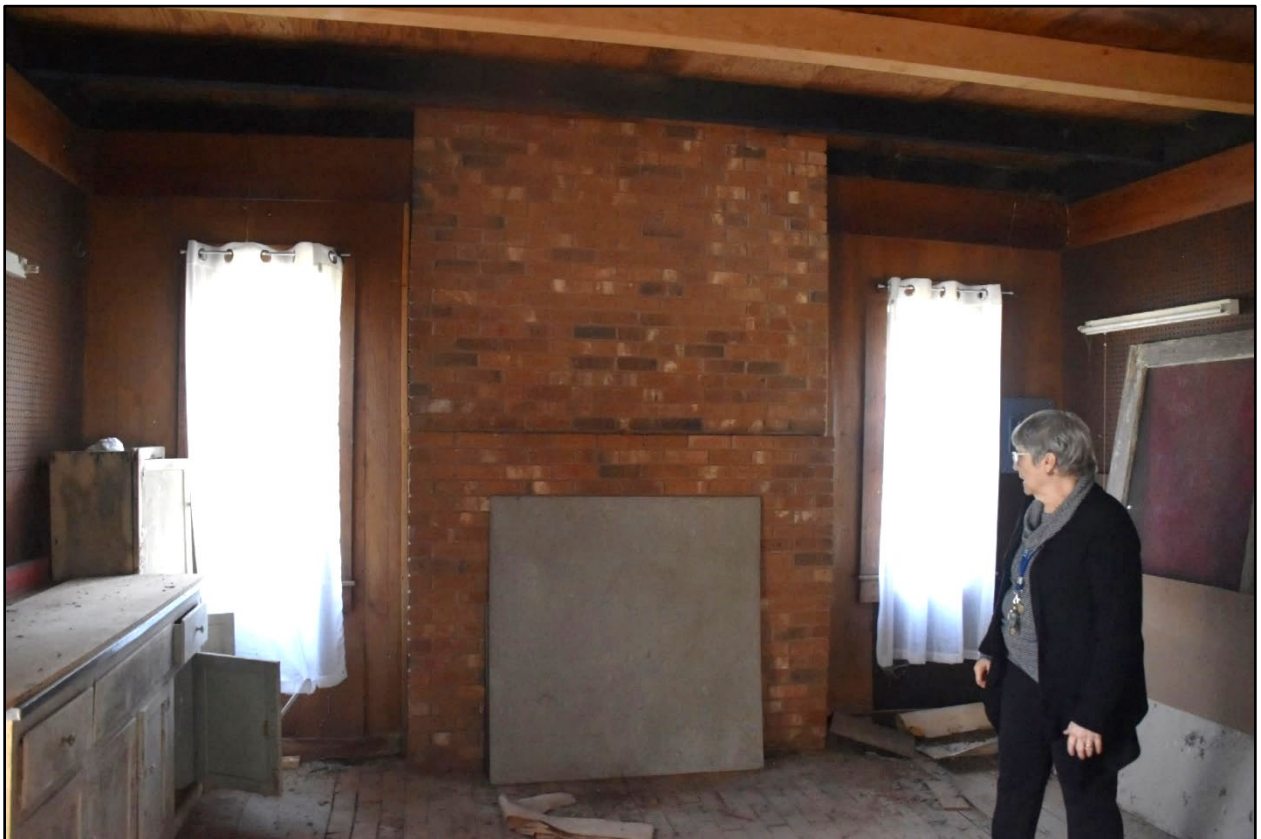
*Figure 181- The north wall of the kitchen/schoolhouse, with non-historic brick veneer over the historic brick chimney.*

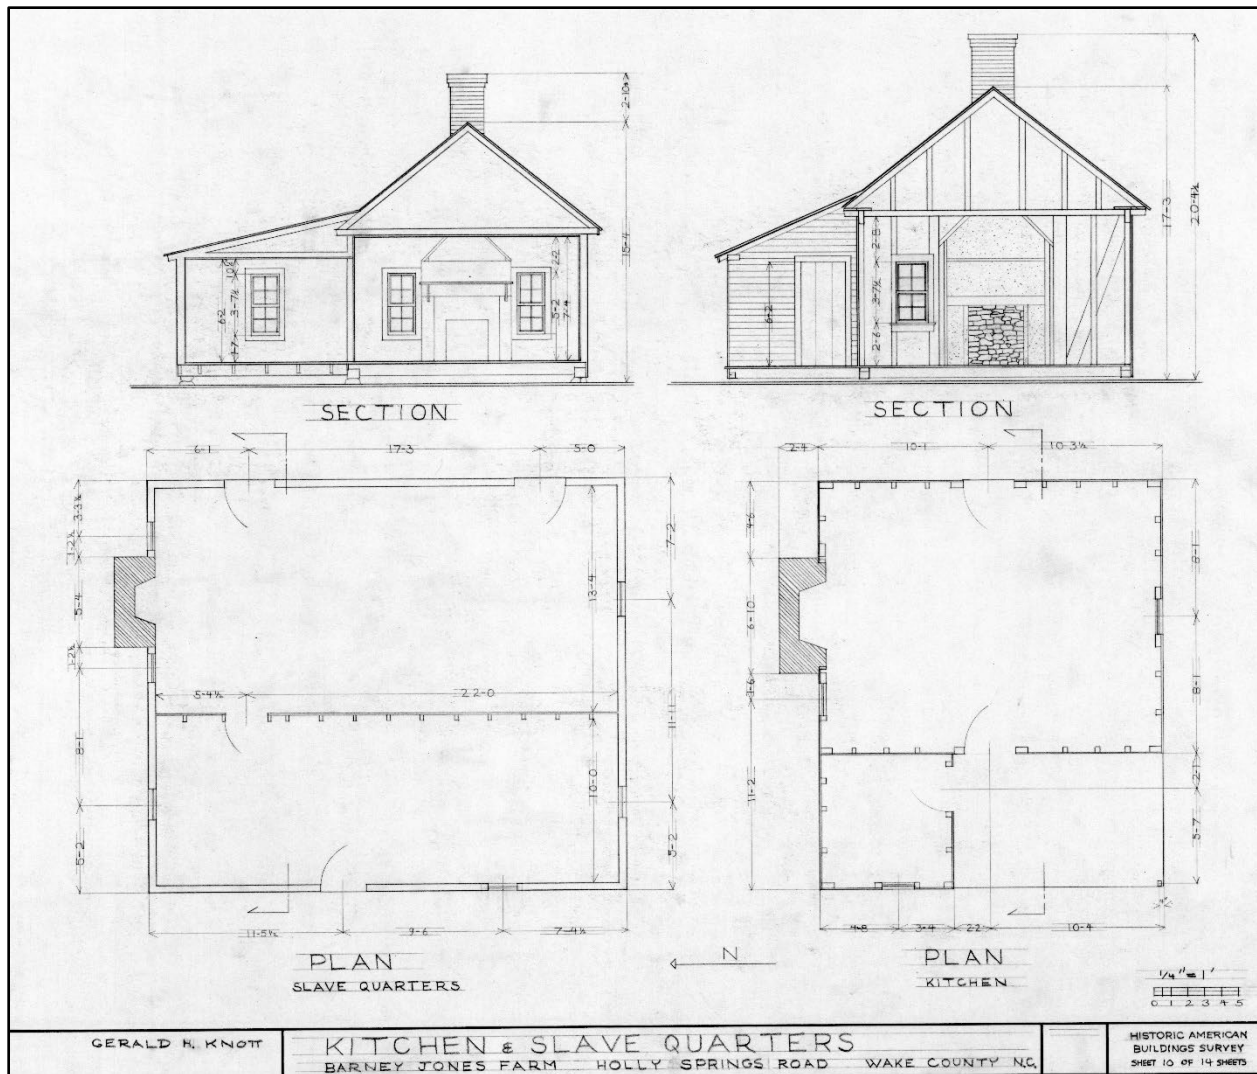
Figure 184- Site plans of the kitchen/schoolhouse (at right) and the purported slave quarters (at left) in 1961; note the presence of a since-removed shed-roofed extension of the slave quarters on the rear/west elevation.

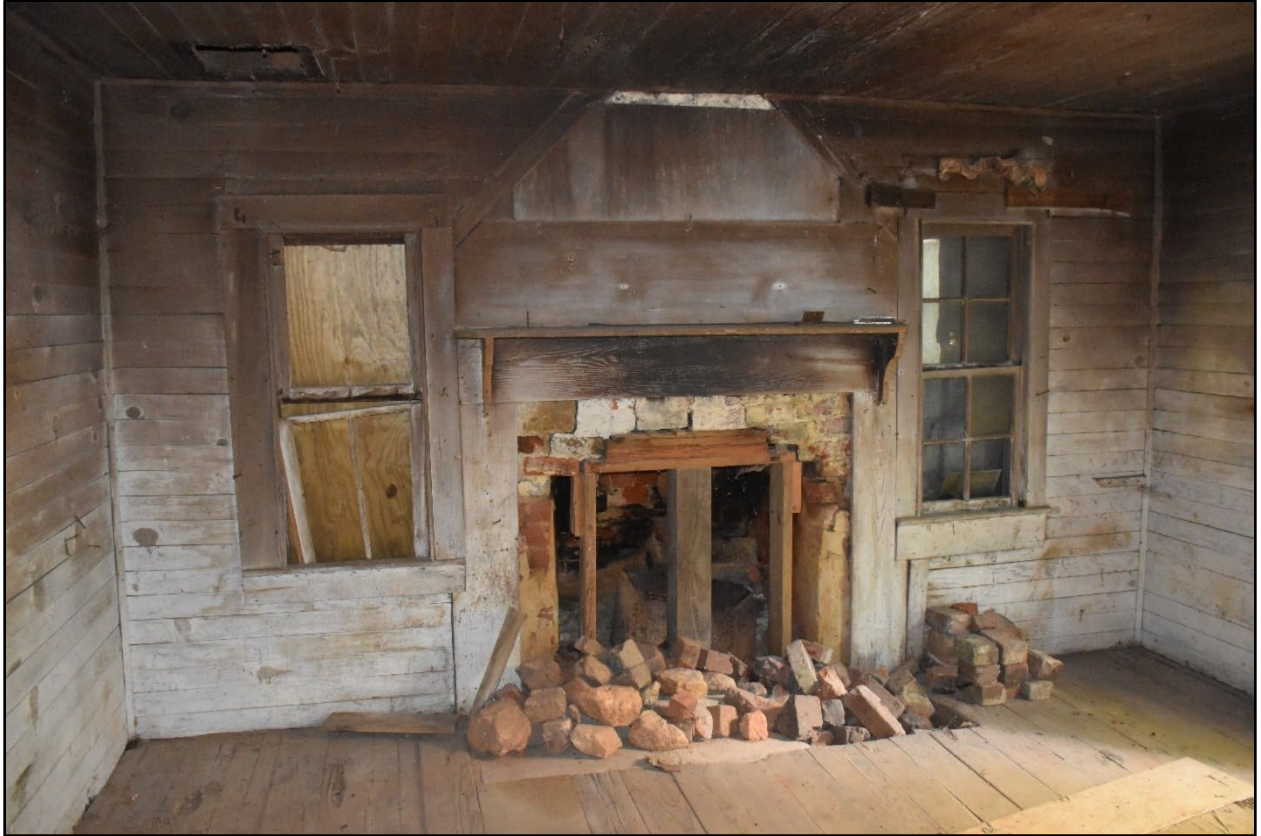
*Figure 191- Inside the north room of the purported slave quarters/Reuben Jones House, facing north towards the covered windows and crumbling fireplace of the north elevation.*

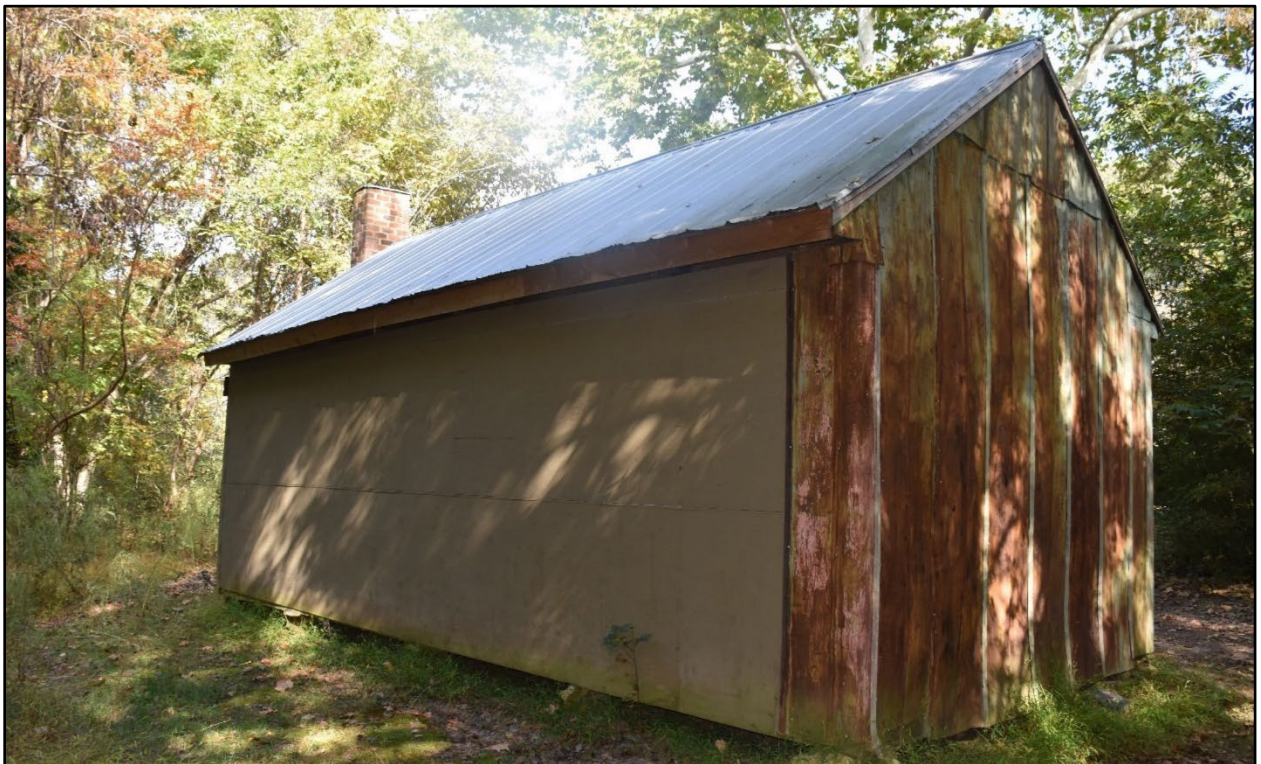
*Figure 196- An oblique view of the structure from the southwest, with historic tin siding visible on the right/south elevation and non-historic modern siding visible on the left/west elevation (alongside the footprint of the shed-roofed addition visible in Figures 211 and 212 that was later removed).*

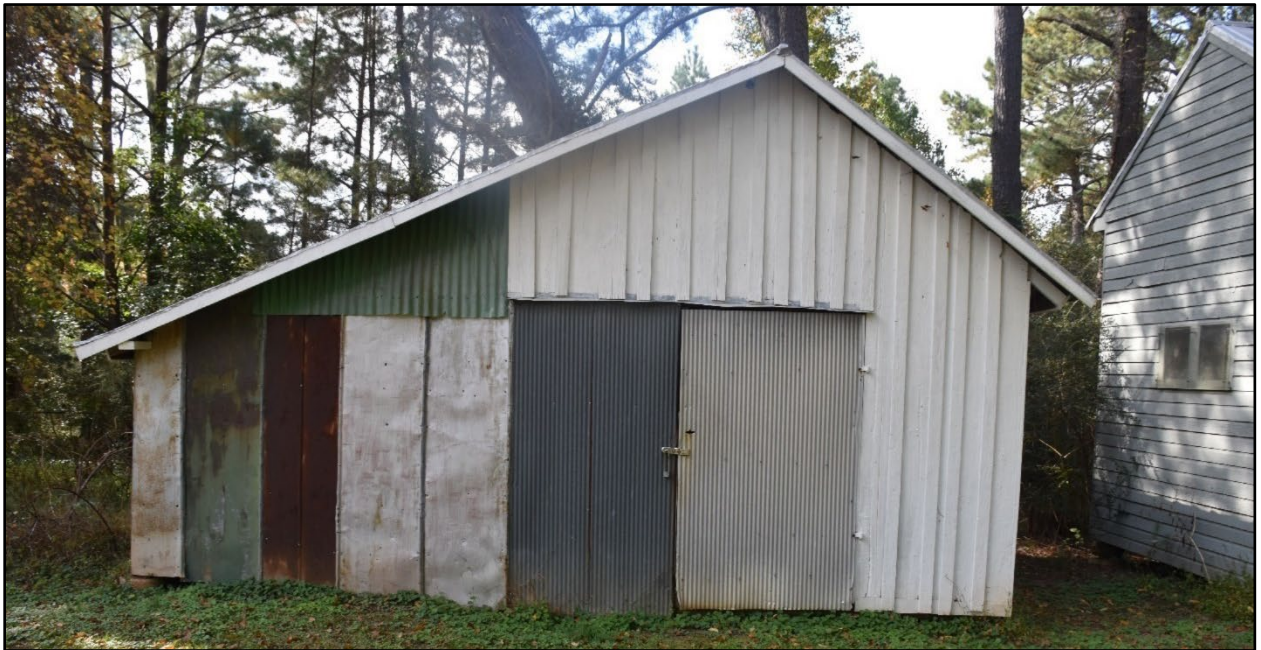
*Figure 202- The east elevation of the cider barn/shed, with an amalgamation of wood, corrugated metal, standing seam metal, and fiberglass siding present.*

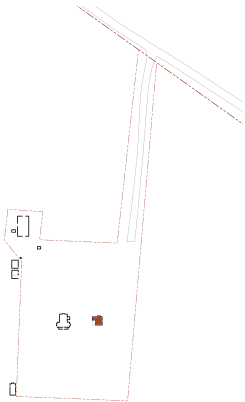
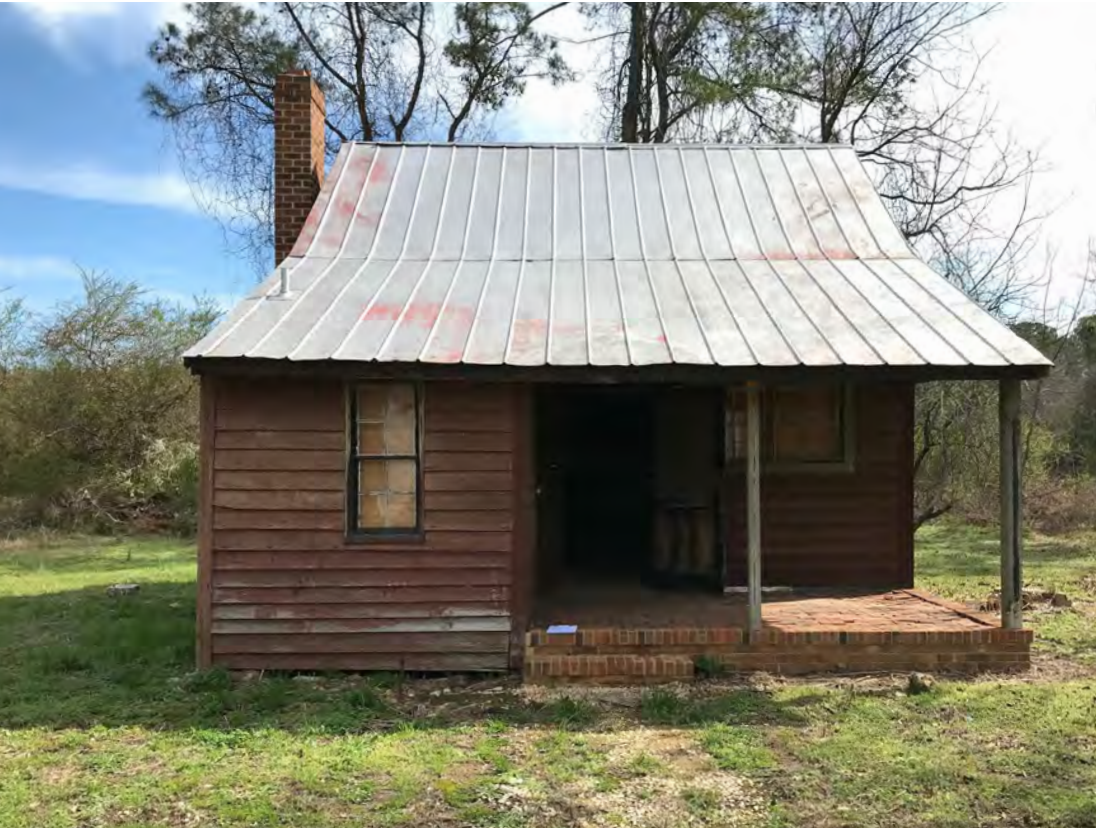
The Dwelling/School House is in fair condition with parts in poor condition. The most critical concern is the chimney pulling away from the structure. Family records indicated Barnabas and his wife lived here while constructing the larger farm house. The structure was then a later detached kitchen to the house, and used as a school house. Family records indicate Barnabas’ daughter, Carrie, taught school in this structure from 1862 until around 1912. <sup>B22</sup>

| | FEATURE NAME | MATERIAL TYPE | CONDITION RATING | PRIORITY RATING | % OR SF IN NEED OF REPAIR | COMMENTS | RECOMMENDATIONS | STRUCTURAL ASSESSMENT (FAIR TO POOR) |
|---|---|---|---|---|---|---|---|---|
| ROOF | Surface Covering | Metal | Poor | Critical | 100% / 450 sf | Rusted, Interior ceiling shows water stains | Replace in kind | |
| EXTERIOR | Surface Covering | Vertical Metal Siding | Fair | Critical | 50% | Siding covered up. Some original wood clapboard siding can be seen adjacent to chimney | Replace siding | A previous lean-to has been demolished/removed with plywood sheathing added. Notable termite damage. |
| | Windows | Wood | Poor | Critical | ~3 windows | Exterior windows boarded up. View from interior - windows are falling out of openings | Repair and Reseal | |
| | Door - Front | Wood | Poor | Serious | 1 door | Not attached to opening and missing boards, Threshold of door currently has metal flashing to protect the opening | Repair / refinish | |
| | Door Jambs | Wood | Poor | Critical | | Termite damage on right interior door jamb | Exterminate and Replace in kind | |
| | Chimney | Brick | Poor | Critical | | Missing Lower portion of chimney, temporarily supported | Rebuild and repair existing brick | Chimney appears to be pulling away from the structure and has been underpinned with steel |
| | Fireplace | Brick | Poor | Critical | | Temporary wood shoring framing the opening, cracked stone base at hearth, brick at hearth removed adjacent to fireplace | Repair hearth base, stabilize fireplace opening, re-lay brick at hearth | |
